# Home Inspection Report

**Prepared By:** Zoey Tham, NJ #24GI00217600

PE Home Inspection, LLC • [www.pehomeinspection.com](http://www.pehomeinspection.com) • 609-203-0265 • pehomeinspection@gmail.com

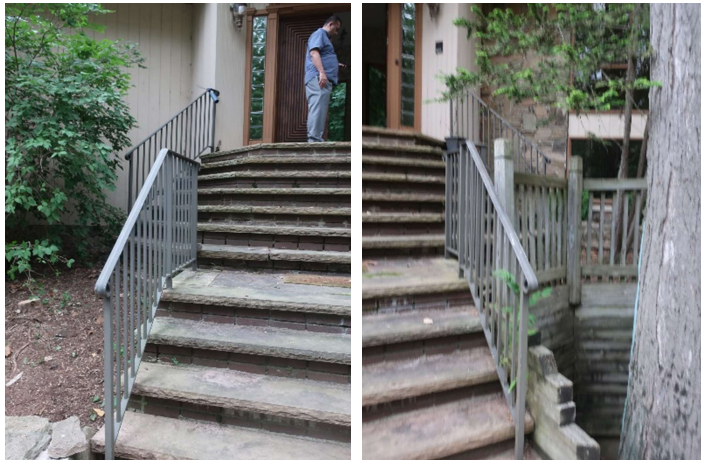
Observation #4.1: The handrails along the stair in front of the main entrance were loose.

Implication: Possible falling hazard.

Comment: Recommends hiring a contractor to secure or replace the handrails.

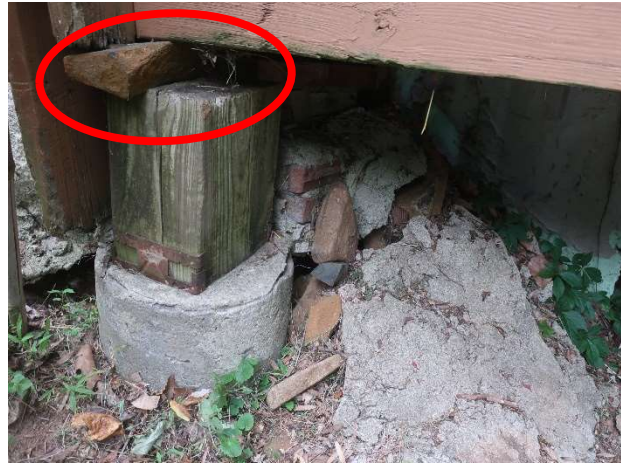
Observation #4.3: One of the wood joists in the large deck at the right side of the building were improperly supported on a wood post with a masonry shim.

Implication: Possible weakened structure

Comment: Recommends hiring a contractor to properly proper connection between the wood joist on the wood post.

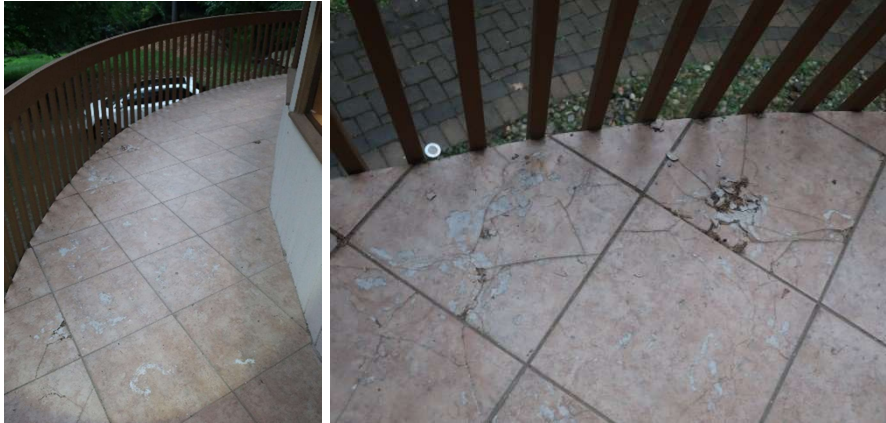
Observation #4.8: A few tiles on the balcony were damaged.

Implication: Possible tripping hazard.

Comment: Recommends hiring a contractor to replace the damaged tiles.

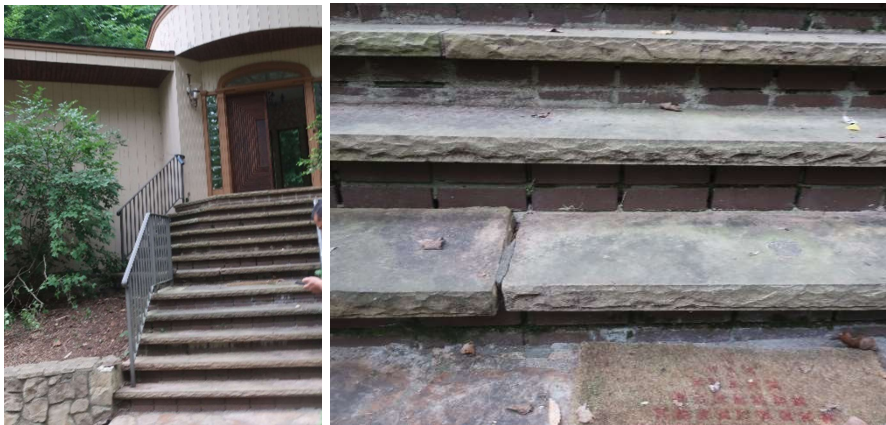
Observation #4.9: The mortar joints between the stone step panels and the brick masonry of the main entrance stair appeared to be deteriorated.

Implication: Possible weaken stair and falling hazard.

Comment: Recommends hiring a contractor to repair the mortar joints.

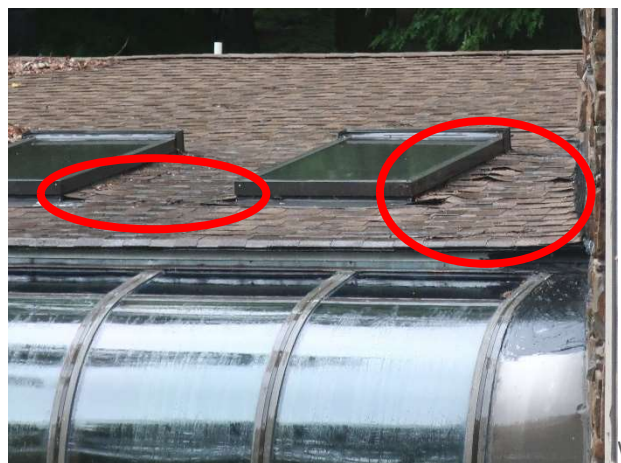
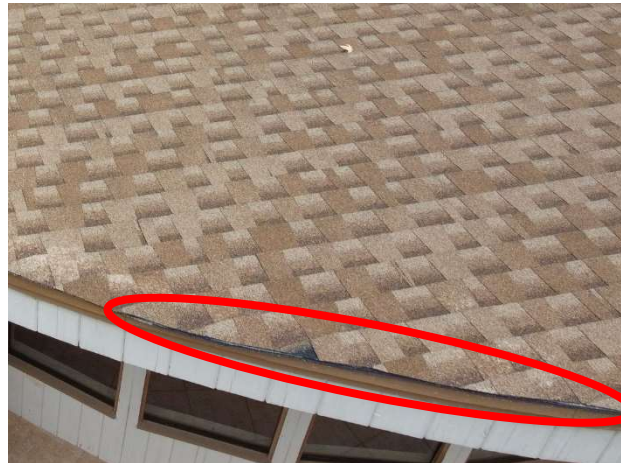
Observation #5.1: Portion of the existing roofing appears to be deteriorated. Fishmouthed shingles were observed around the skylight and at the edge of the roof.

Implication: Possible water infiltration below the shingles and into the house

Comments: Recommends hiring a licensed roofer to further evaluate and repair/replace the roofing as required.

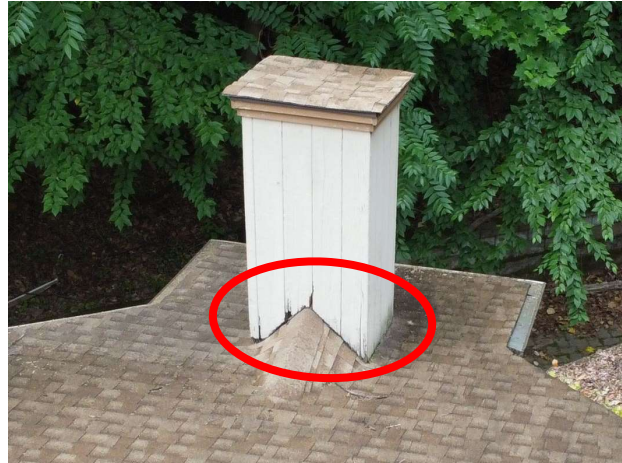
Observation #5.2: Flashing around one of the chimneys appears to be missing. The bottom of the wood shingle cover around this chimney was deteriorated. The flashing behind another chimney appeared to be not properly installed.

Implication: Possible water infiltration below the shingles and into the house

Comments: Recommends hiring a licensed roofer to further evaluate and repair/replace the chimney flashing as required.

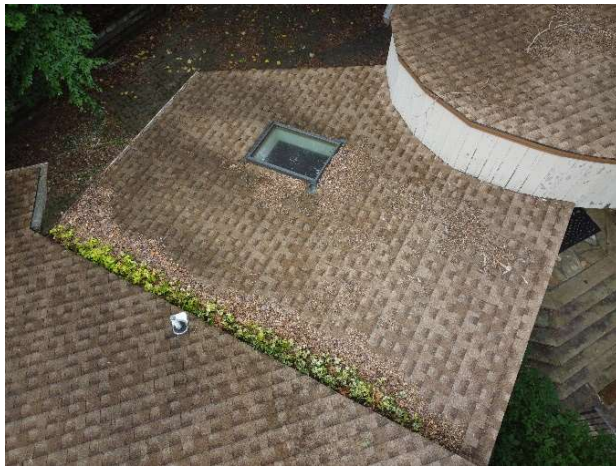
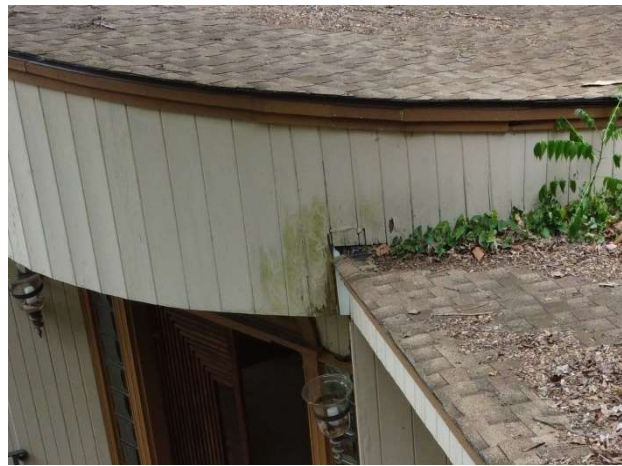
Observation #5.3: Excessive debris was observed on the roof. Vegetation was growing on top of some portion of the roof.

Implication: Possible roofing damage from falling of tree brunch. The saturated leaves on the roof would become compost. The compost from the leave in addition with the excessive moisture from the poor roof drainage would allow vegetation to grow.

Comments: Vegetation can damage the roofing and could cause water infiltration. Recommends cleaning the debris and remove the vegetation on top of the roof and hiring a licensed roofer to further evaluate the roof for required repair/replacement

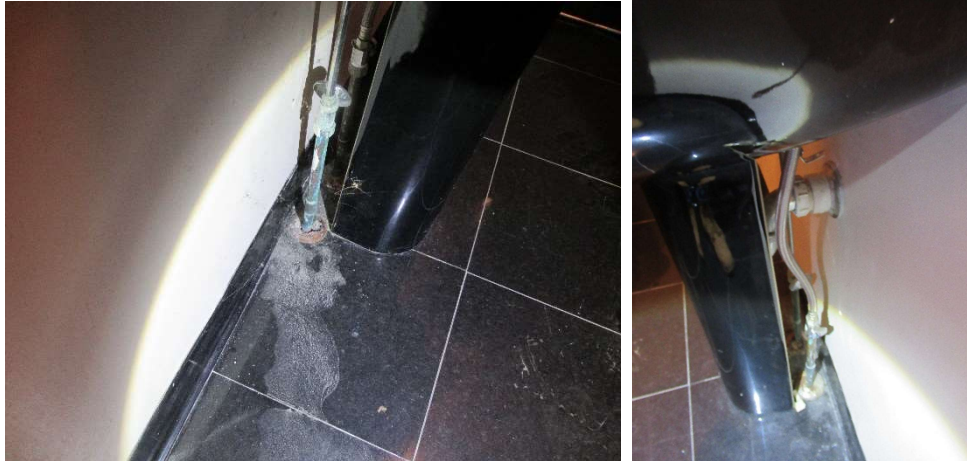
Observation #6.2: Visible patina stain along copper piping, loose copper pipe and broken escutcheon plate

Implication: Indicate excessive moisture or water leakage

Comment: Recommends hiring a plumber for further evaluation and repair.

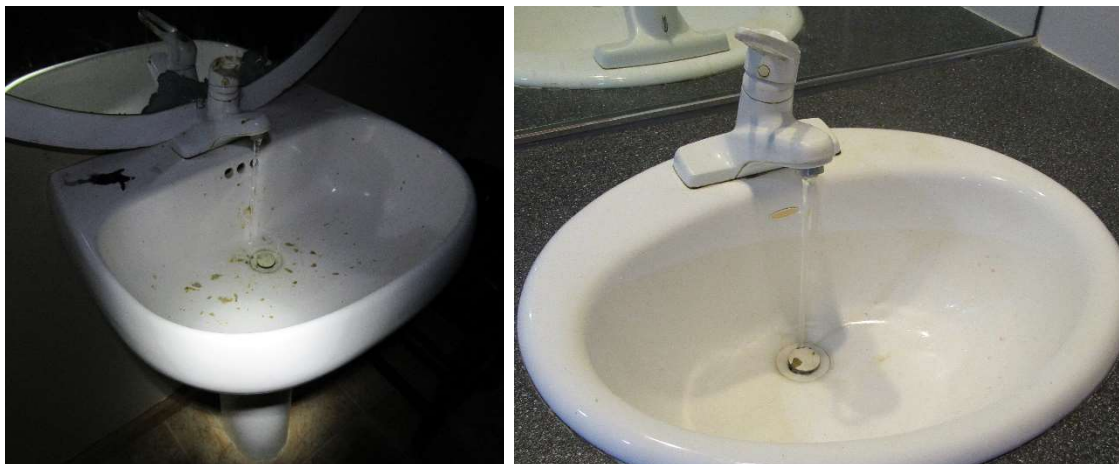
Observation #6.3: The water pressure in most of the bathroom sink was low

Implication: Possible water piping system clogged by debris such as dirt, debris, mineral deposits, and corrosion.

Comment: Recommends hiring a plumber for further evaluation and repair.

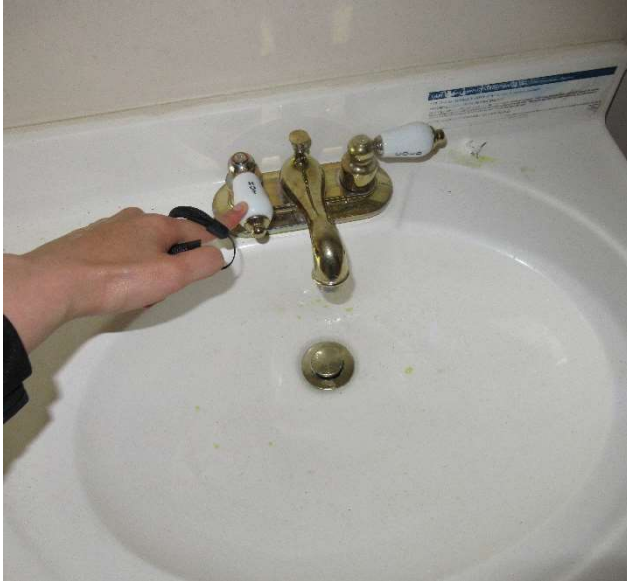
Observation #6.4: There was no hot water supply on all the hot water faucets.

Implication: The gas water heater system may be faulty.

Comment: Recommends hiring a plumber for further evaluation and repair and HVAC to inspect the gas water heater.

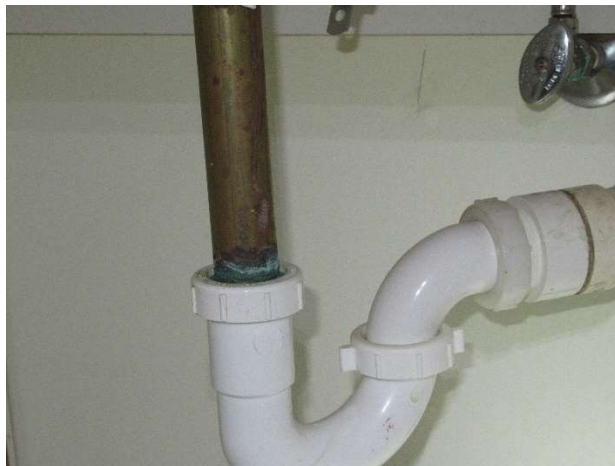
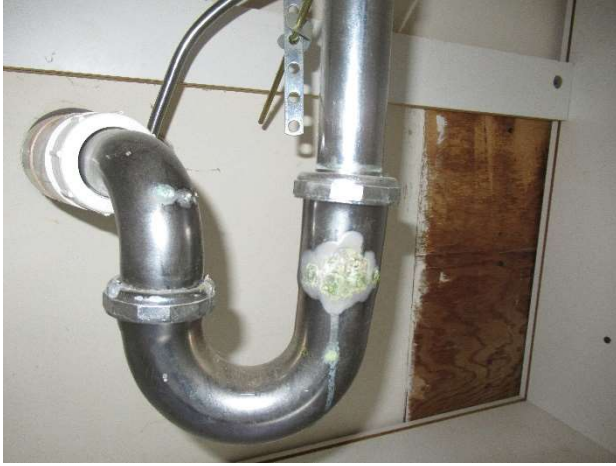
Observation #6.5: Visible patina stain along copper piping under bathroom sink

Implication: Indicate excessive moisture or water leakage

Comment: Recommends hiring a plumber for further evaluation and repair.

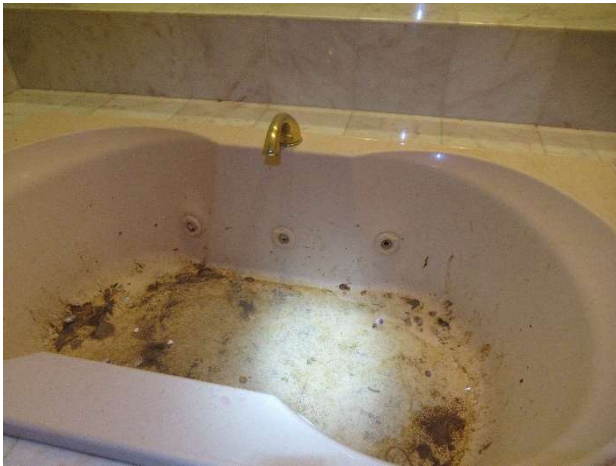
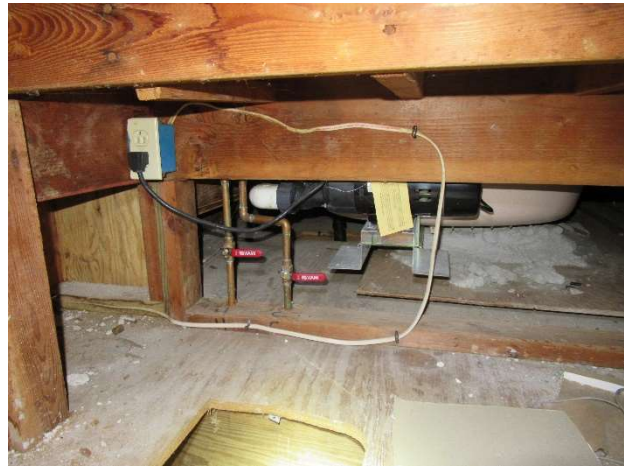
Observation #6.6: Master bedroom bathroom tub was not functioning. The water supply valves were shut off.

Comment: Recommends consulting the seller agent regarding the operational of the bathtub.

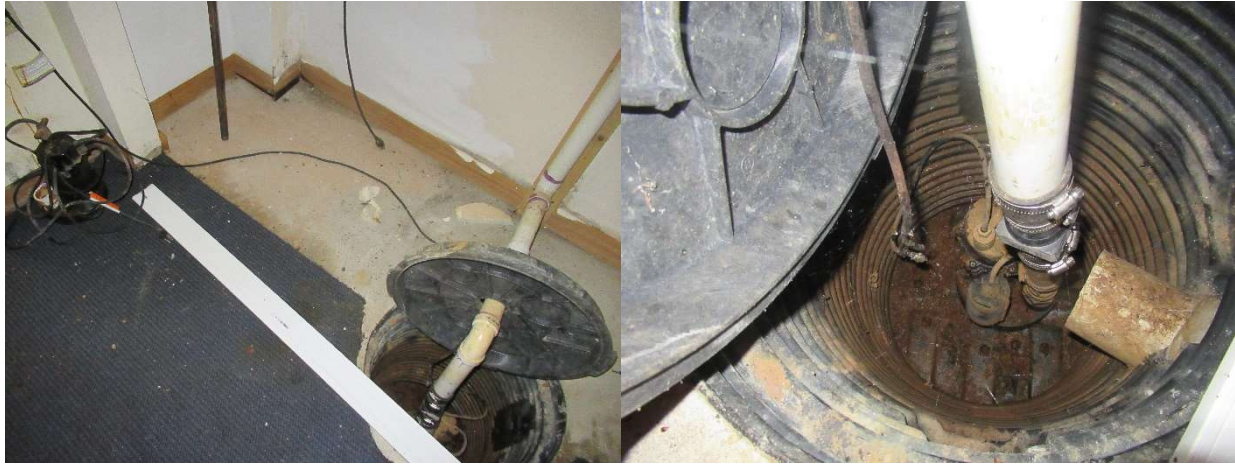
Observation #6.9: The sump pump in the basement was observed to be inoperable

Implication: Possible risk of flooding hazards in the basement.

Comment: Recommends hiring a handyman to repair or replace the sump pump.

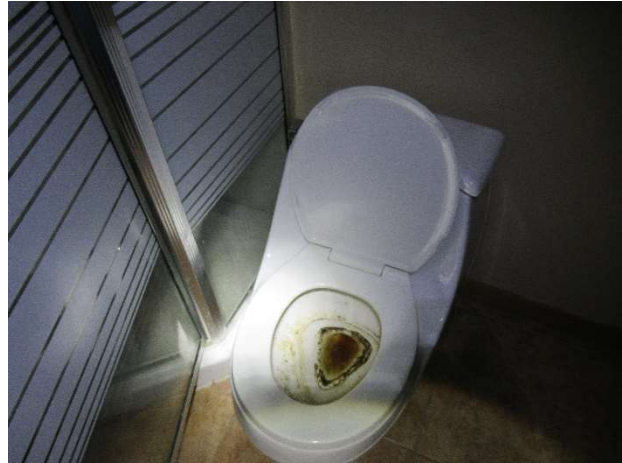
Observation #6.11: Most of the sinks appeared to be dirty and missing sink drain cover. Most of the toilets were observed to be dirty.

Comment: Recommends regular cleaning and maintenance.

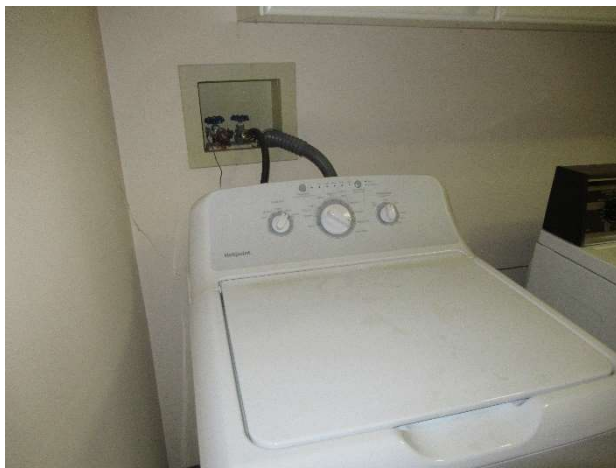
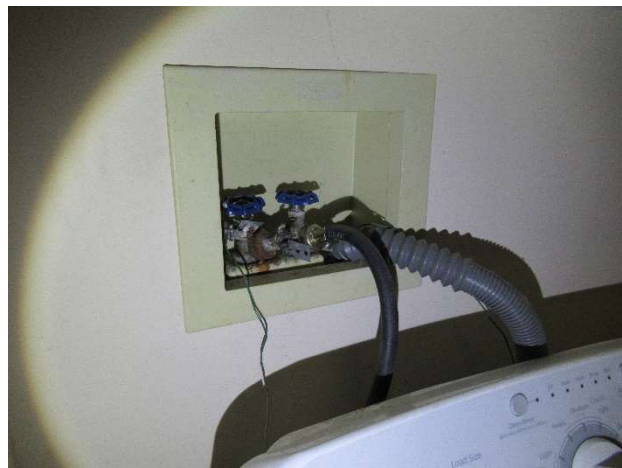
Observation #6.12: One of the washer machine valves was missing a connecting pipe

Implication: Possible missing hot or cold-water feed.

Comment: Recommends hiring a plumber for further evaluation and repair as required.

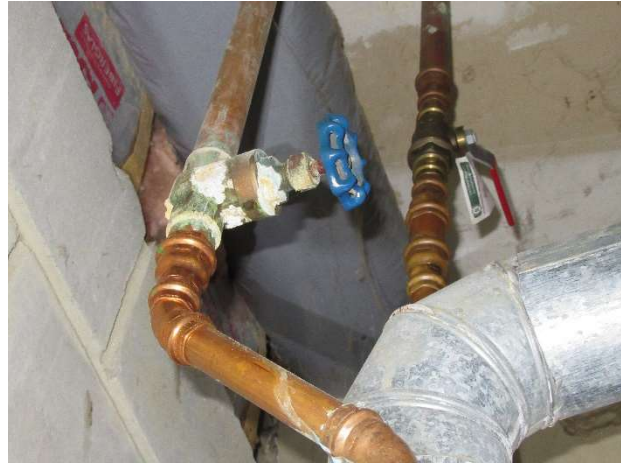
Observation #6.13: Visible patina stain along copper piping

Implication: Indicate excessive moisture or water leakage

Comment: Recommends hiring a plumber for further evaluation and repair.

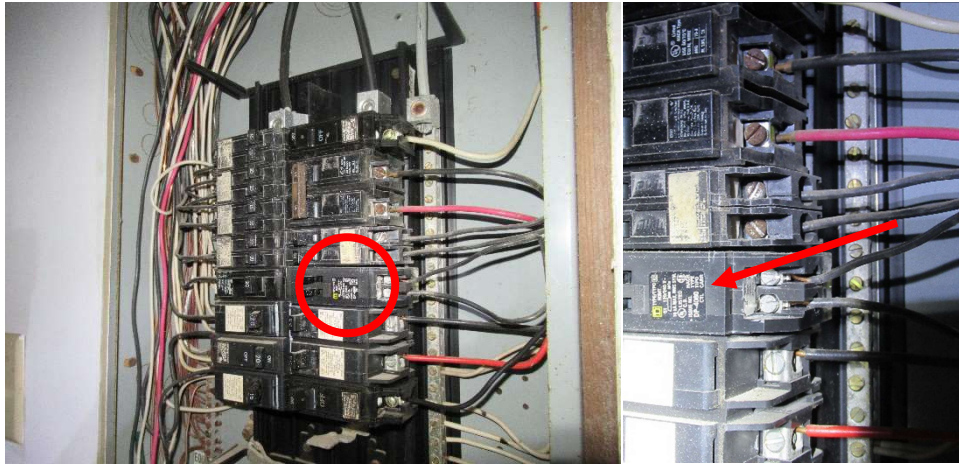
Implication: Possible safety hazard

Comment: A breaker from different manufacturer may not be used even if it seems to fit. Recommends hiring an electrician for further evaluation and replacement.

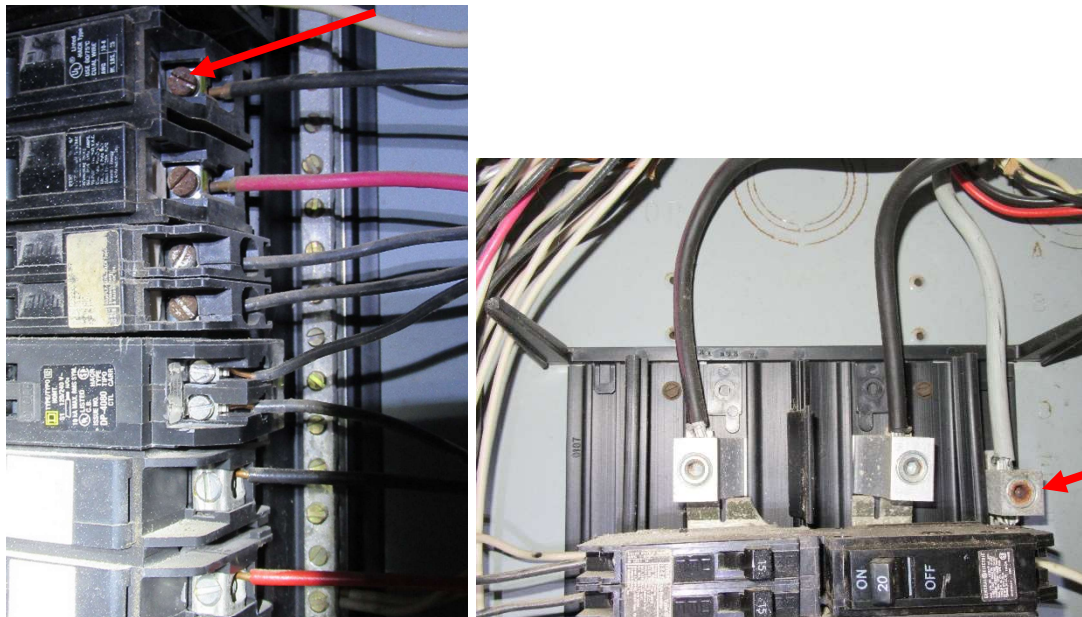
Observation #7.8: Visible corrosion on the screw inside electrical panels

Implication: Indicate excessive moisture condition in the basement area

Comment: Recommends hiring an electrician for further evaluation, repair and replacement.

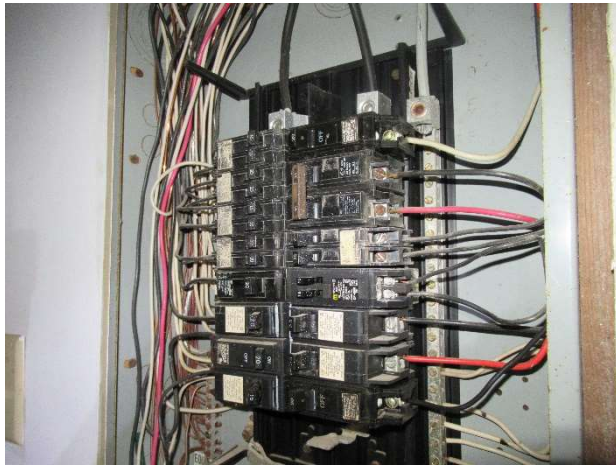
Observation #7.9: White wire was connected to a dual-pole circuit breaker

Implication: The conductors connecting dual-pole circuit breakers are “hot”, white wire is an incorrect color.

Comment: Recommends this white wire to be marked with colored tape or paint by an electrician.

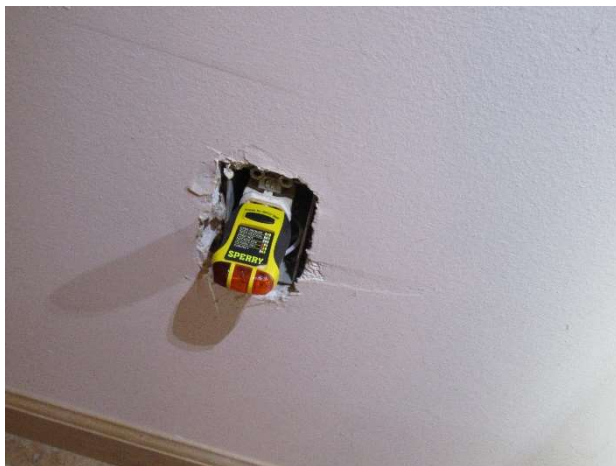
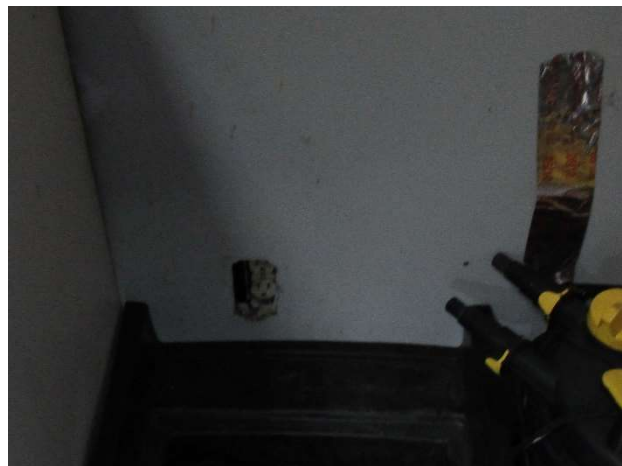
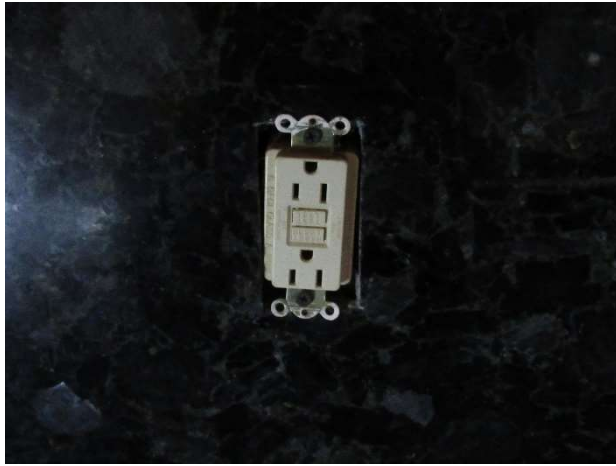
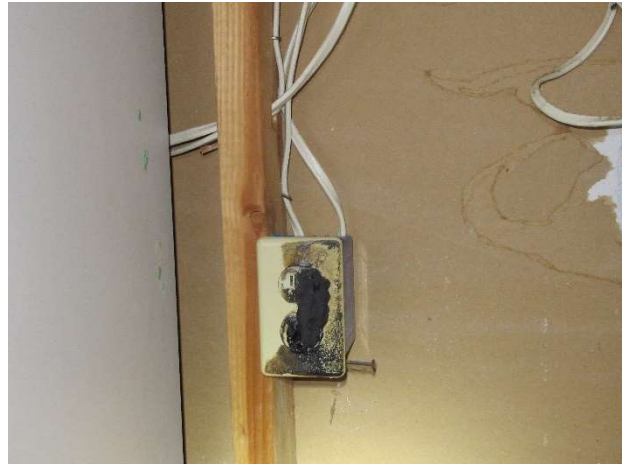
Observation #7.12: Multiple receptacle outlets were malfunction and missing cover plate

Implication: Possible safety hazard

Comment: Recommends hiring an electrician for further evaluation, repair and replacement.

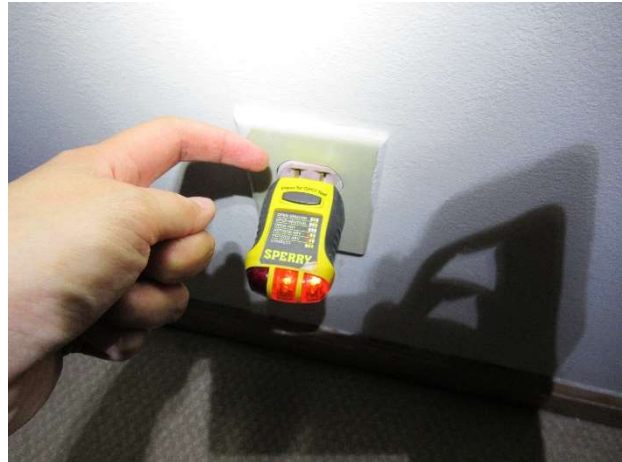
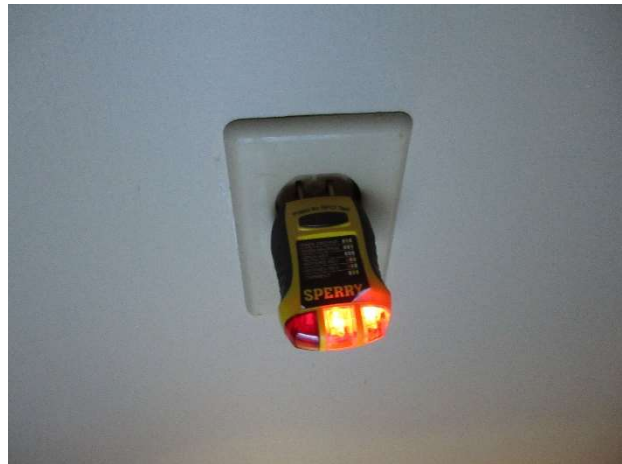
Observation #7.17: The electrical tester was not able to plug in all the way on some of the electrical outlets

Implication: Possible safety hazard

Comment: Recommends hiring an electrician for further evaluation, repair and replacement.

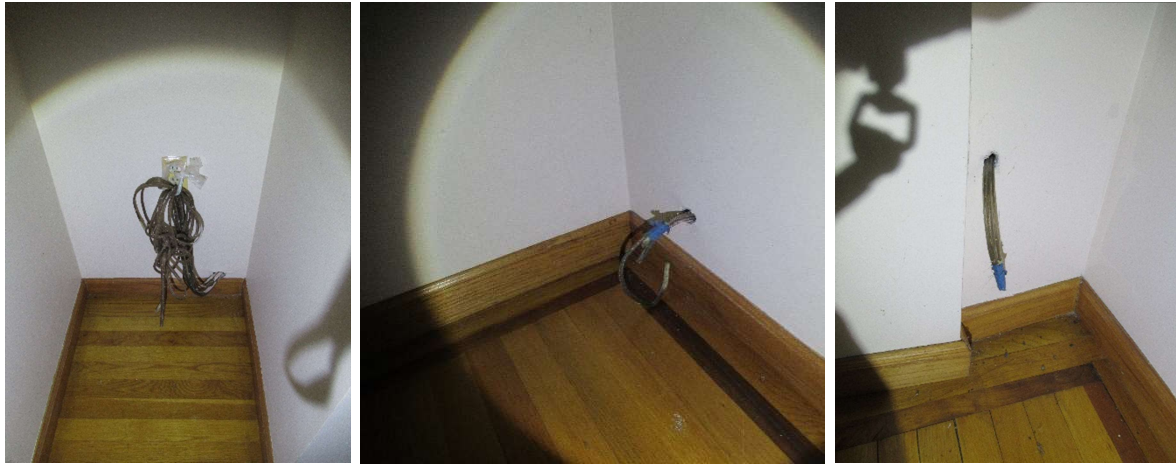
Observation #7.18: There were a few conductors terminated at walls without proper enclosure

Implication: Possible safety hazard

Comment: Recommends hiring an electrician for further evaluation, repair and replacement.

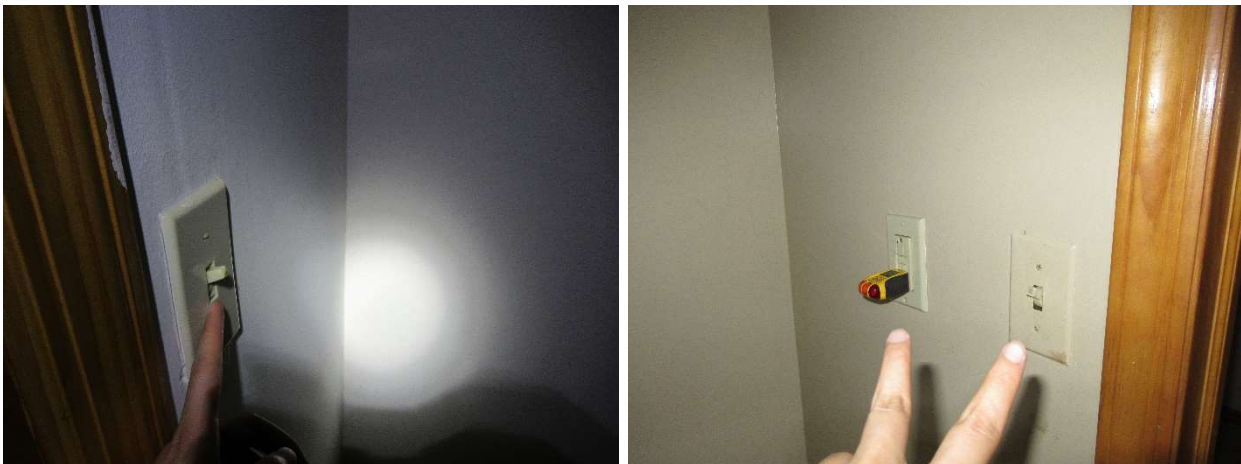
Observation #7.19: Some of the electrical switches were malfunction

Comment: Recommends hiring an electrician for further evaluation, repair and replacement.

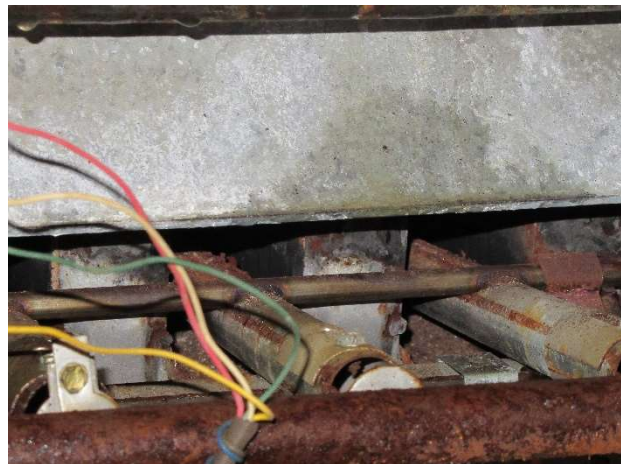
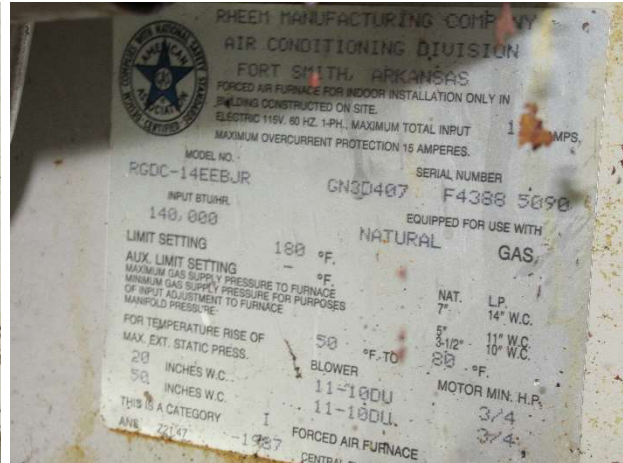
Observation #8.1: The furnace was malfunction and the ribbon burners appeared to be severely rusted. The furnace manufacture date is 1988 and it is near the end of the service life.

Comment: Recommends installing new furnace.

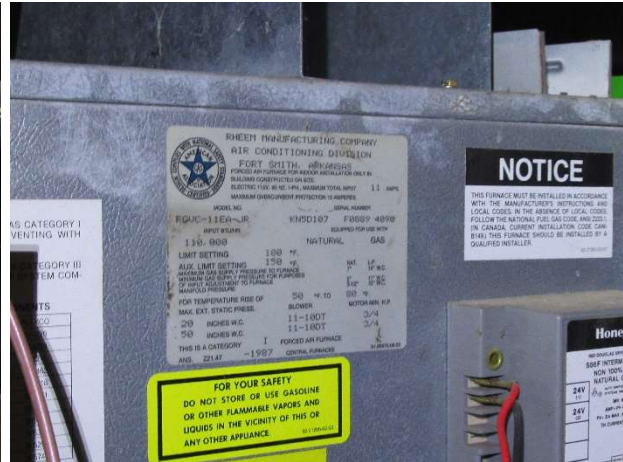
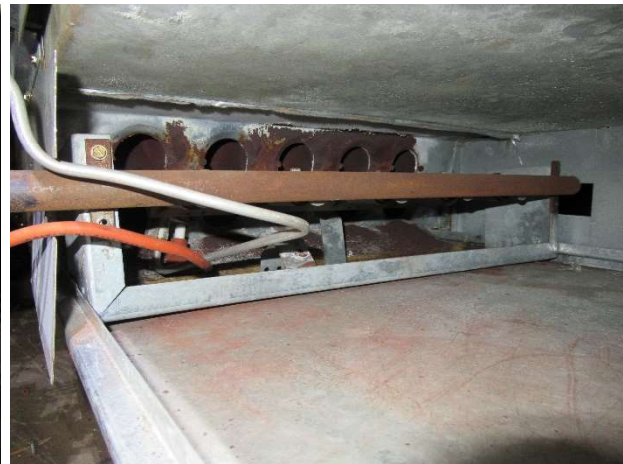
Observation #8.5: The furnace was malfunction and rusty. No flame was observed during test run. The furnace manufacture date is 1989 and it is near the end of the service life.

Comment: Recommends installing new furnace.

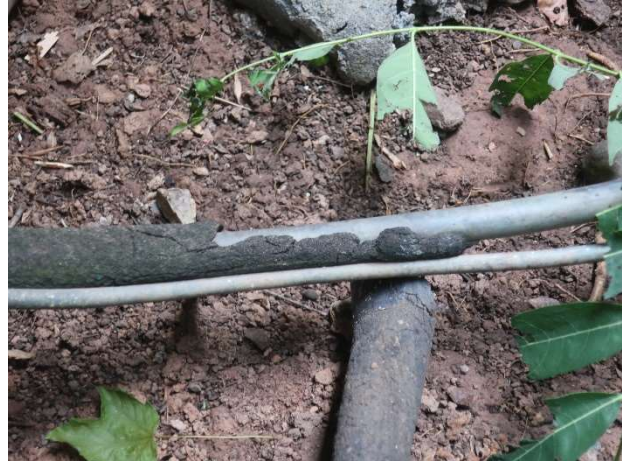
Observation #9.2: The insulation on outdoor air conditioner freon line was deteriorated with section loss.

Implication: Reduce efficiency of air conditioning system

Comment: Recommends repair or replacement of freon line insulation.

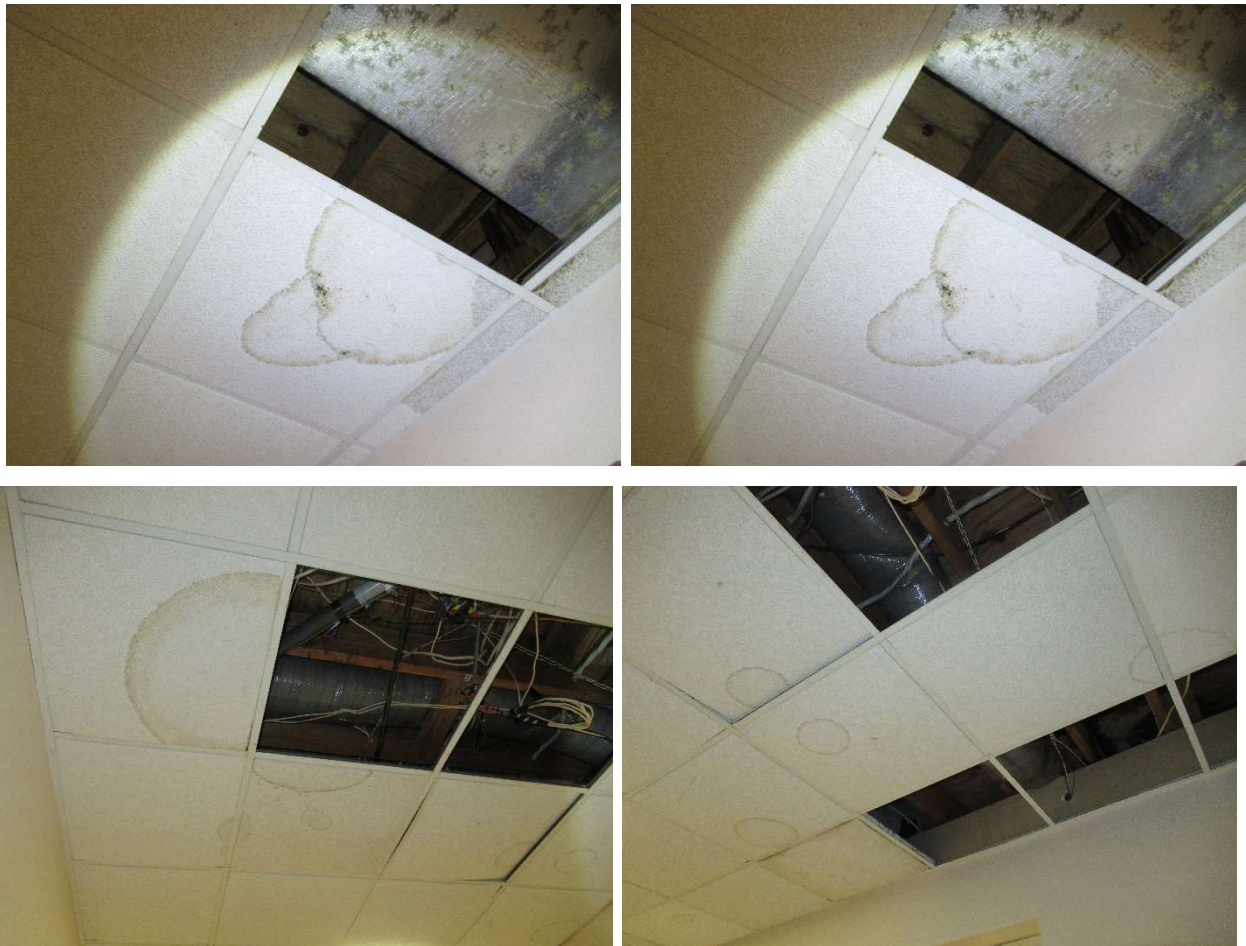
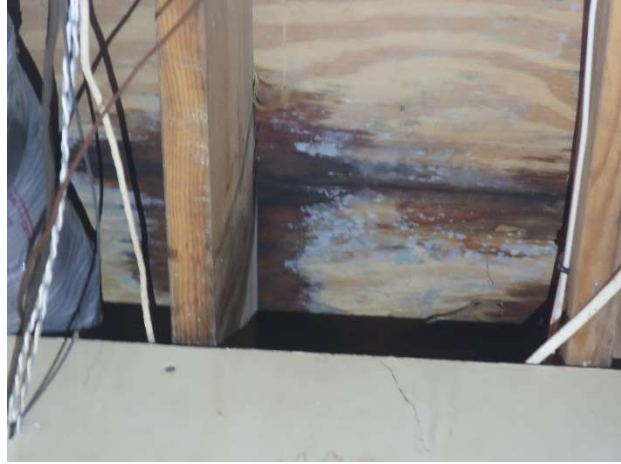
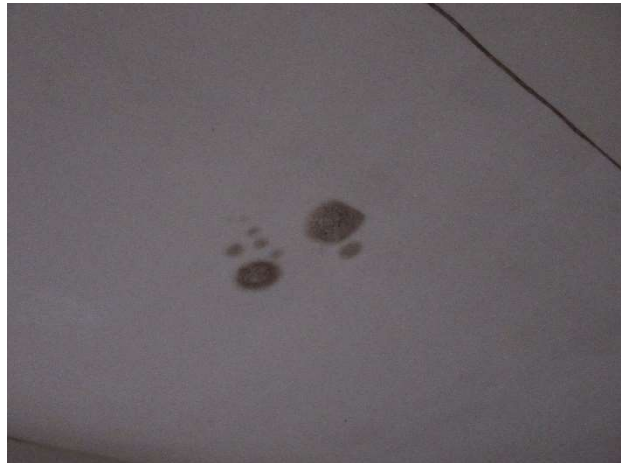
Observation #10.2: Water stains were observed in the basement drop ceiling and garage ceiling at many locations. Mold was observed on some of the floor planks above the drop ceiling.

Implication: Possible previous water leakage from piping or floor above.

Comments: Recommends hiring a contractor to replace the drop ceiling with water stains and hiring a plumber to evaluate the piping above the ceiling for possible source of water leakage and perform the required repair.

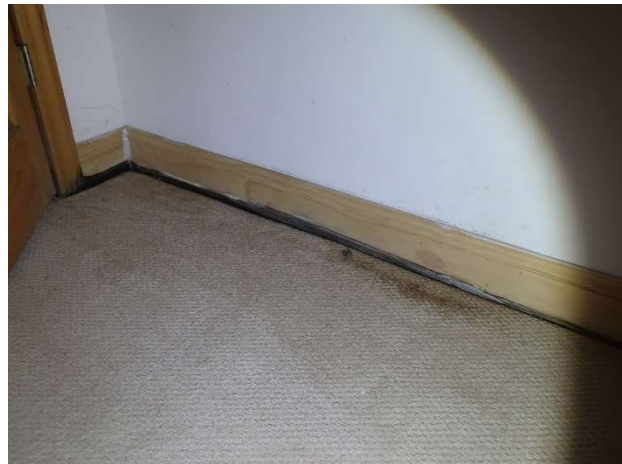
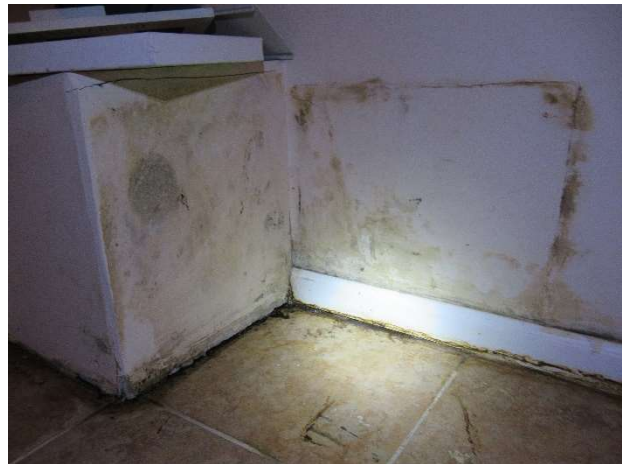
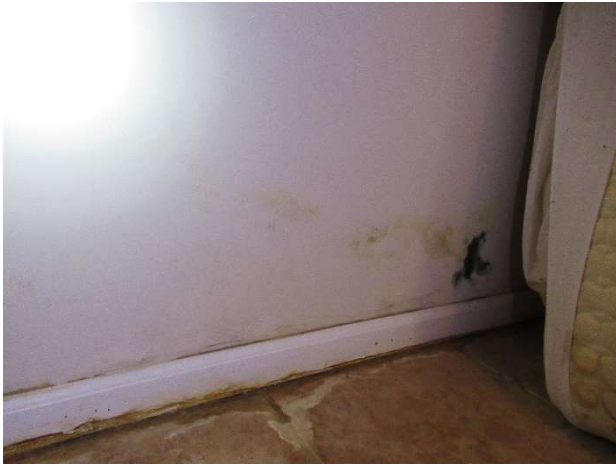
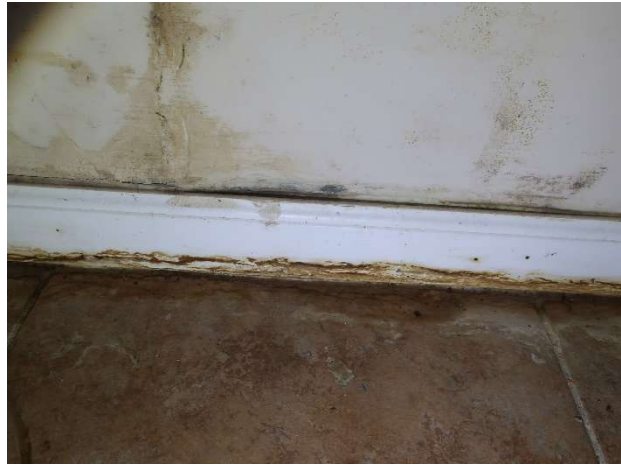
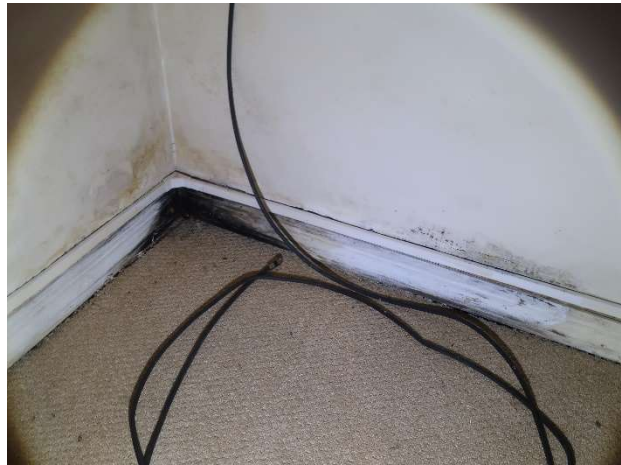
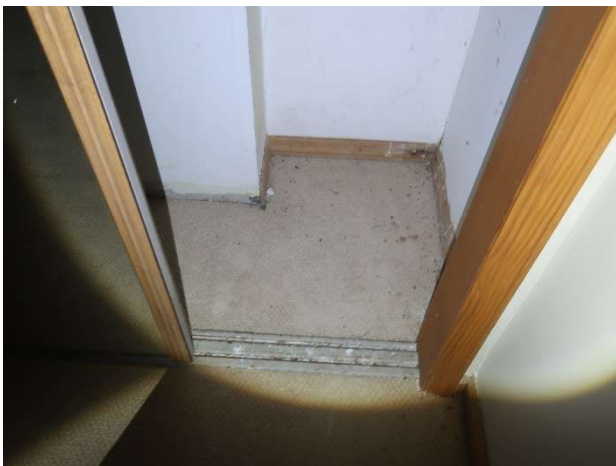
Observation #10.3: Water stain and mold were observed at multiple locations along the interior face of the basement wall.

Implication: Health Issue. Excessive moisture condition in along the basement wall. Possible water infiltration from the exterior side of the wall. This could imply possible damage of the waterproofing at the exterior side of the foundation wall or even damage in the foundation walls.

Comments: Recommends hiring a contractor and a structural engineer to further investigate the source of the water infiltration and the condition of the existing foundation wall. Repair the damaged waterproofing and foundation walls as required. Remove and replace the damaged interior wall finishes and floor moldings.

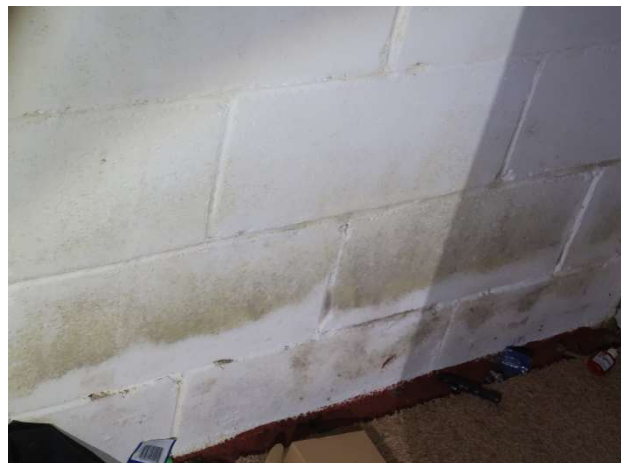
Observation #10.4: The bottom of the masonry wall in the garage space appeared to have black mold stains.

Implication: Health Issue. Excessive moisture condition in along the bottom of the masonry wall. Possible water infiltration from the exterior side of the wall.

Comments: Recommends hiring a contractor and a structural engineer to further investigate the source of the water infiltration and the condition of the existing masonry wall. Install waterproofing and repair masonry walls as required.

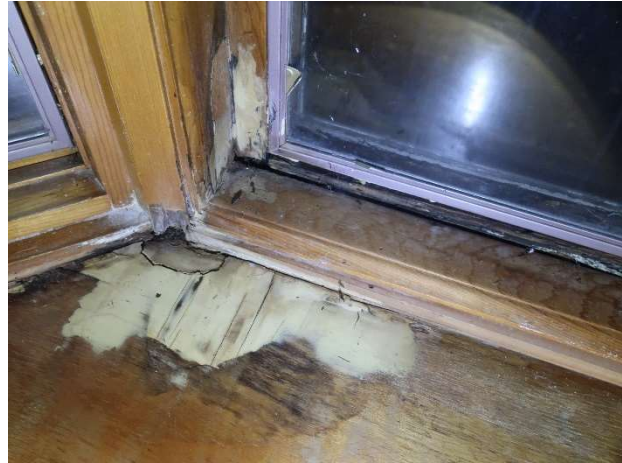
Observation #10.6: One of the bay window frames appeared to have significant water damage.

Implication: Water infiltration. Possible damage to window and adjacent structural components.

Comments: Recommends hiring a window profession to the replace the window frame and the window as required.

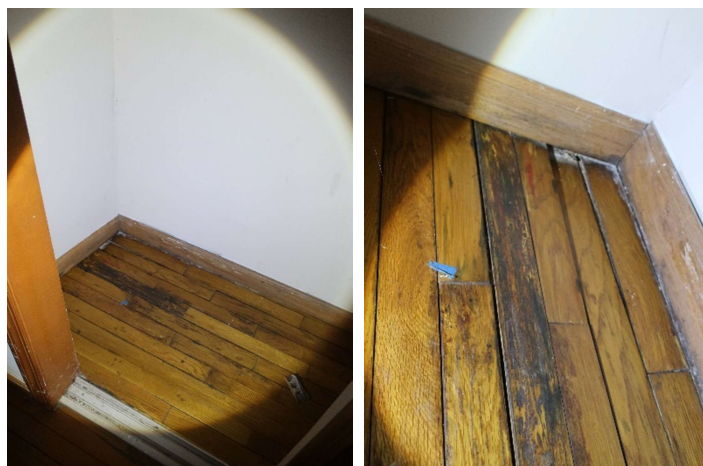
Observation #10.7: The hardwood floor finish in a closet on the 1<sup>st</sup> floor appeared to have water damaged and is loose.

Implication: Water infiltration. Possible tripping hazard.

Comments: Recommends hiring a contractor to replace the damaged and loose floor finish and evaluate the floor structure below.

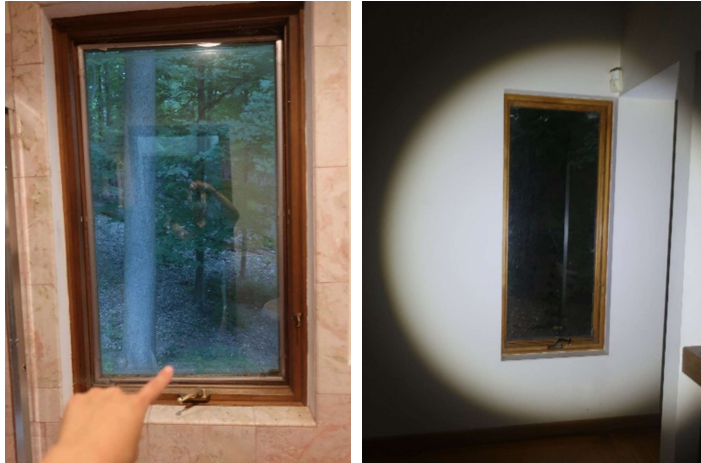
Observation #10.8: Some of the windows were inoperable or broken.

Comments: Recommends hiring window professional to further evaluate and replace the windows as required.

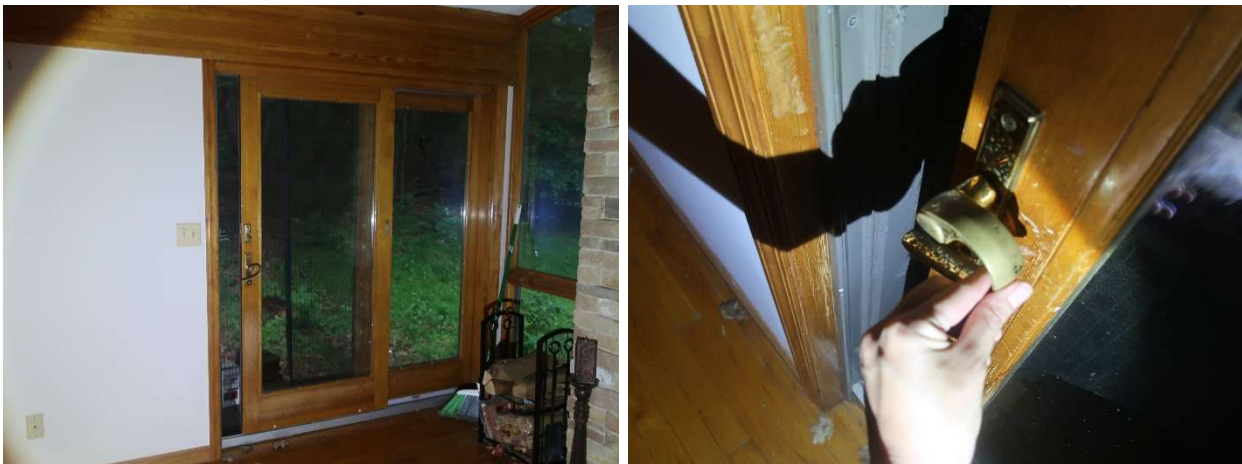
Observation #10.9: The door handle in a sliding door to the rear side of the house is loose or broken.

Comments: Recommends replacing the loose door handle.

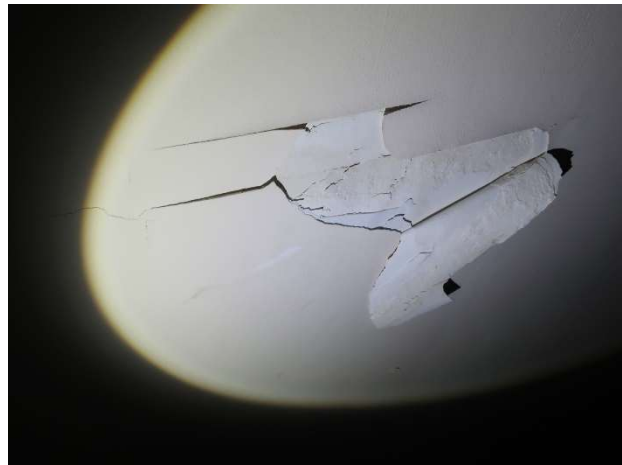
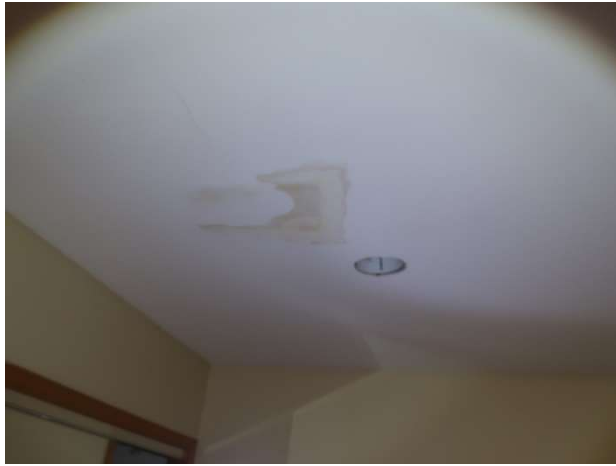
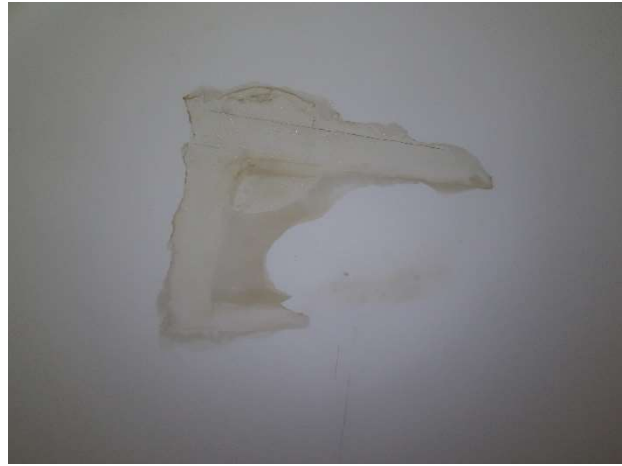
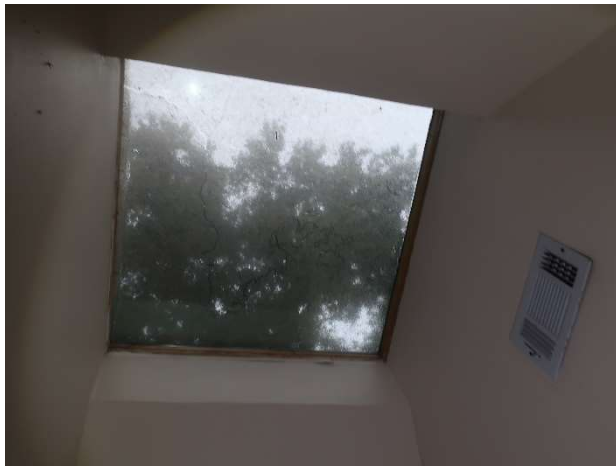
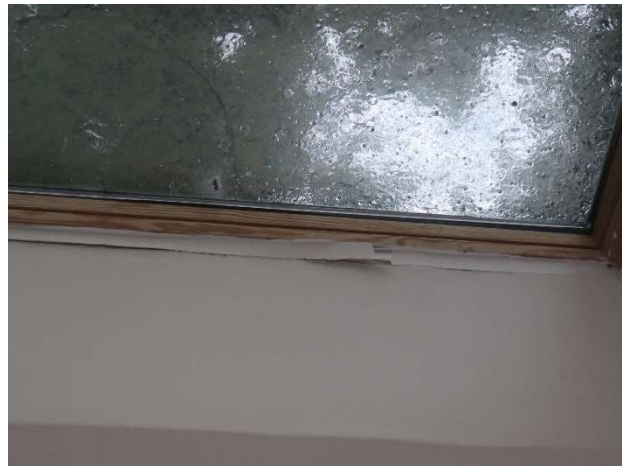
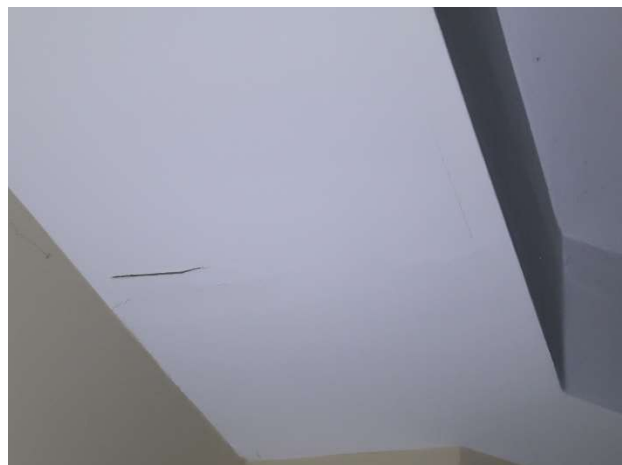
Observation #10.10: Water damage was observed on the 1<sup>st</sup> and 2<sup>nd</sup> floor ceiling finishes in many locations.

Implication: Water infiltration. Possible deteriorated/damaged roofing or damage roof structural elements.

Comments: Recommends hiring a contractor to localize remove the damage ceiling finish to expose the roof structural element behind for further investigation. See roofing section for roofing related observations.

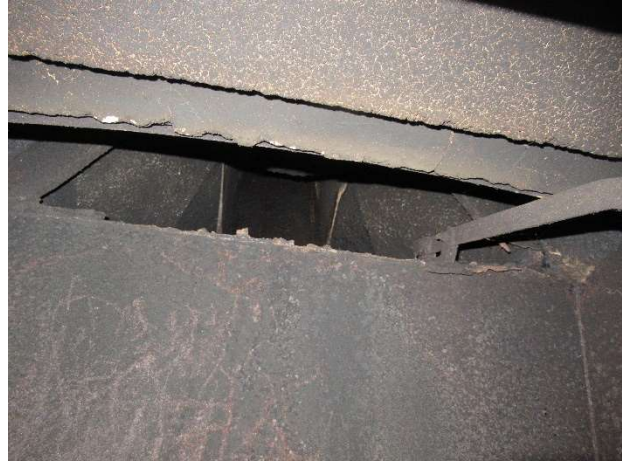
Observation #12.2: The interior of firebox was full of debris and ashes. The interior elements were appeared to be deteriorated.

Comments: Recommends hiring a qualified specialist for further evaluation and general contractor for repair work. Recommends regular cleaning of the firebox interior.
