Home Inspection Report

Prepared By: Zoey Tham, #16000141960

PE Home Inspection, LLC • www.pehomeinspection.com • 609-203-0265 • pehomeinspection@gmail.com

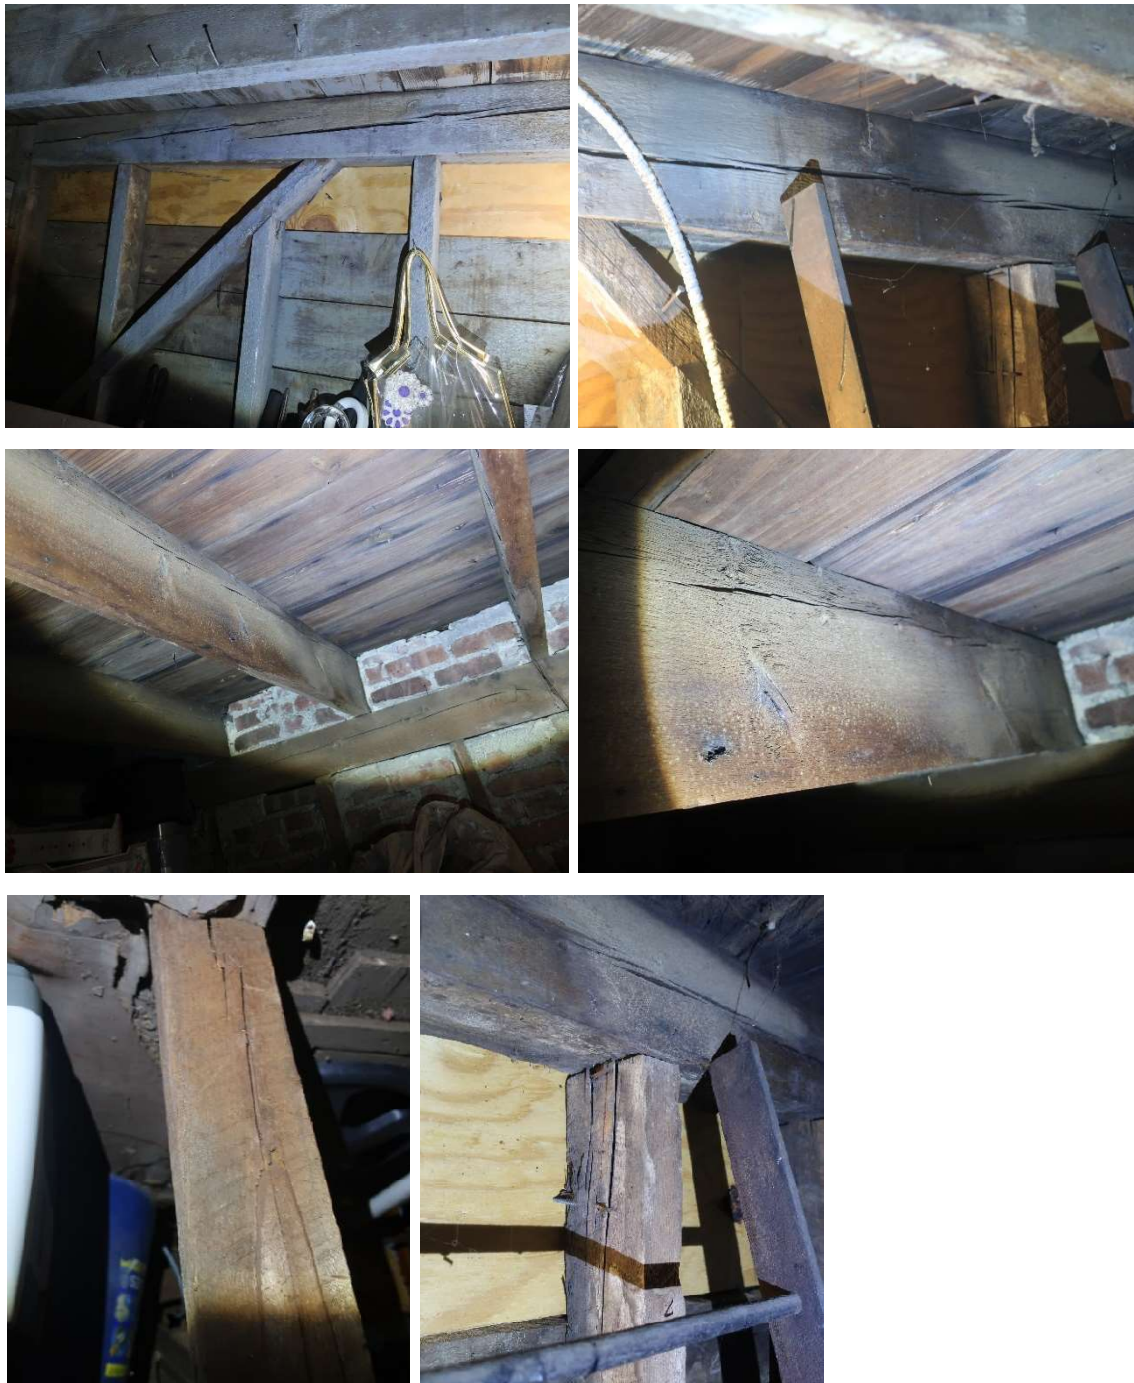
Condition: A few of the roof joists and posts in the rear building appeared to be cracked.

Observation #4.1: A few of the roof joists and posts in the rear building appeared to be cracked.

Comments: Recommends continue monitoring the development of cracks and hiring a structural engineer for future evaluation and correction.

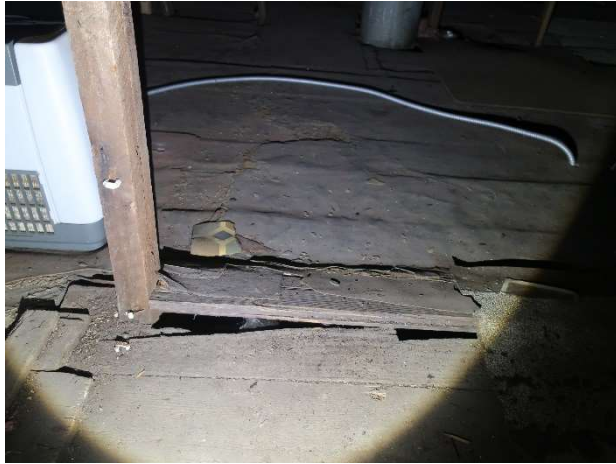
Condition: Some of the attic floor planks was damaged and popped out.

Observation #4.2: Some of the attic floor planks was damaged and popped out.

Implication: Possible tripping hazard.

Comments: Recommends hiring a contractor to repair the attic floor.

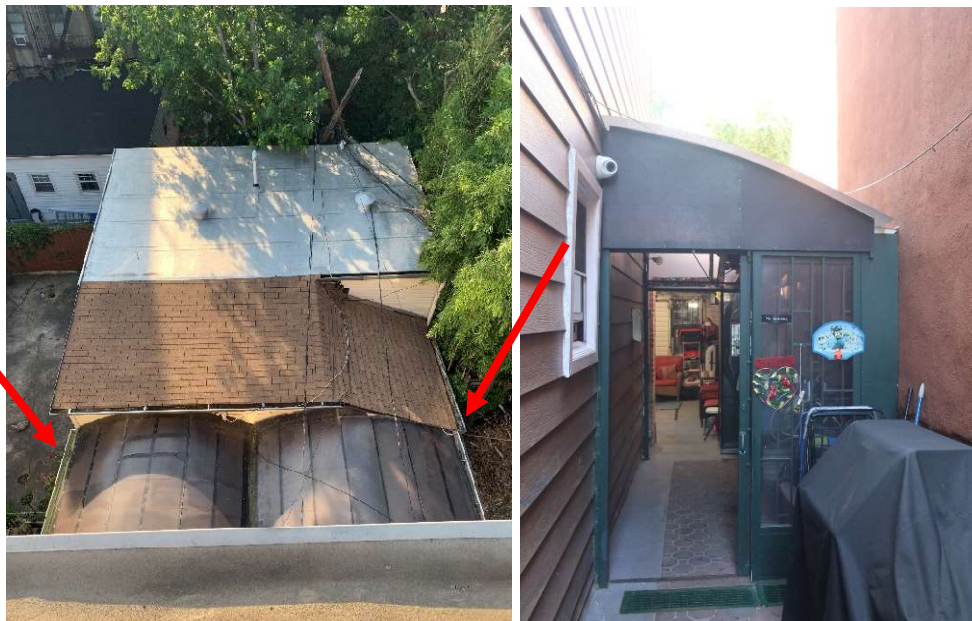
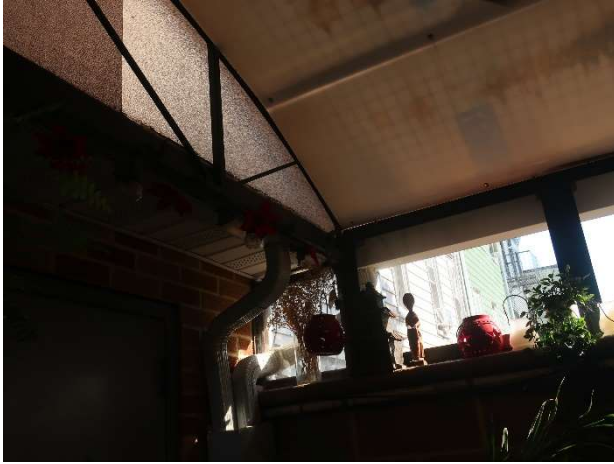
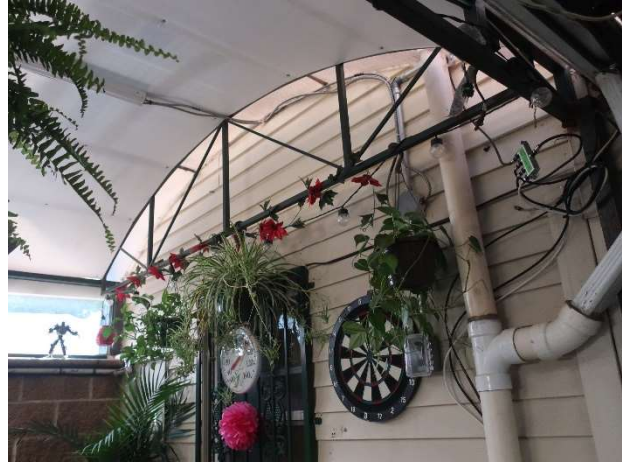
Observation #4.3: As-built backyard shed located less than 3 feet from the property line and exceeded maximum height of 7 ft 5 inches.

Implication: Possible violated NYC Building Code- Rules of the City of New York §101-14

Comments: Recommends consulting DOB to avoid future penalties.

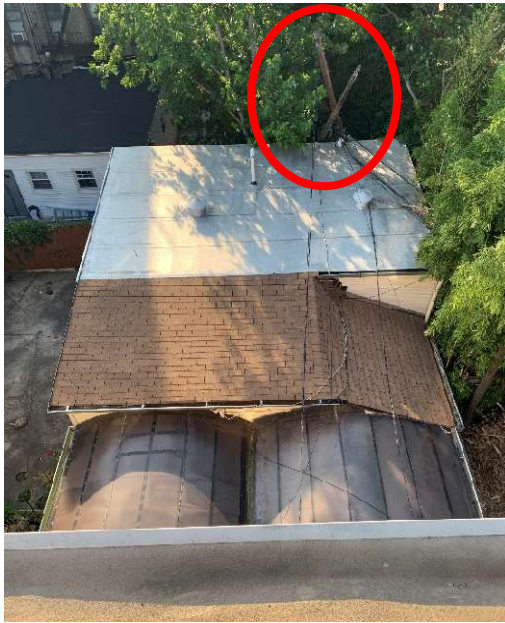
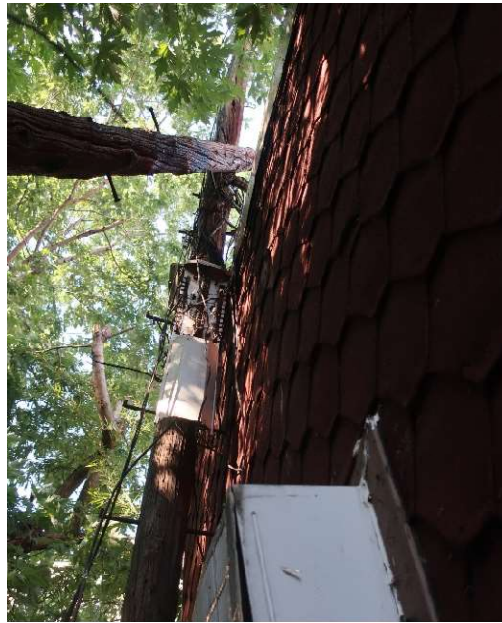
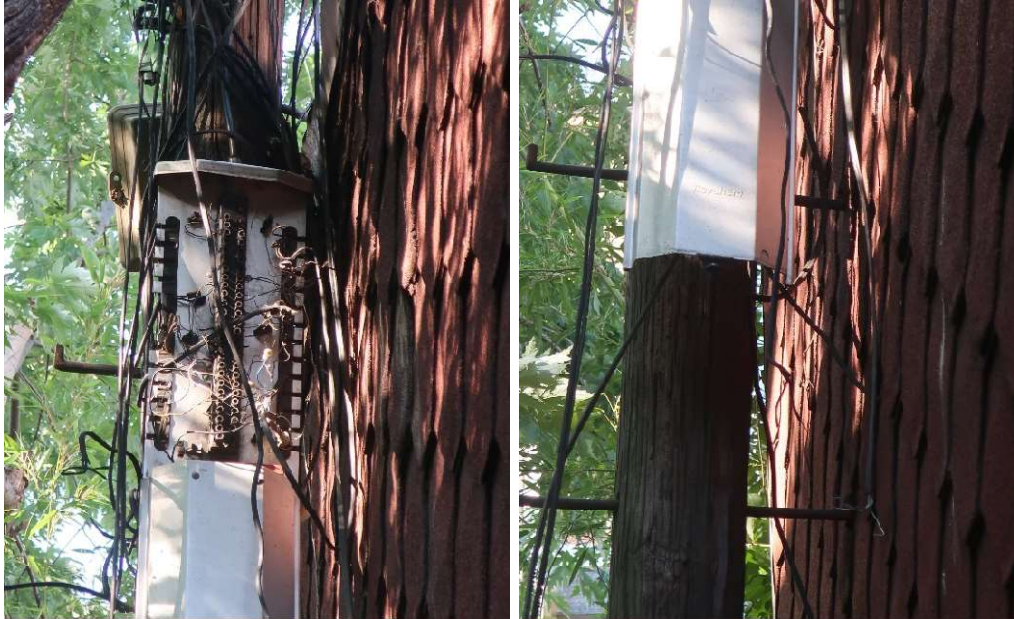
Condition: Two utility poles were leaning against the siding of the rear building.

Observation #4.4: Two utility poles were leaning against the siding of the rear building.

Implication: The utility poles are unstable which could possibly damage the siding. The hot wires touching the siding poses a risk of fire hazards.

Comments: Recommends contacting utility company for repair and maintenance.

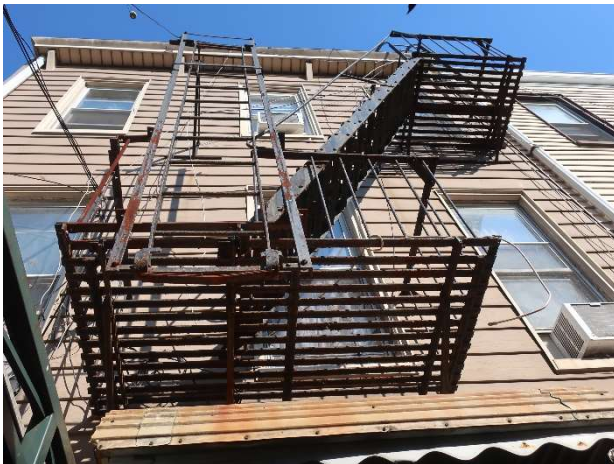
Condition: The fire escape appeared to be severely deteriorated.

Observation #4.5: The fire escape appeared to be severely deteriorated.

Implication: Corroded steel element occurred due to aging, lack of maintenance, and long-term exposure to weathering. Possible weakened the structural capacity of the fire escape.

Comments: Recommends hiring a contractor for regular repair and maintenance.

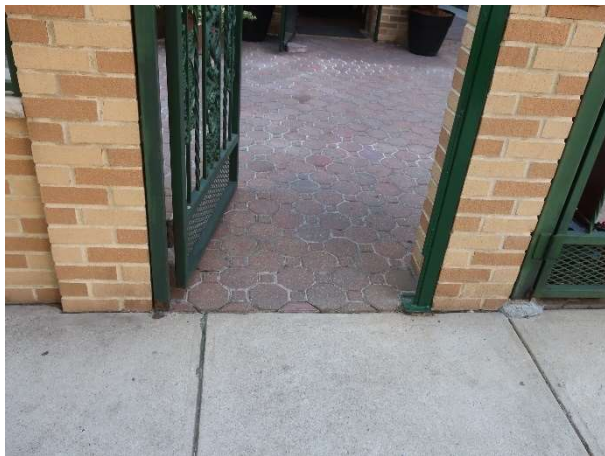
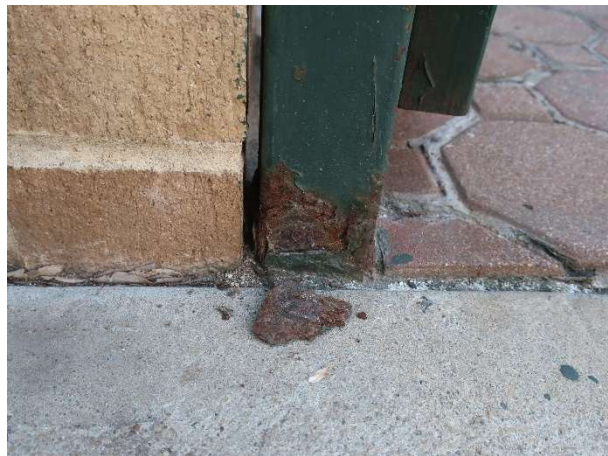
Observation #5.1: The steel gate at the main entrance appeared to have minor corrosion.

Implication: Possible long-term exposure to water and weakened the steel post.

Comment: Recommends hiring a contractor for regular repair and maintenance.

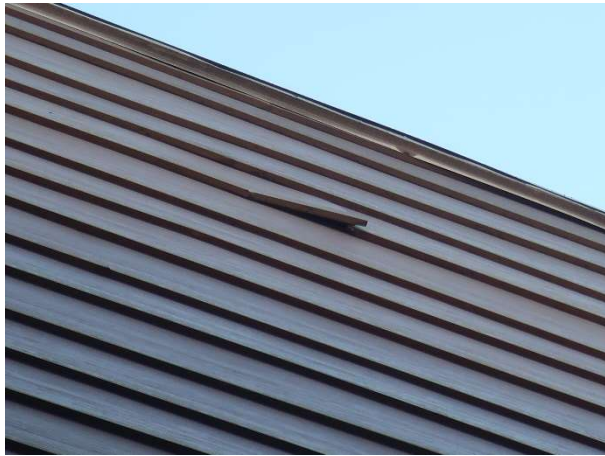
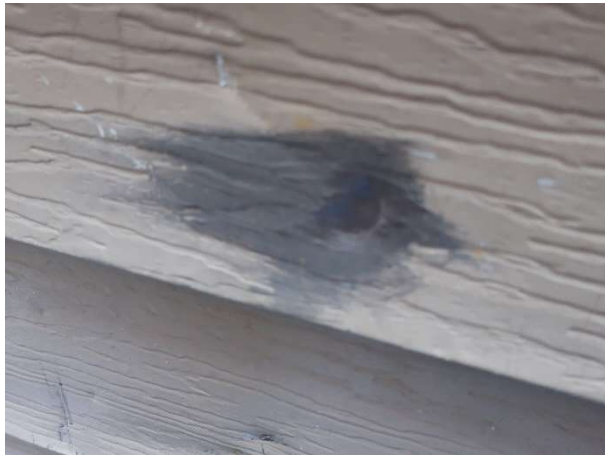
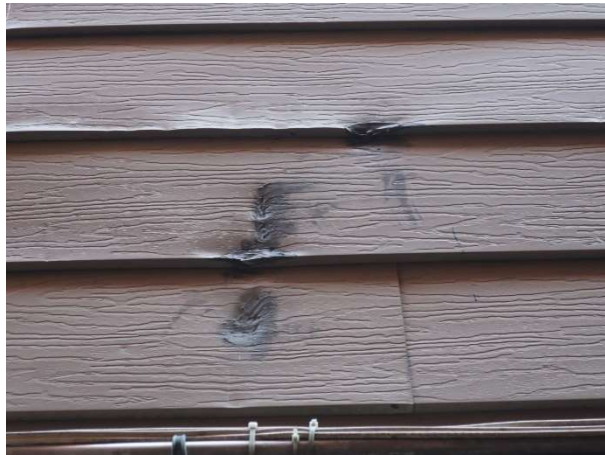
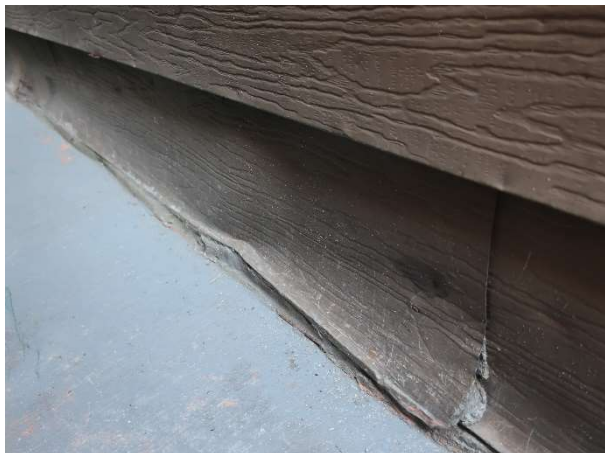
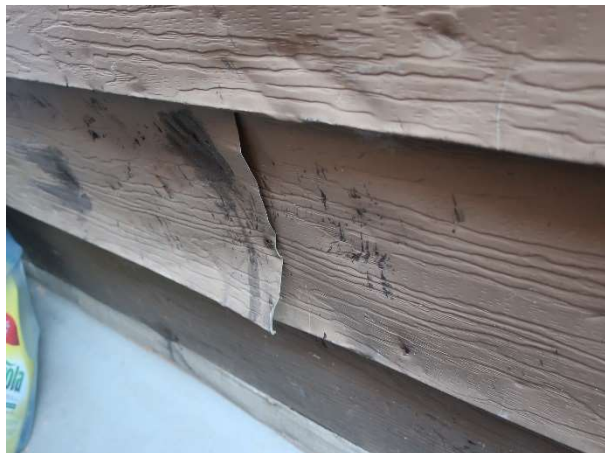
Condition: Localize damaged sidings and improper siding connections were observed at the main building.

Observation #5.2: Localize damaged sidings and improper siding connections were observed at the main building.

Implication: Possible water infiltration into building space and causes damage to the structural wood members

Comment: Recommends hiring a contractor to replace the damaged and defected siding.

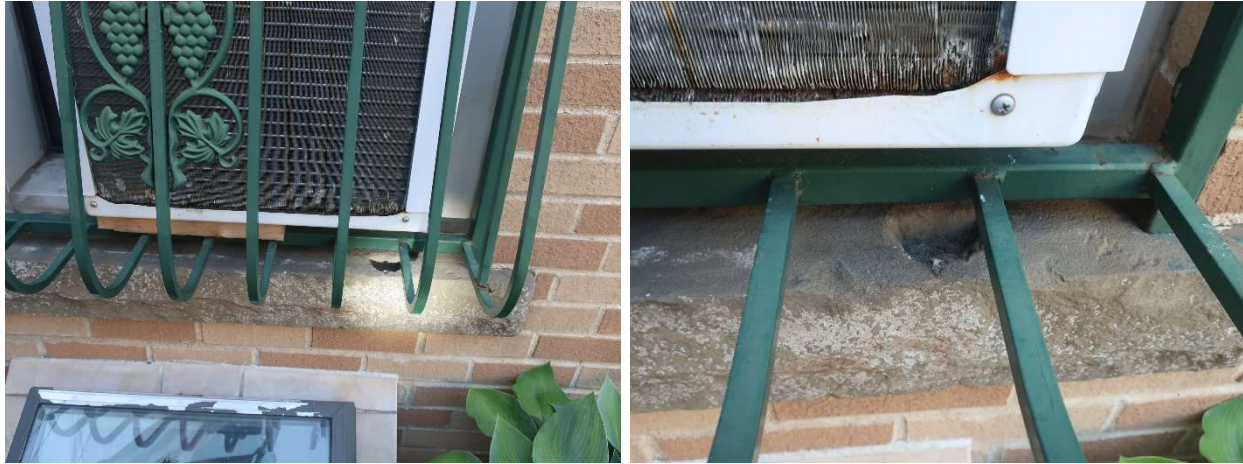
Observation #5.3: Observed concrete spall at windowsill.

Implication: Possible water trap in the hole and further deteriorate windowsill.

Comment: Recommends sealing the hole at the windowsill.

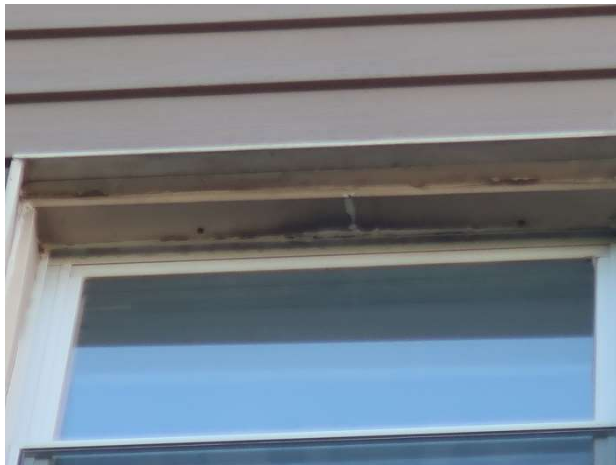
Observation #5.4: The window frame appeared to be deformed/damaged.

Comment: Recommends further observation and evaluation of window frame condition.

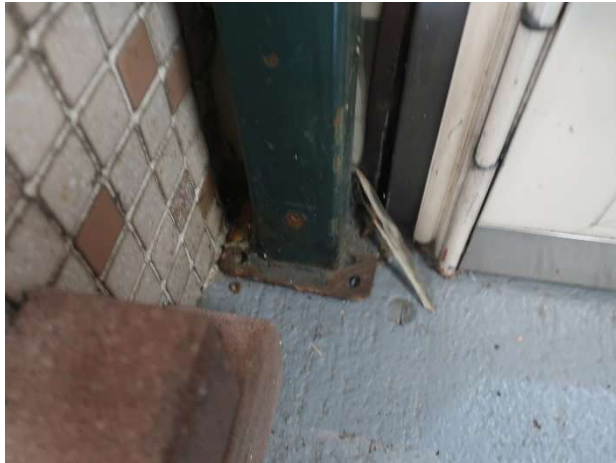
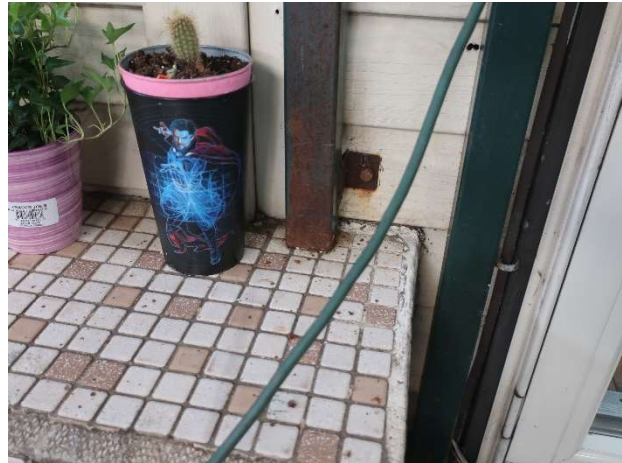
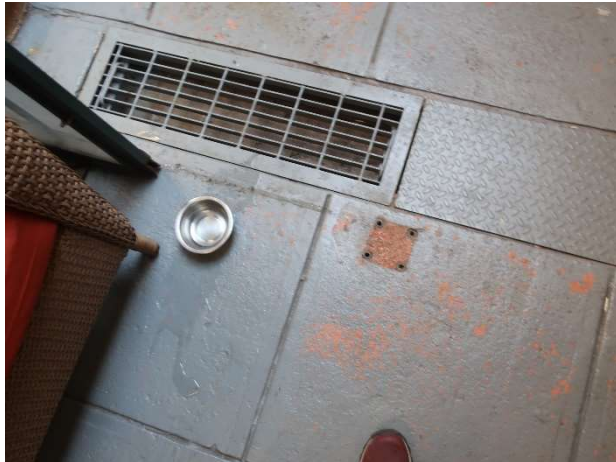
Observation #5.5: Some of the steel post of the backyard sheds appeared to be improperly connected to solid concrete. Anchors were missing at one of the post base plates. One post was missing the base plate, and one post appeared to have been previously removed.

Implication: Possible weakened shed support.

Comment: Recommends hiring a structural engineer to evaluate the structural stability and integrity of the shed.

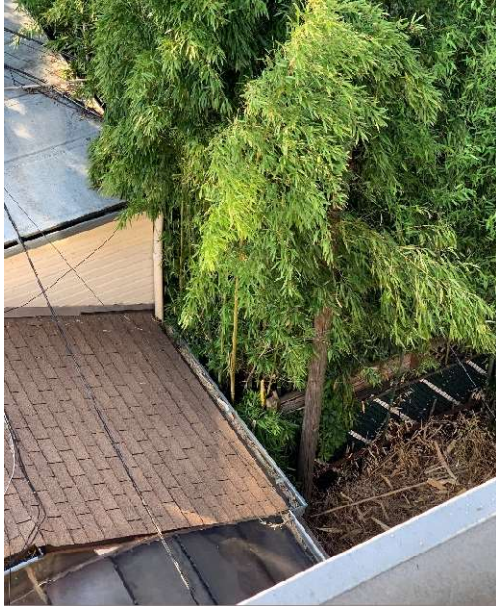
Observation #6.2: The rear building gutters appears to be clogged by leaves and debris.

Implication: Water may overflow and drain down near the foundation wall. Possible damage to foundation wall and water infiltration.

Comments: Recommends gutters and downspouts to be cleaned regularly.

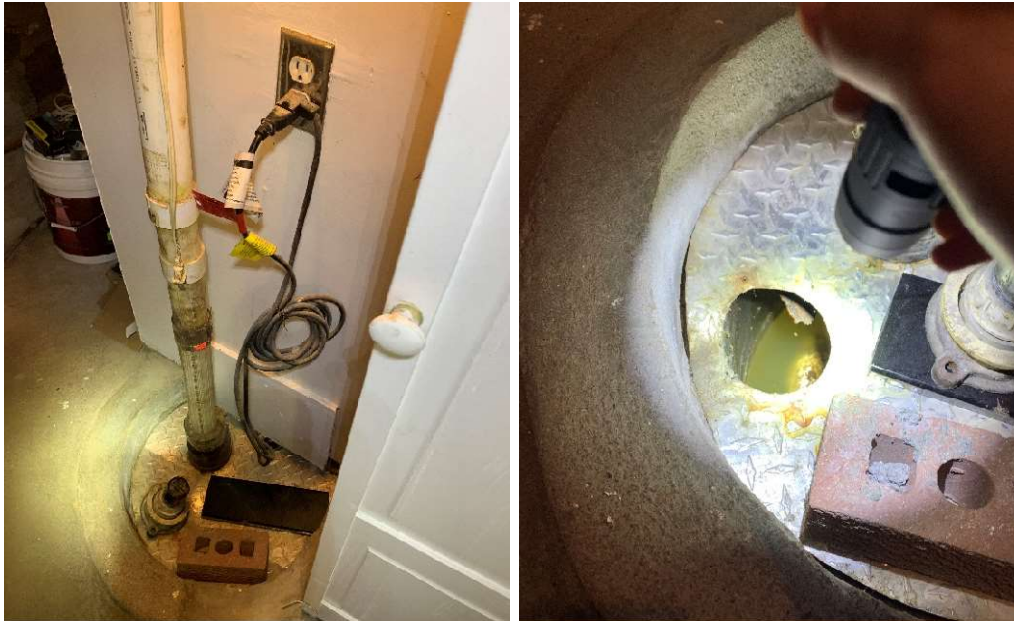
Condition: The existing ejector pump was not operable, and it has no vent pipe and sealed cover.

Observation #7.1: The existing ejector pump was not operable, and it has no vent pipe and sealed cover.

Implication: Possible wastewater back flow and risk of flooding the basement

Comment: Recommends hiring a plumber to install sewage ejector pump.

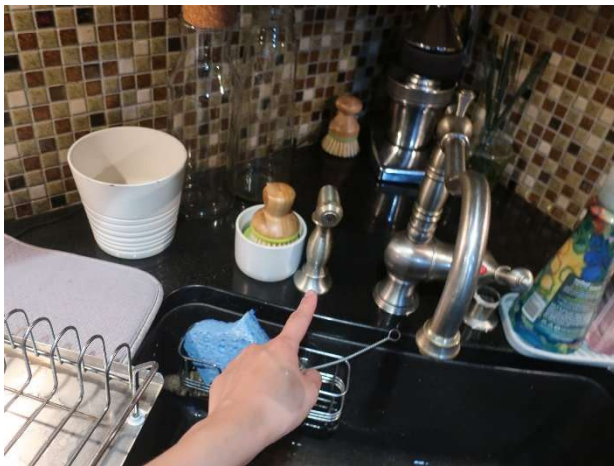
Observation #7.2: The main building first floor kitchen faucet was inoperable.

Comment: Recommends repairing or replacing the faucet.

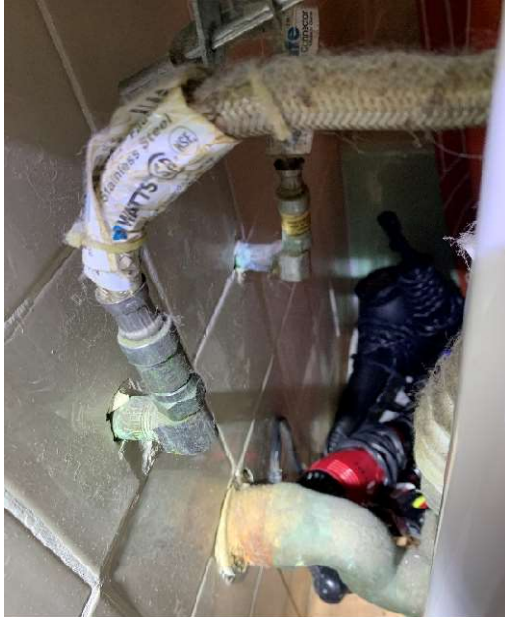
Observation #7.3: Visible patina stain along copper piping

Implication: Indicate water moisture

Comment: Recommends cleaning patina corrosion and keeping the copper pipe dry.

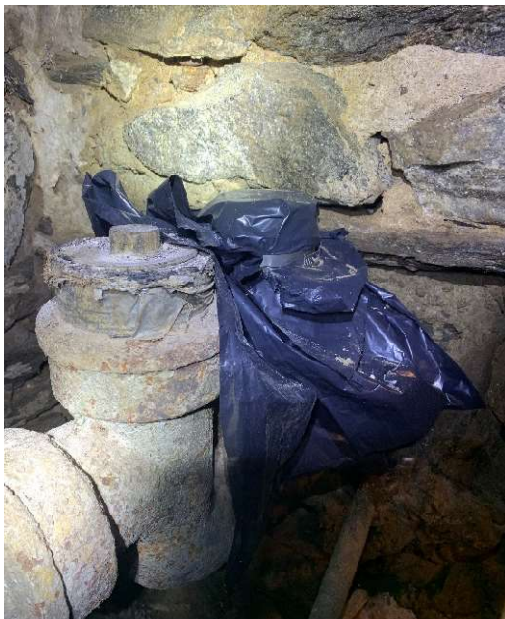
Observation #7.4: The cast iron wastewater cleanout cap was missing.

Implication: Possible wastewater back flowing into basement

Comment: Recommends installing a clean out cap

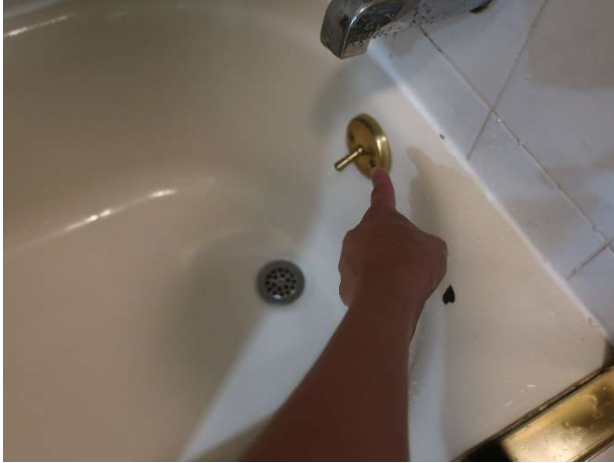
Observation #7.5: Bathtub water stop handle was inoperable

Comment: Recommends repairing or replacing the water stop handle

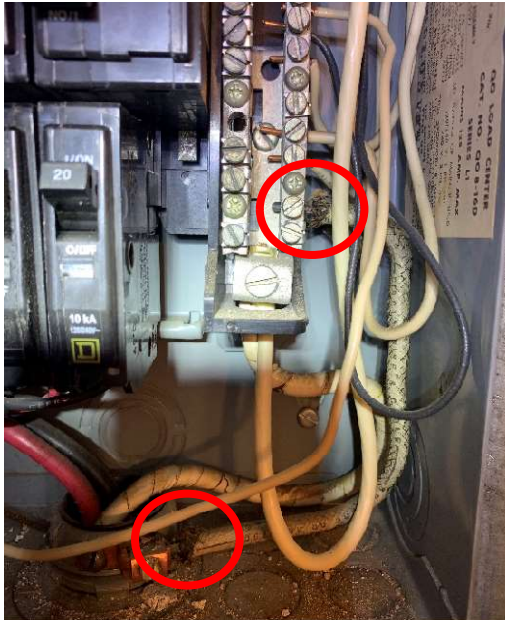
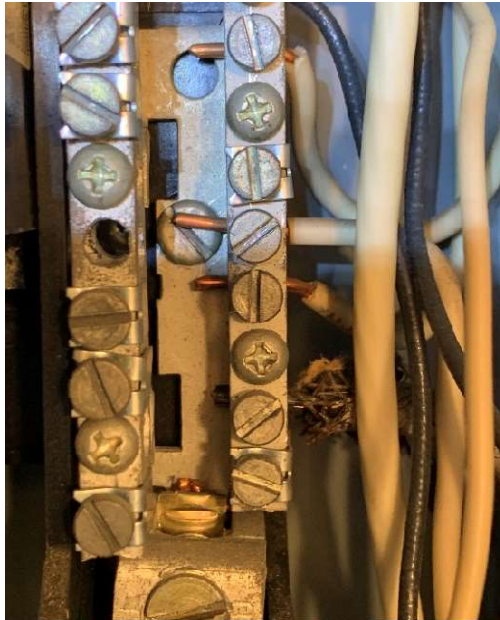
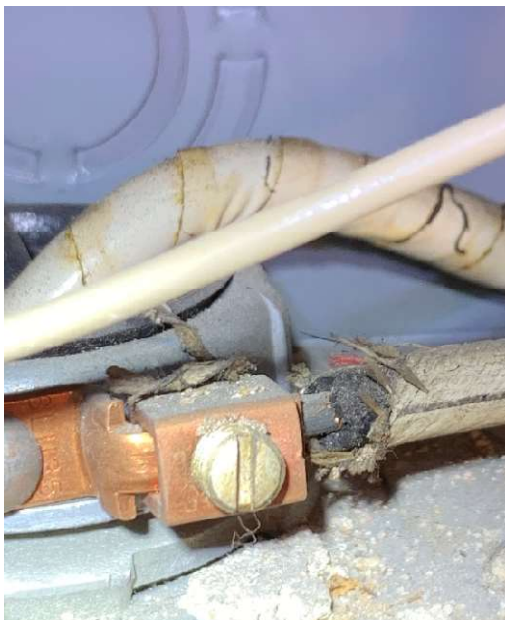
Condition 1: Cloth sheathing wiring observed inside the electrical panel for the first floor. Cloth wire appeared to have frayed at the end near the lug connector.

Observation #8.1: Cloth sheathing wiring observed inside the electrical panel for the first floor. Cloth wire appeared to have frayed at the end near the lug connector.

Implication: Possible safety hazard

Comment: Recommends hiring an electrician for further evaluation and replacement.

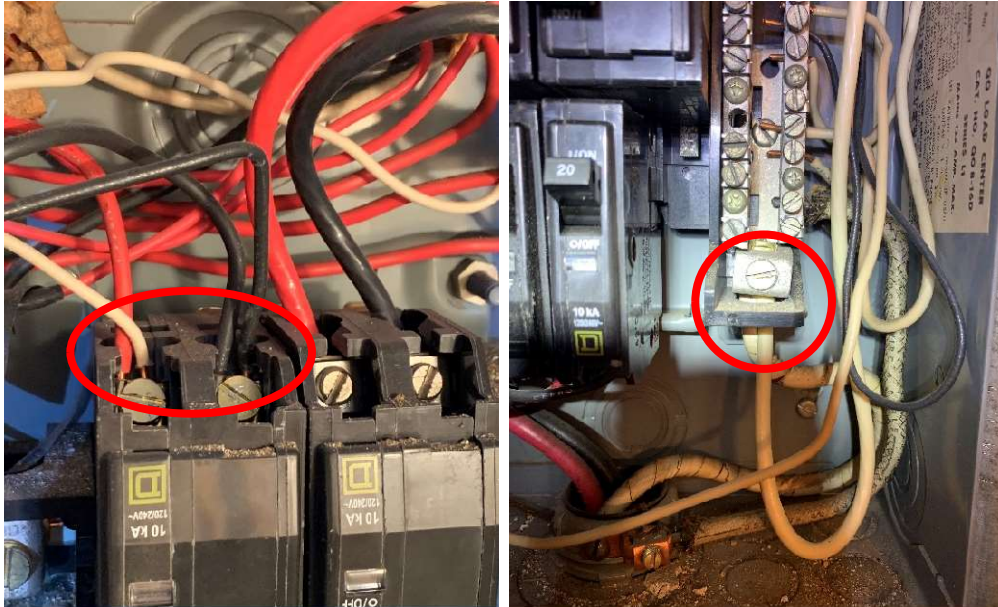
Condition 2: Improper double tap was observed at multiple lugs.

Observation #8.2: Improper double tap was observed at multiple lugs.

Implication: Multiple conductors in one lug may not be protected by the overcurrent protection device (OPD) or may be over fused

Comment: Recommends hiring an electrician for further evaluation and repair

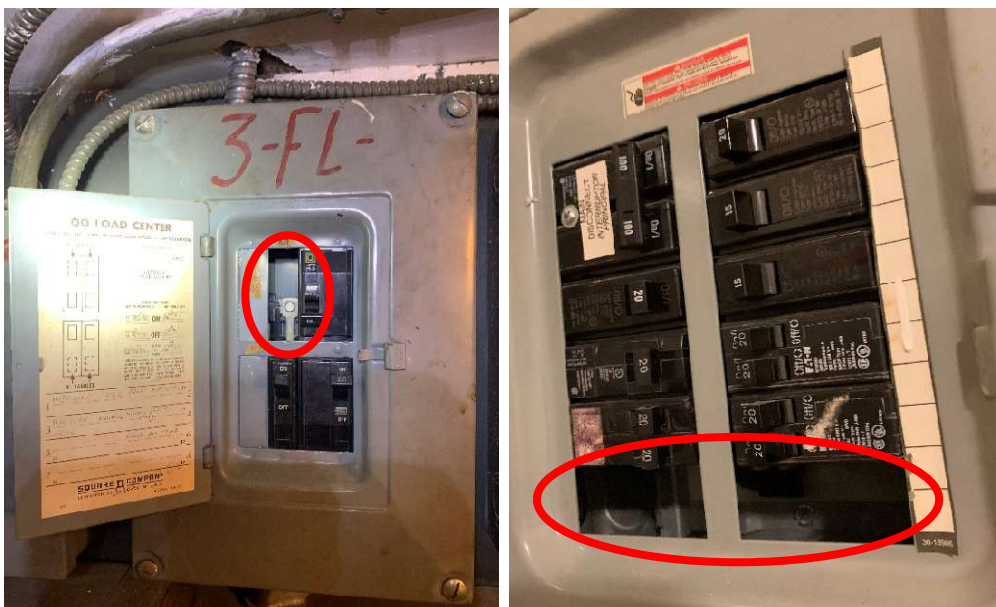
Condition 3: Missing breaker knockouts at the main electrical panel.

Observation #8.3: Missing breaker knockouts at the main electrical panel

Implication: Possible safety hazard

Comment: Recommends hiring electrician to seal these breaker blanks

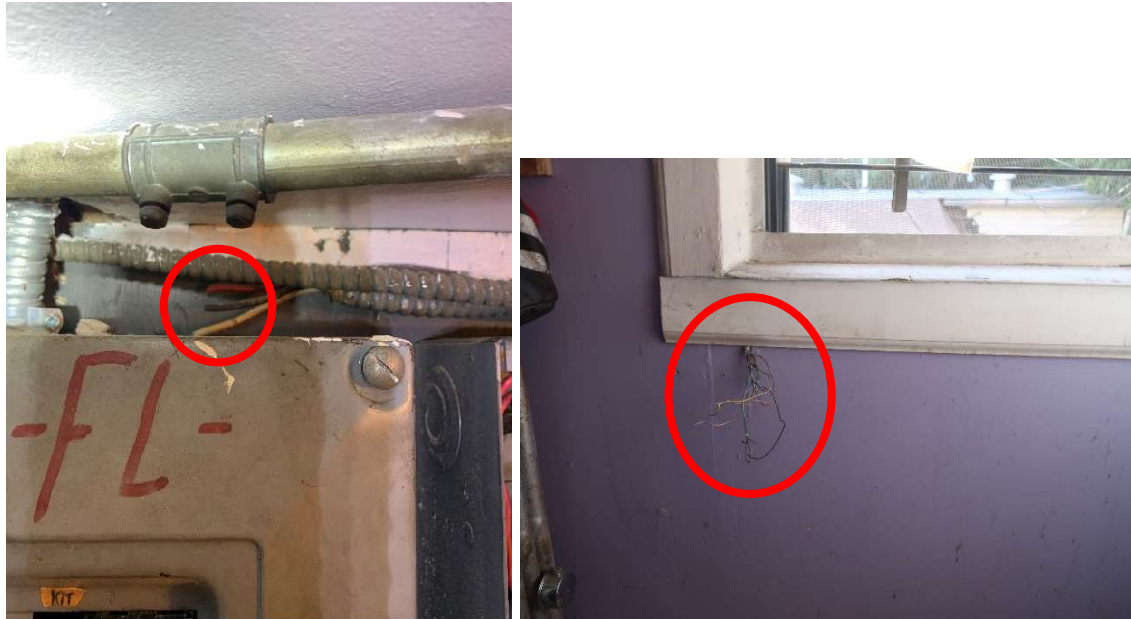
Condition 1: Conductors were exposed without proper capping.

Observation #8.4: Conductors were exposed without proper capping

Implication: Possible safety hazard

Comment: Recommends hiring an electrician for further evaluation and repair

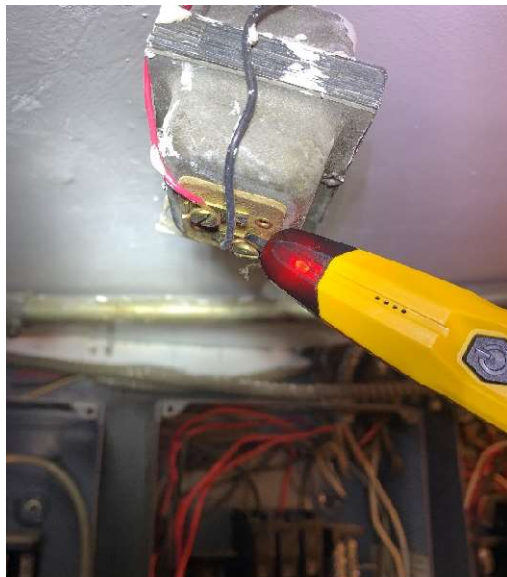
Condition 2: Live electrical wires hanging on the basement ceiling near the electrical panels

Observation #8.5: Live electrical wires hanging on the basement ceiling near the electrical panels

Implication: Possible safety hazard

Comment: Recommends hiring an electrician for further evaluation and repair

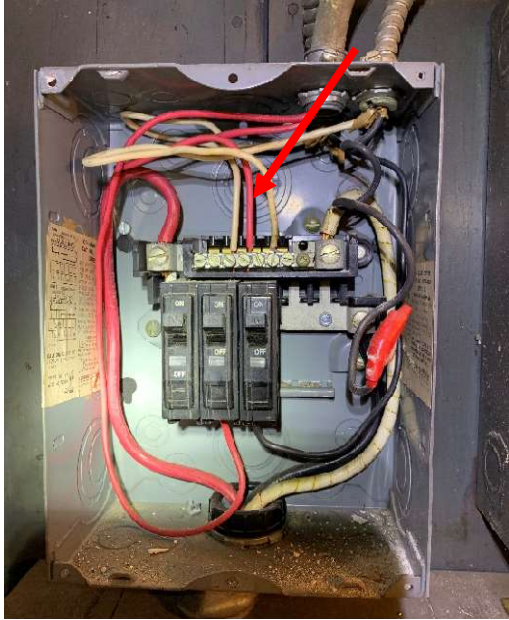
Condition 4: The red 'hot' wire was connected to the neutral/ground bus bar.

Observation #8.6: The red 'hot' wire was connected to the neutral/ground bus bar.

Implication: The conductor connecting to bus bar is an incorrect color.

Comment: Recommends this red wire to be marked with colored tape or paint by an electrician.

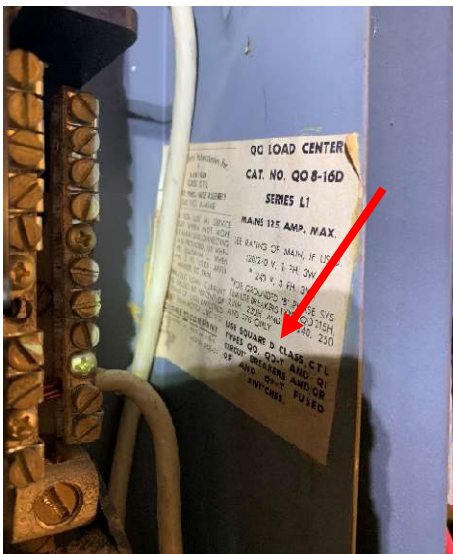
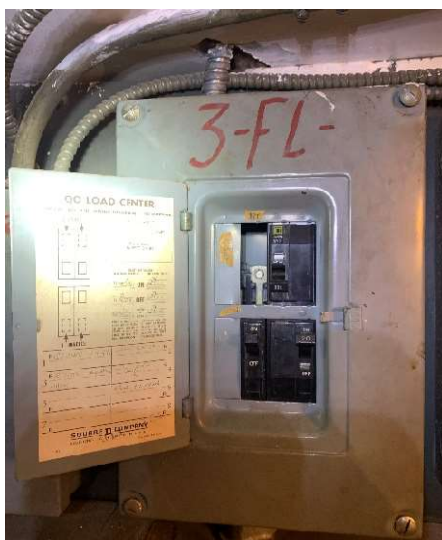
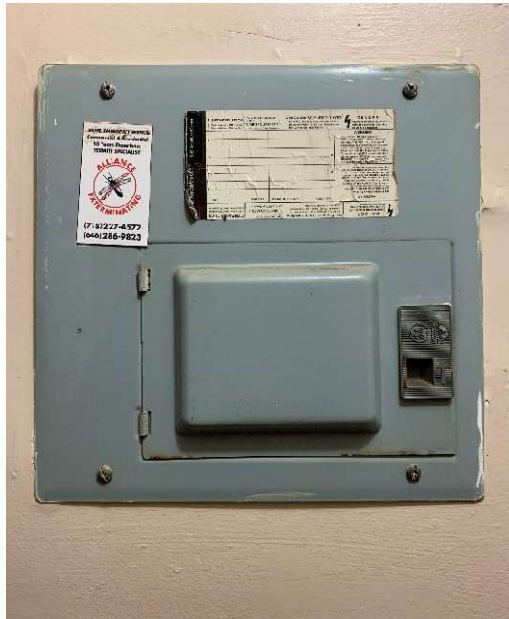
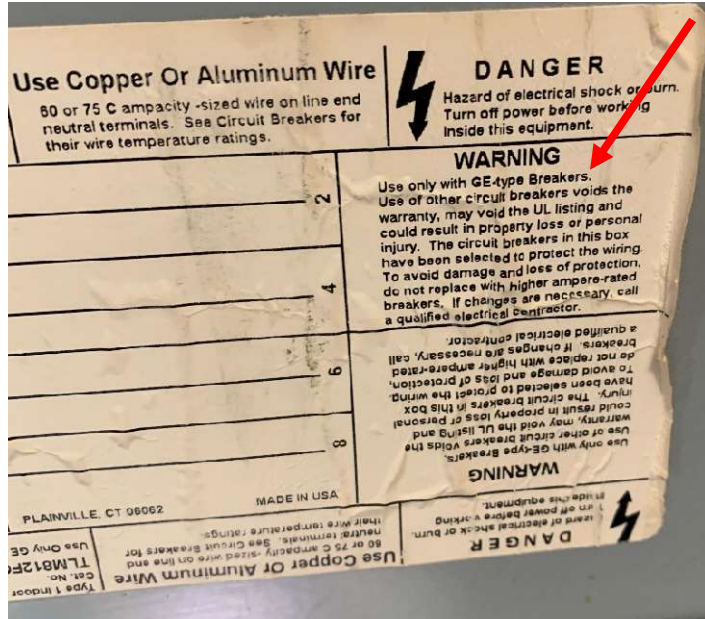
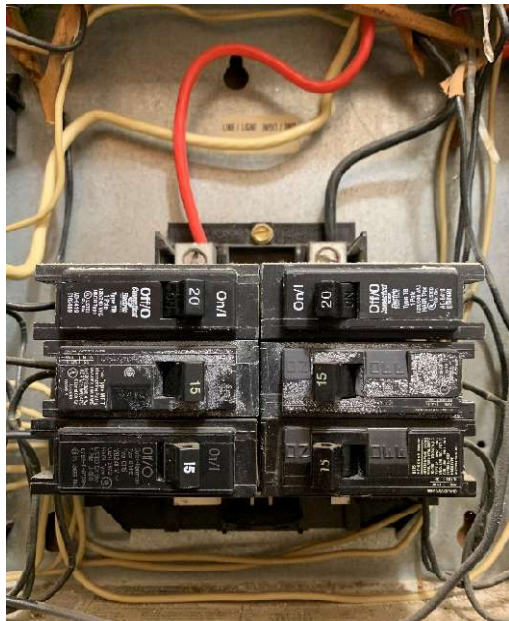
Condition 5: Most of the breakers installed do not match the electrical panel brand.

Observation #8.7: Most of the breakers installed do not match the electrical panel brand.

Implication: Possible safety hazard

Comment: A breaker from different manufacturer may not be used even if it seems to fit. Recommends hiring an electrician for further evaluation and replacement.

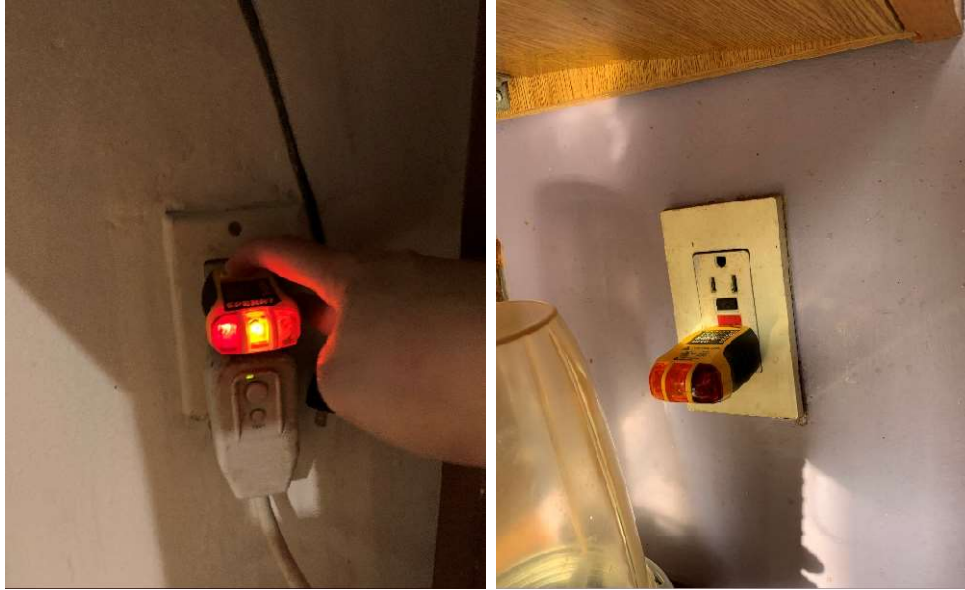
Condition 1: GFCI outlets do not trip when being tested.

Observation #8.8: GFCI outlets do not trip when being tested.

Implication: Possible safety hazard

Comment: Recommends hiring an electrician for further evaluation, repair, and replacement.

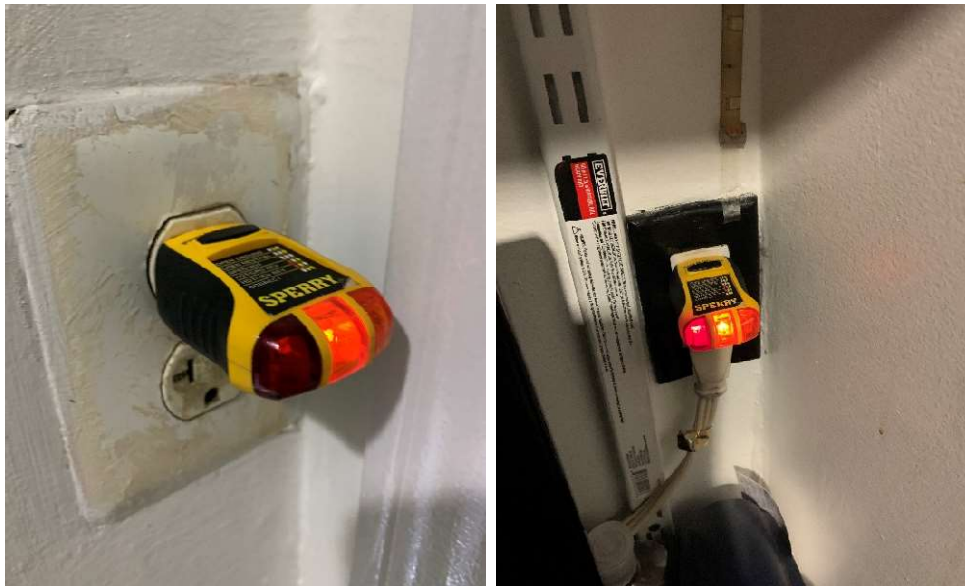
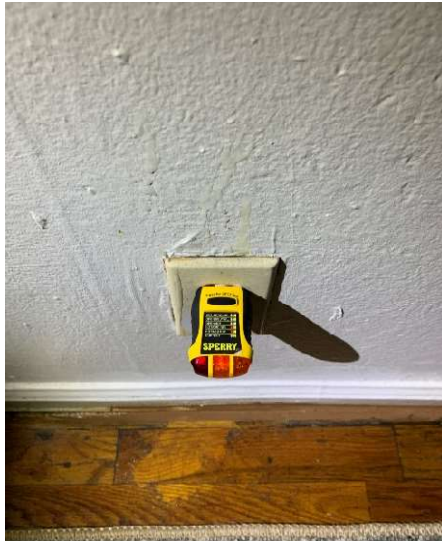
Condition 2: Various electrical outlets and switches were malfunction when tested.

Observation #8.9: Various electrical outlets and switches were malfunction when tested

Implication: Possible safety hazard

Comment: Recommends hiring an electrician for further evaluation, repair, and replacement.

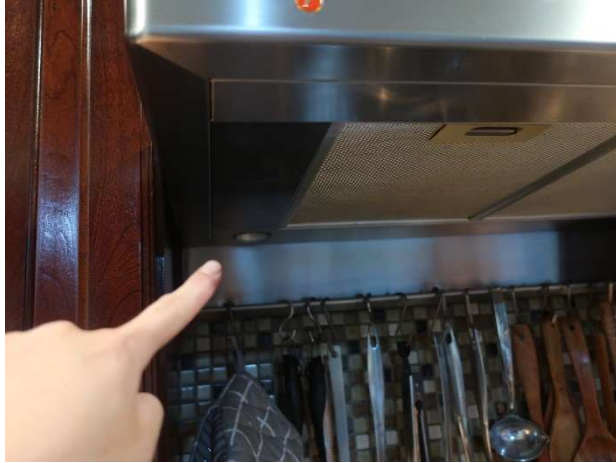
Observation #8.10: The light in the kitchen hood was not working.

Comments: Recommends repairing or replacing the defected light.

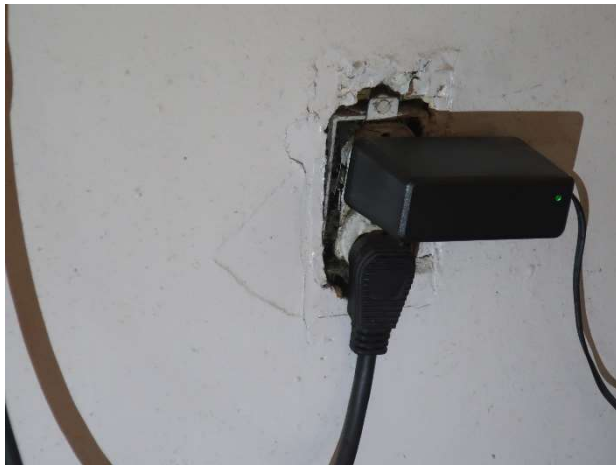
Condition 3: The cover plate for the receptacle outlet was missing.

Observation #8.11: The cover plate for the receptacle outlet was missing.

Implication: Possible safety hazard

Comments: Recommends installing the cover plate.

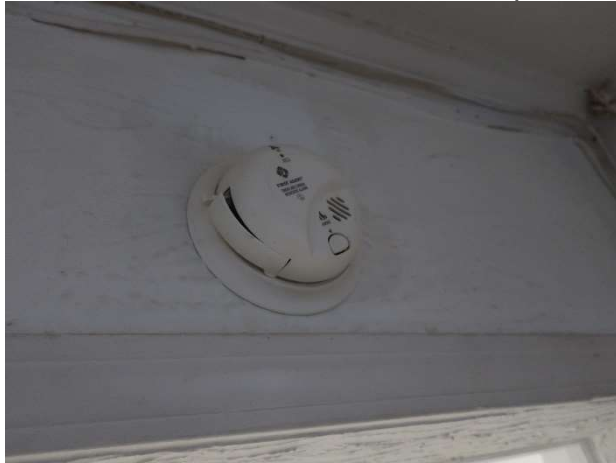
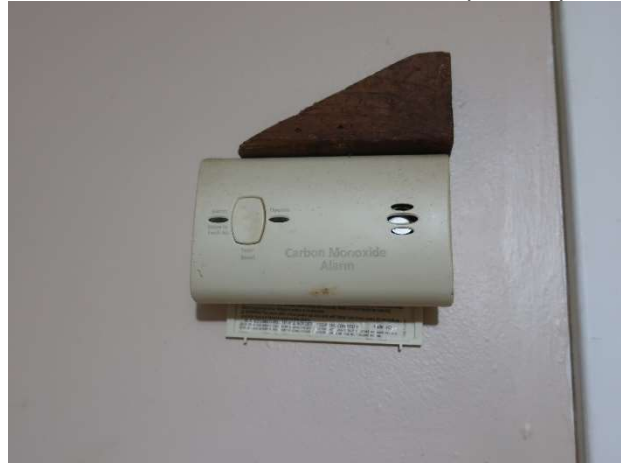
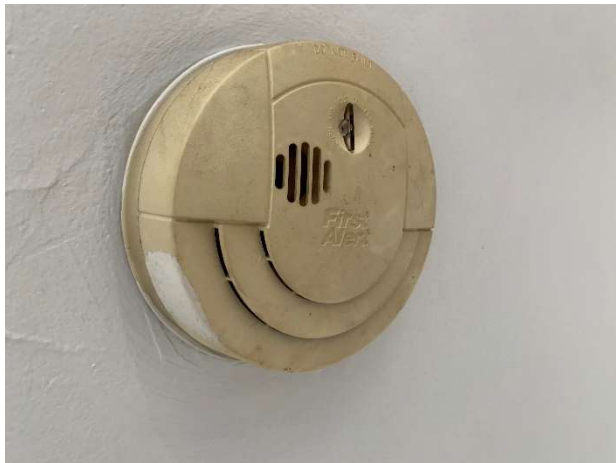
Condition: Several alarm devices were installed. We could not verify if the device can detect both smoke and carbon monoxide.

Observation #8.12: Several alarm devices were installed. We could not verify if the device can detect both smoke and carbon monoxide.

Comments: Recommends consulting the seller for more information. Install adequate smoke and carbon monoxide alarm per National Fire Protection Association (NFPA).

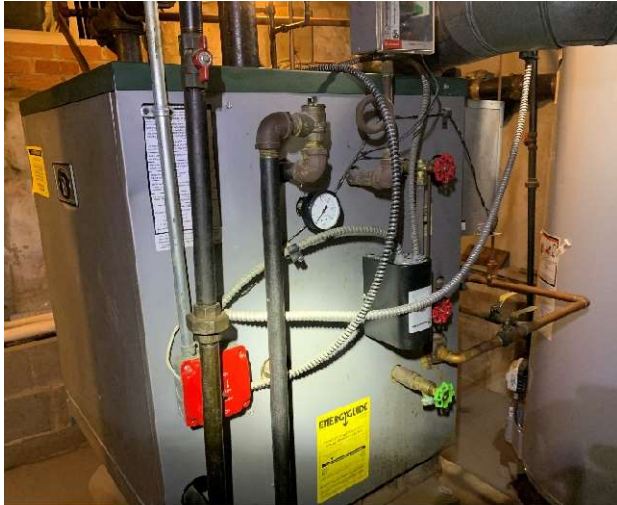
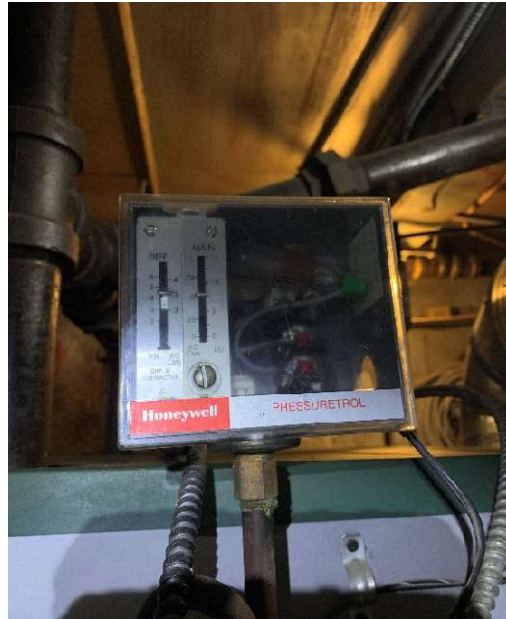
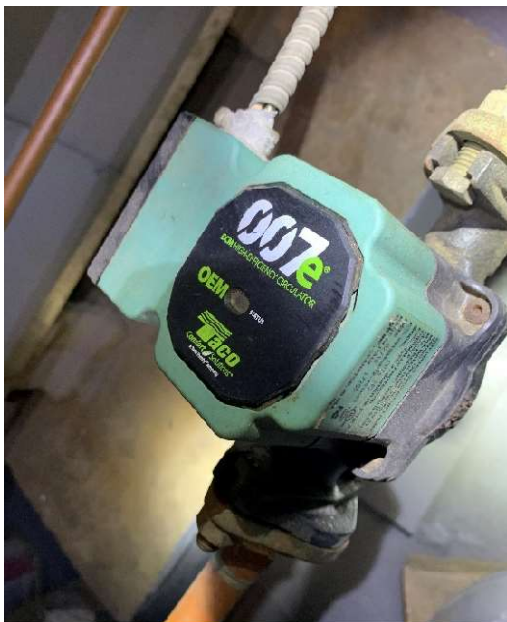
Observation #9.1: The steam boiler was converted to hot water boiler. The circulator pump was added to deliver hot water to the radiator. The converted boiler system is missing the expansion tank.

Comments: Recommends hiring a HVAC technician for further evaluation.

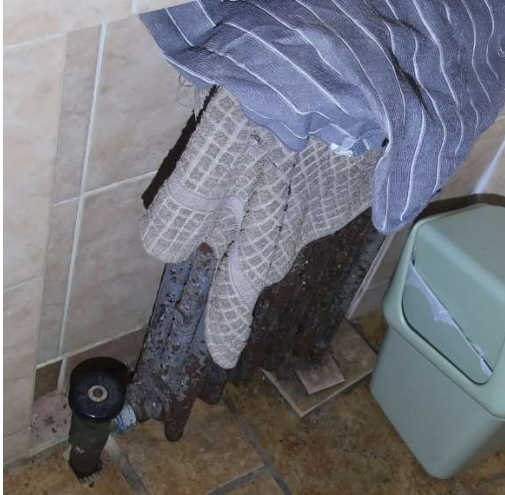
Condition: Some of the radiators in the unit appeared to have age-related wear and tear.

Observation #9.2: Some of the radiators in the unit appeared to have age-related wear and tear.

Implication: Radiators are in risk of possible failure in the near future due to aging.

Comment: Recommends regular inspection, repair, and maintenance.

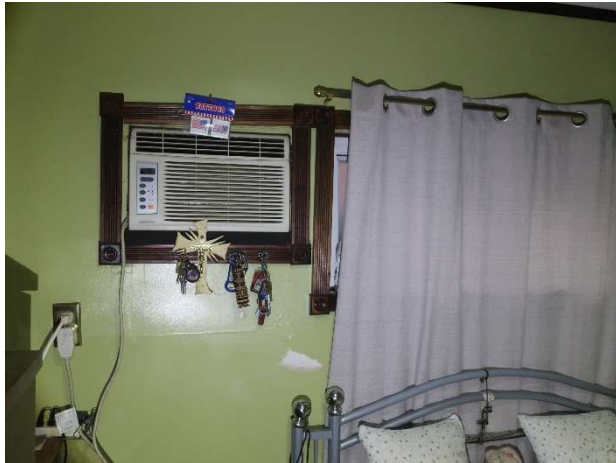
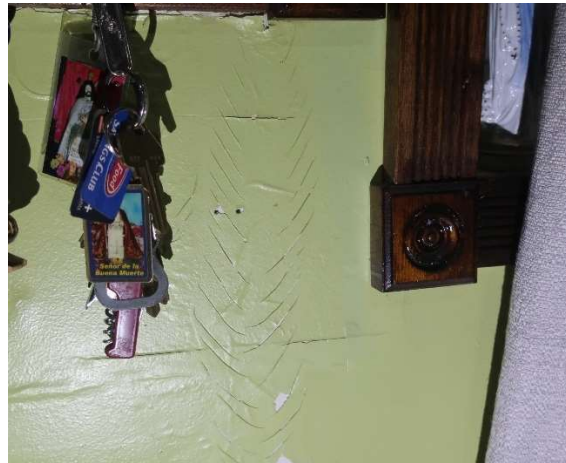
Observation #11.1: The interior wall finish in the rear building bedroom appeared to have water damage.

Implication: Possible water infiltration to interior space

Comments: Recommends consulting the seller agent regarding previously reported water infiltration. Hire a contractor to remove and replace the damaged water finish and to further evaluate the wall studs behind the finish.

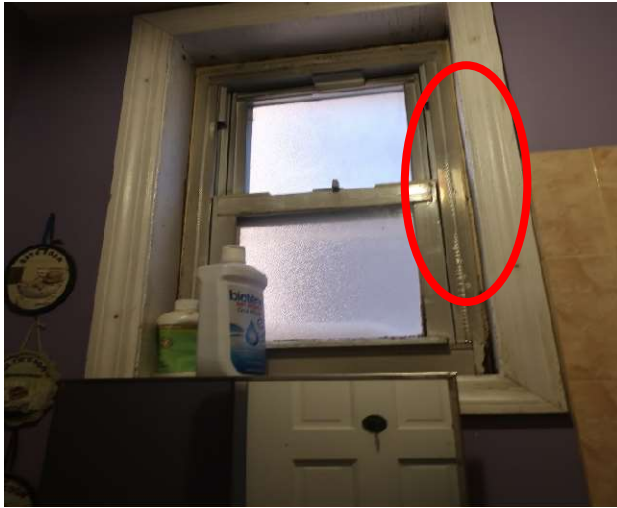
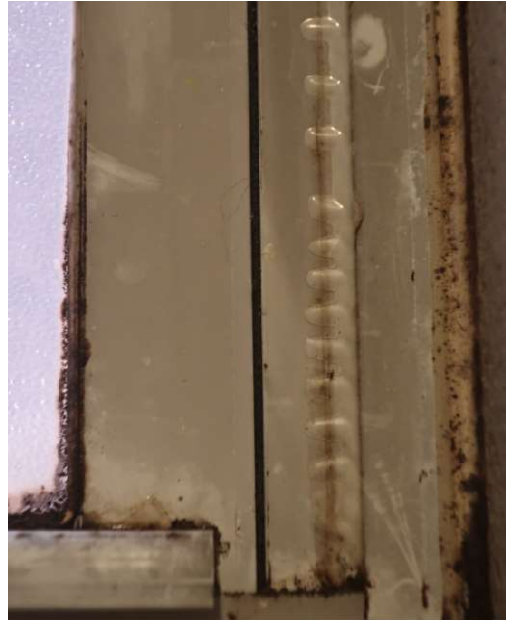
Observation #11.2: The main building 2nd floor bathroom window frame appeared to have mold and deterioration.

Implication: Indicate excessive moisture or possible water infiltration

Comments: Recommends hiring a window professional to further evaluate the condition of the window.
