Home Inspection Report

Prepared By: Zoey Tham, #16000141960

PE Home Inspection, LLC • www.pehomeinspection.com • 609-203-0265 • pehomeinspection@gmail.com

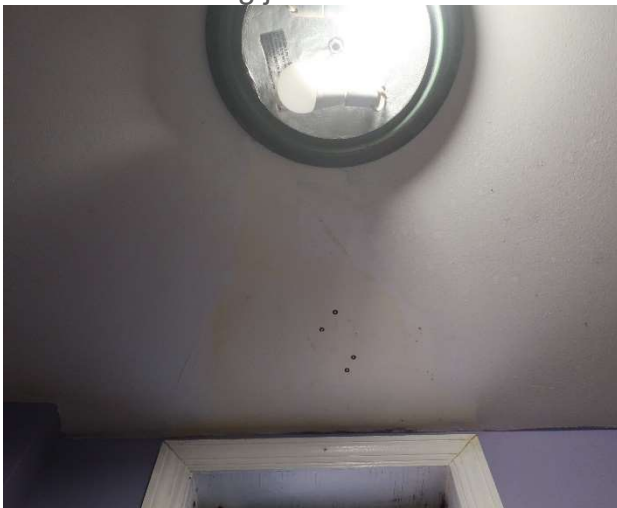
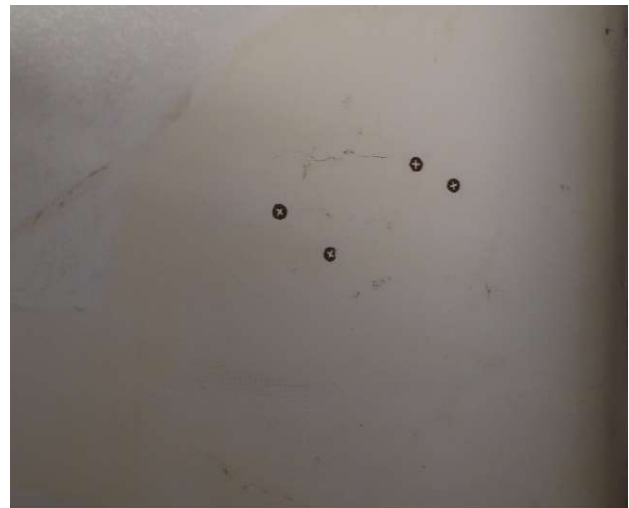
Observation #11.3: The bathroom ceiling appeared to have water stain and have been previously repaired.

Implication: Possible water leakage/infiltration

Comments: Recommends remove and replace area of water damaged ceiling. Further assess the ceiling joists.

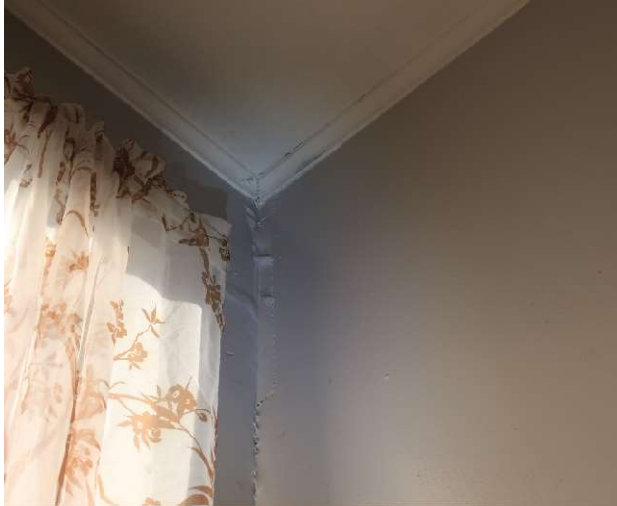
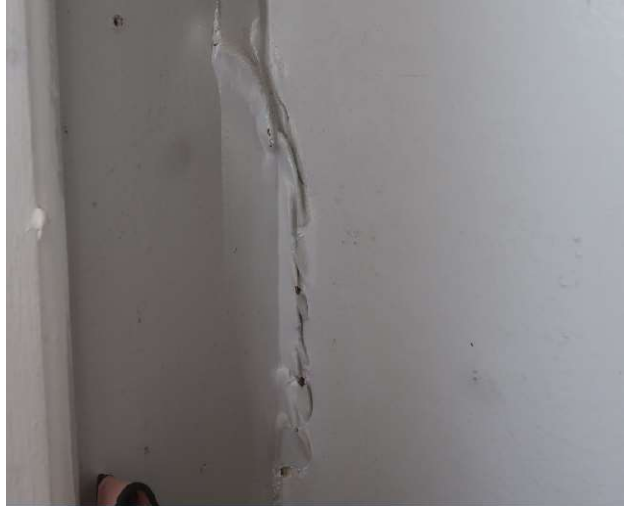
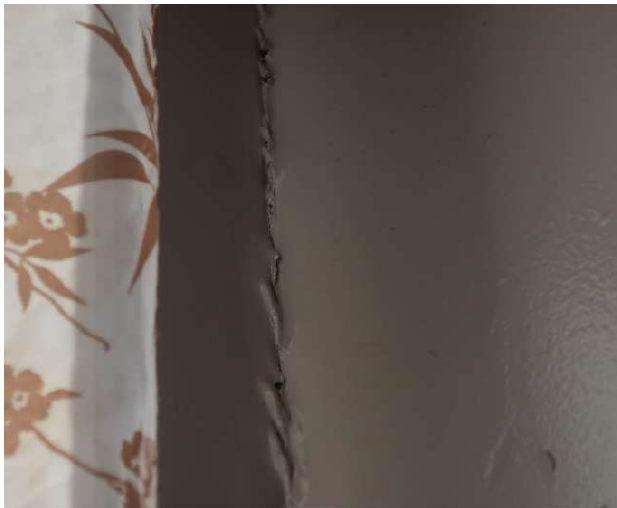
Observation #11.4: The interior wall finish at the rear side of the 2nd floor of main building appeared to have water damage.

Implication: Possible water leakage/infiltration

Comments: Recommends remove and replace area of water damaged wallpaper. Further inspect the wall studs and drywall.

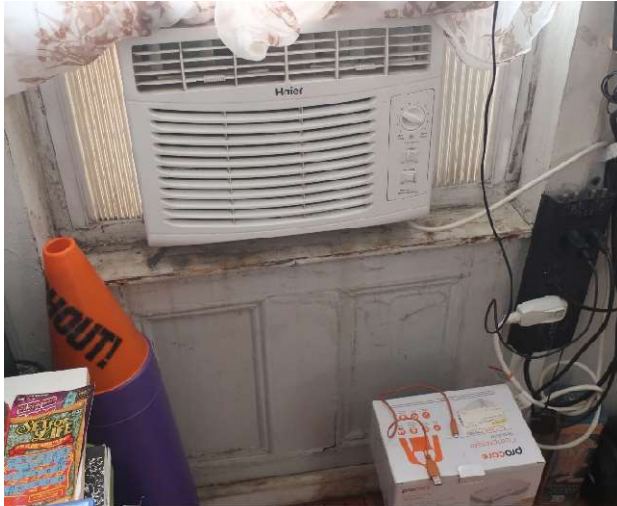
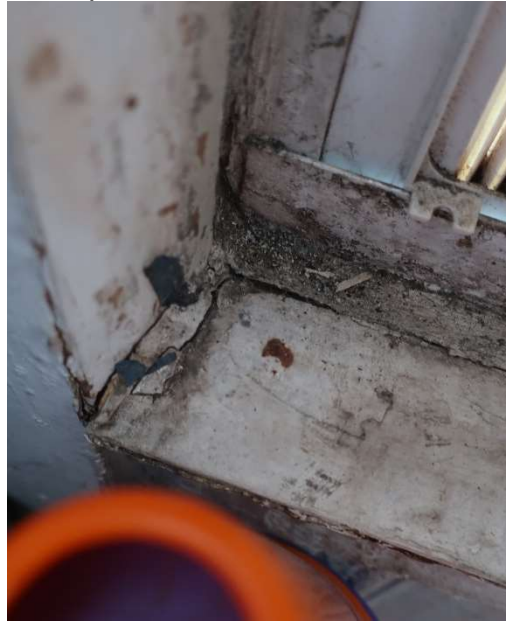
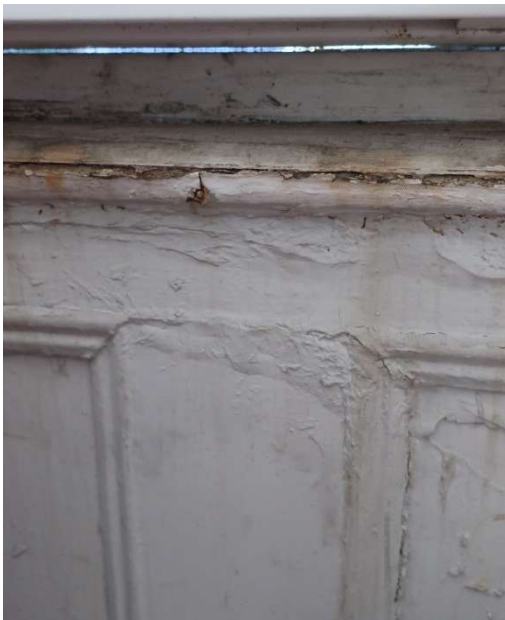
Observation #11.5: The main building 2nd floor windowsill and interior wall finish below appeared to be severely deteriorated.

Implication: Possible water leakage/infiltration

Comments: Recommends hiring a contractor to replace the windowsill and wall finish.

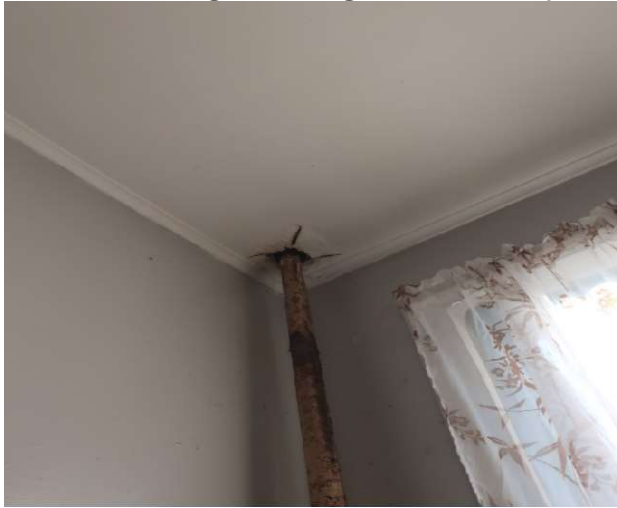
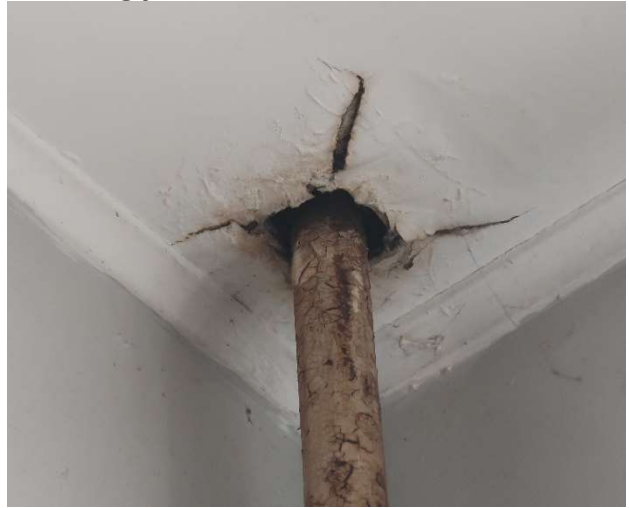
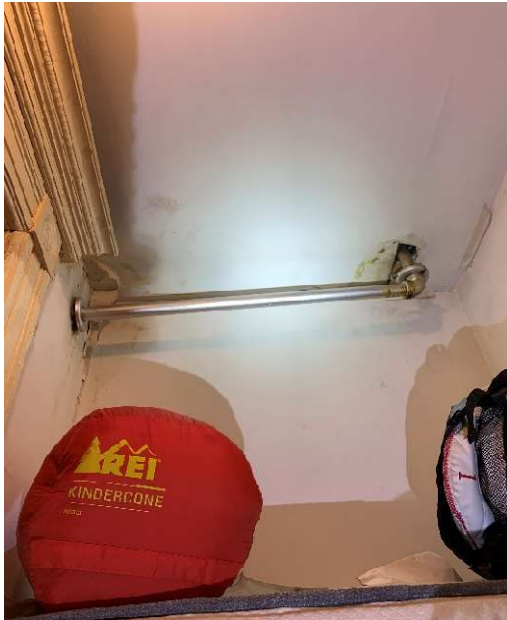
Observation #11.6: The boiler and water pipes appeared to be severely corroded, and the floor penetration was damaged.

Implication: Indicate water leakage or excessive moisture

Comments: Recommends cleaning and repainting the pipe and remove and replace area of water damaged ceiling to further inspect the ceiling joists.

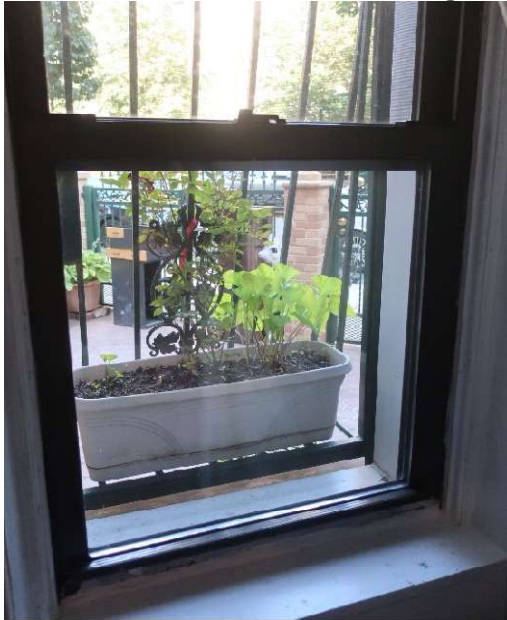
Condition: One of the windows was not able to stay open.

Observation #11.7: The window at the main building first floor was not able to stay open.

Comments: Recommends hiring a window professional to repair the defected window.

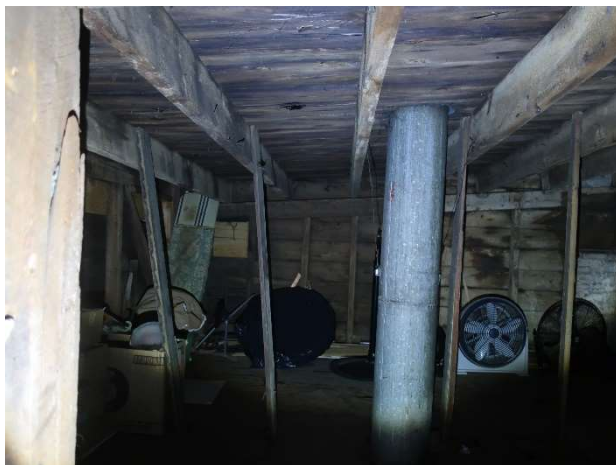
Observation #12.1: Attic venting system was not observed.

Implication: Possible attic mold and mildew, ice damming, temperature fluctuations inside your home, and deterioration

Comments: Recommends hiring a contractor to install proper venting.
