# Home Inspection Report

**Prepared By:** Zoey Tham, NJ #24GI00217600

PE Home Inspection, LLC • [www.pehomeinspection.com](http://www.pehomeinspection.com) • 609-203-0265 • pehomeinspection@gmail.com

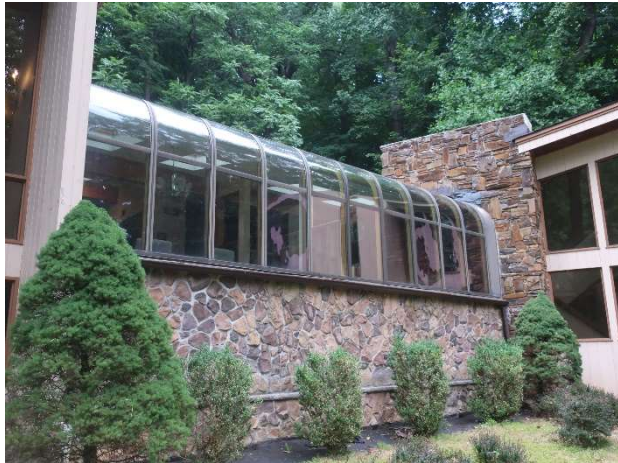
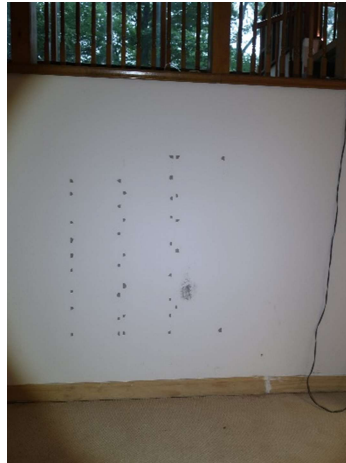
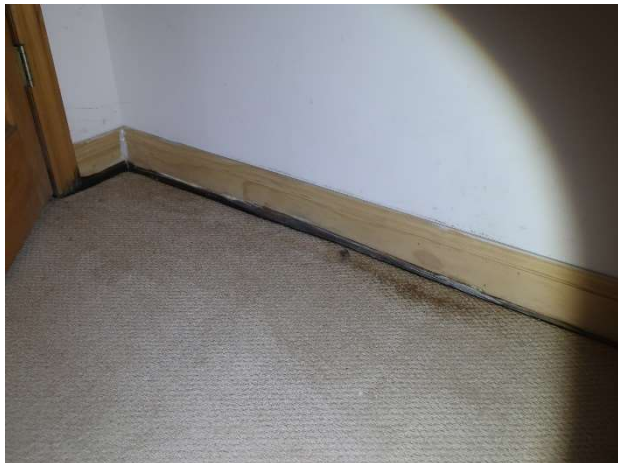
Observation #3.1: Water damage and mold were observed at multiple locations along the interior side of the foundation wall.

Implication: Possible water damage in the foundation walls

Comments: Recommends hiring a contractor to locally remove the interior finish to expose the foundation wall and hiring a structural engineer to further investigate the source of the water infiltration and the condition of the existing foundation wall. Repair the damaged waterproofing and foundation walls as required. See observation 11.3 for more information.

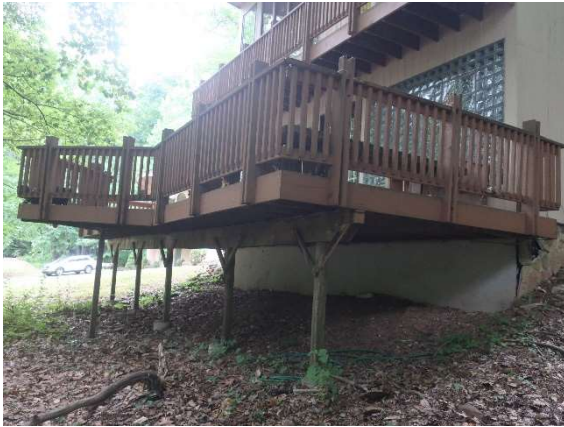
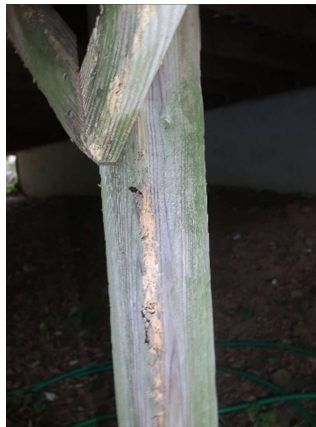
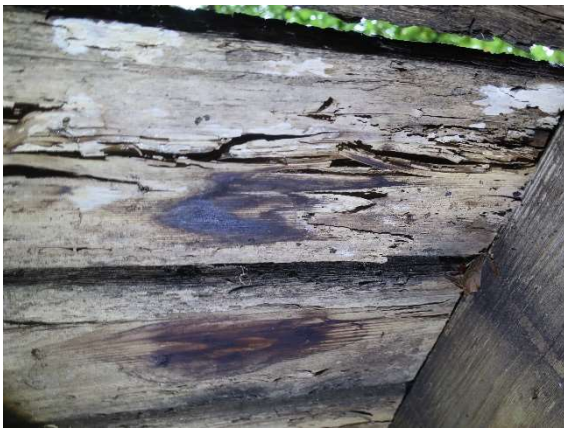
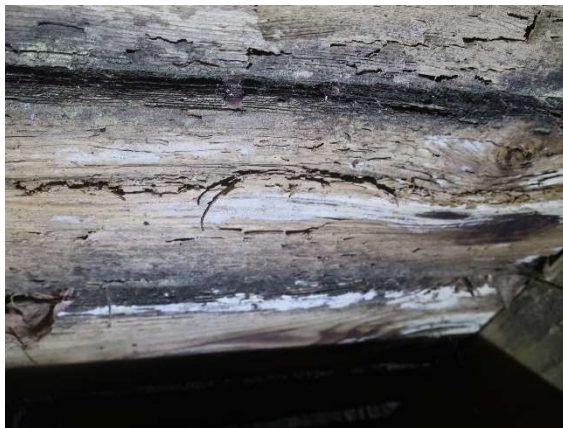
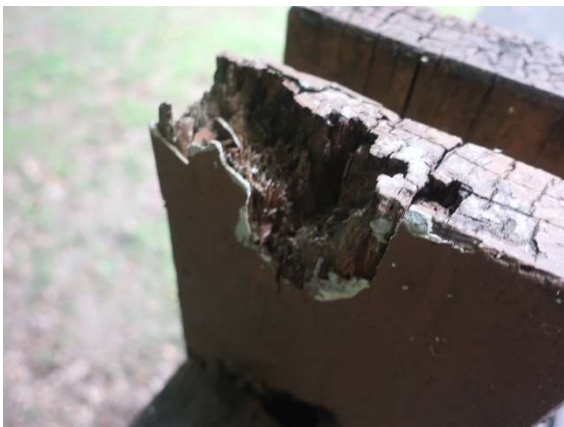
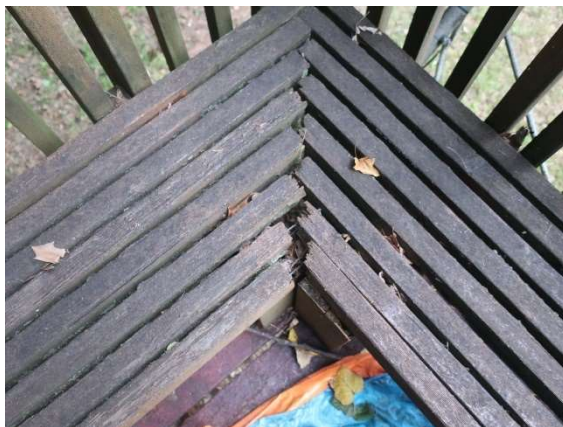
Observation #4.2: Significantly deteriorated wood planks and damaged wood braces, wood posts and wood handrail were observed in the large deck at the right side of the building. Some of the wood members appeared to be damaged by wood destroying insect.

Implication: Safety hazard. Possible collapse on deck planks or deck structure.

Comment: Recommends hiring a contractor to repair/replace all the damaged wood elements in the deck.

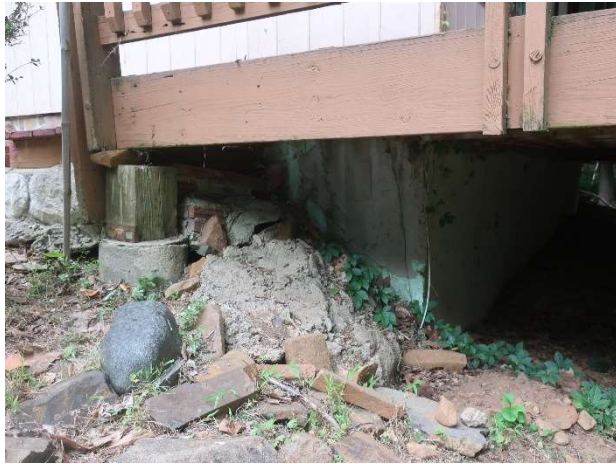
Observation #4.3: One of the wood joists in the large deck at the right side of the building were improperly supported on a wood post with a masonry shim.

Implication: Possible weakened structure

Comment: Recommends hiring a contractor to properly proper connection between the wood joist on the wood post.

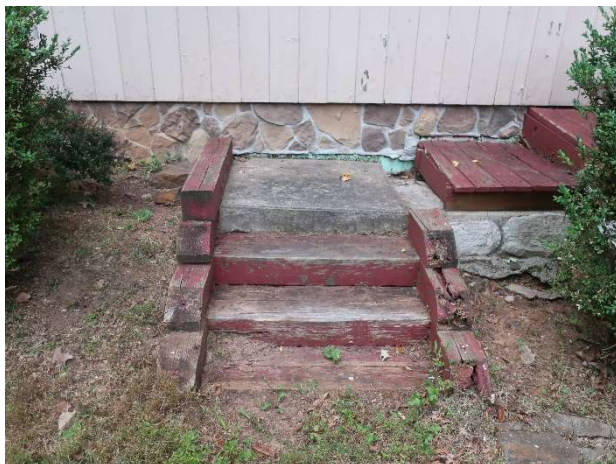
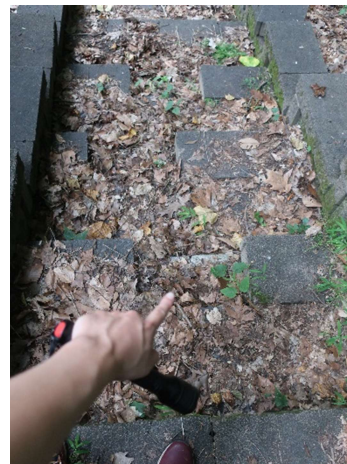
Observation #4.4: The exterior stone and wood stairs were significantly deteriorated and not stable.

Implication: Possible falling and tripping hazard.

Comment: Recommends hiring a contractor to repair/replace the deteriorated stairs.

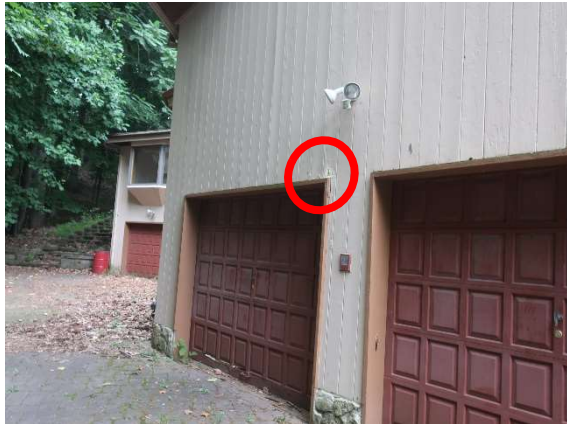
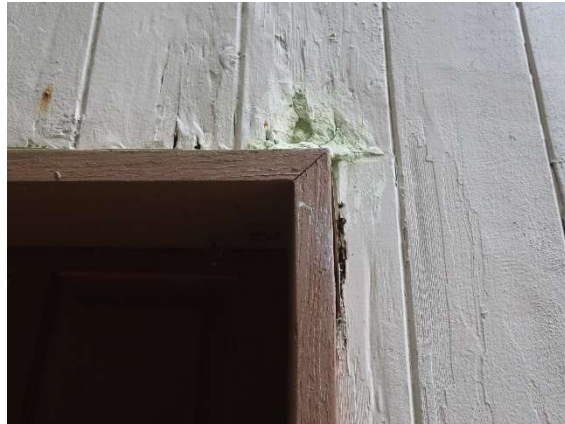
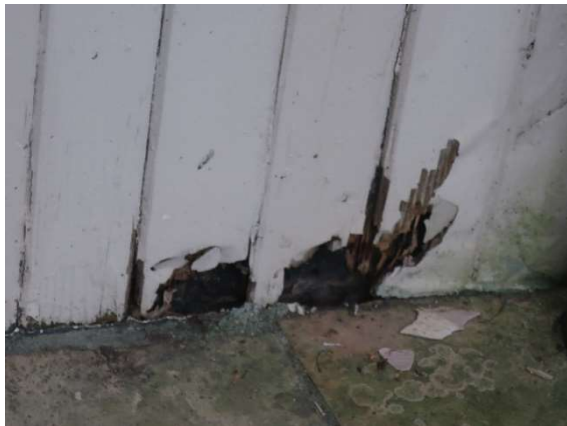
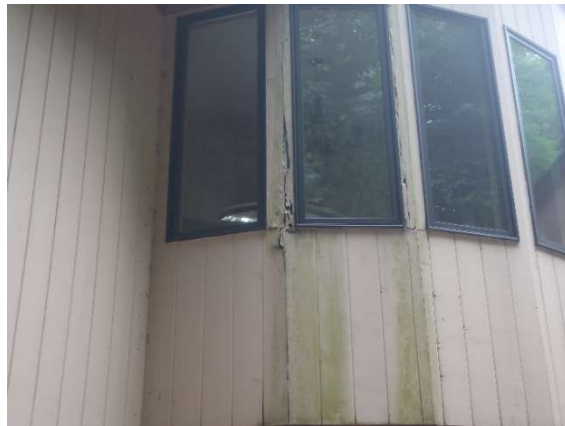
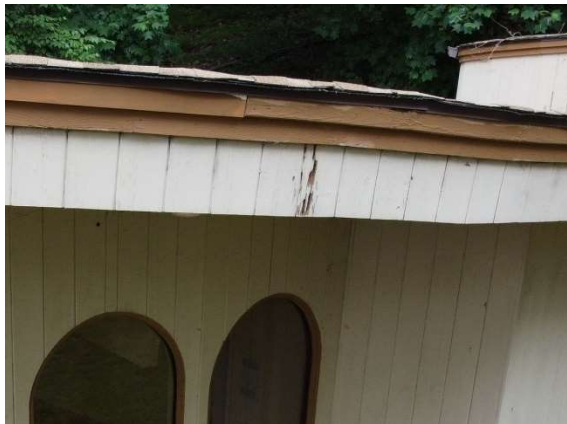
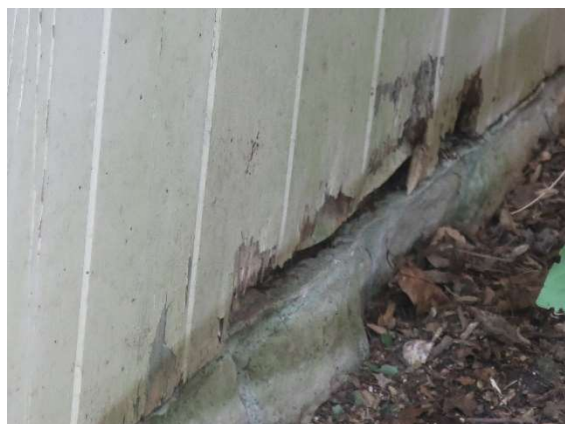
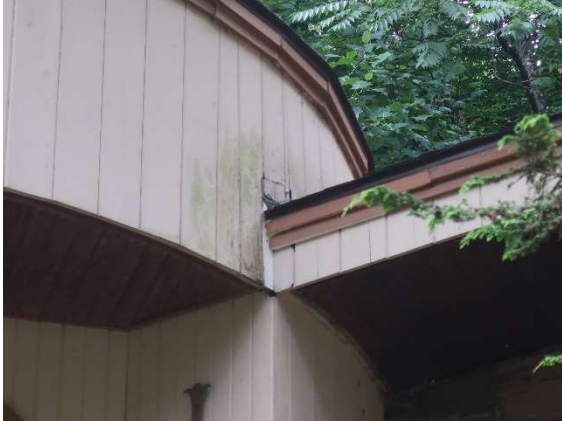
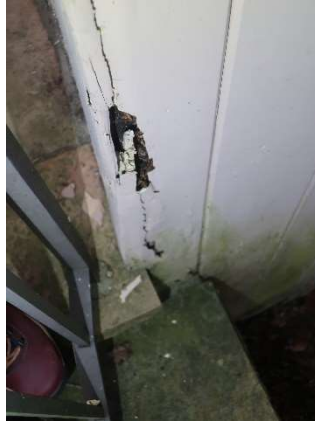
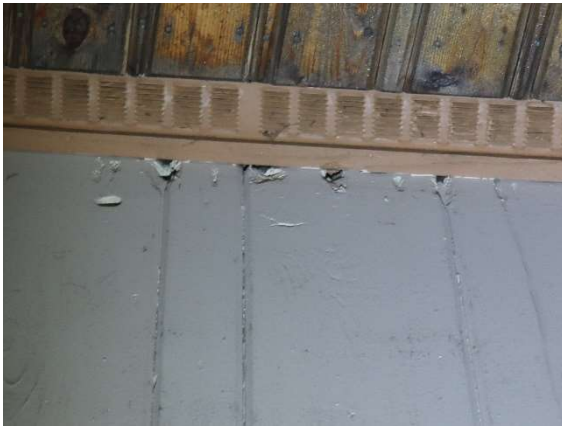
Observation #4.5: Deteriorated and damaged wood siding were observed in many locations. Some of the damages appeared have been caused by wood destroying insect.

Implication: Possible water infiltration into interior space and damage to the structural wood members.

Comment: Recommends hiring a contractor to replace the damaged siding.

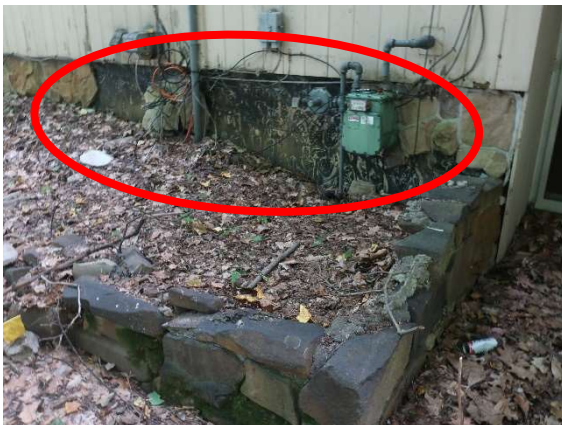
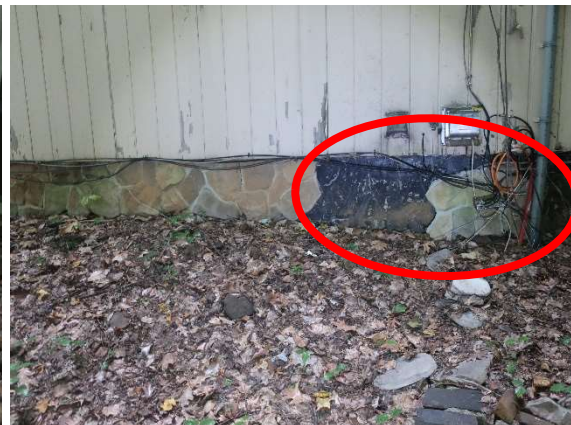
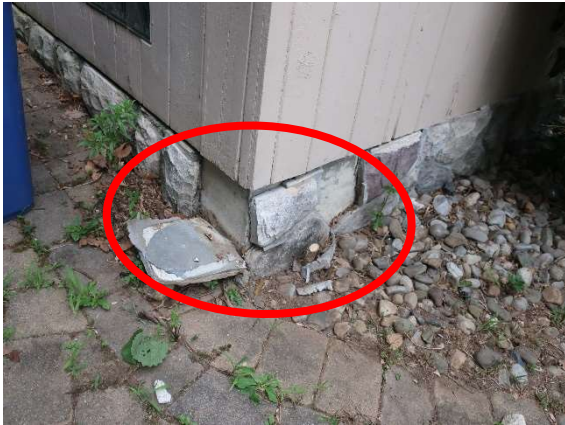
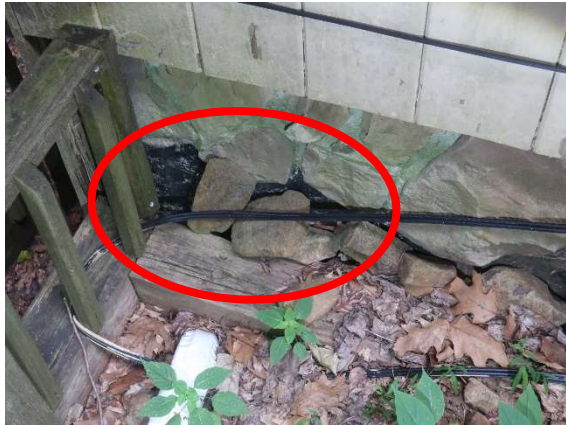
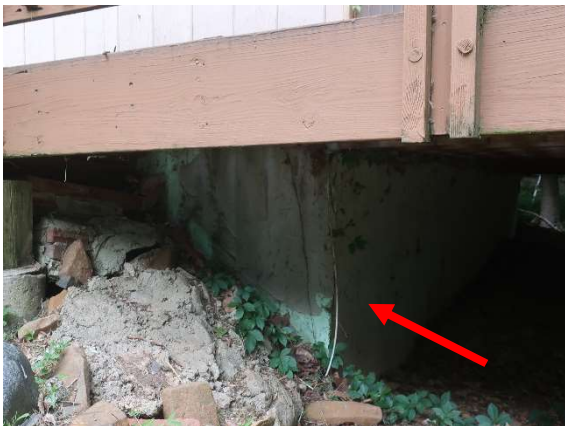
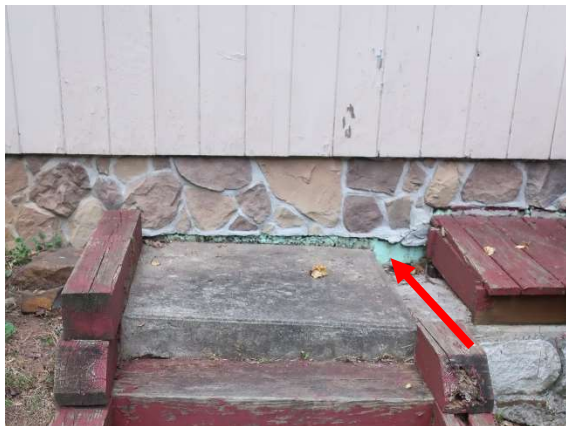
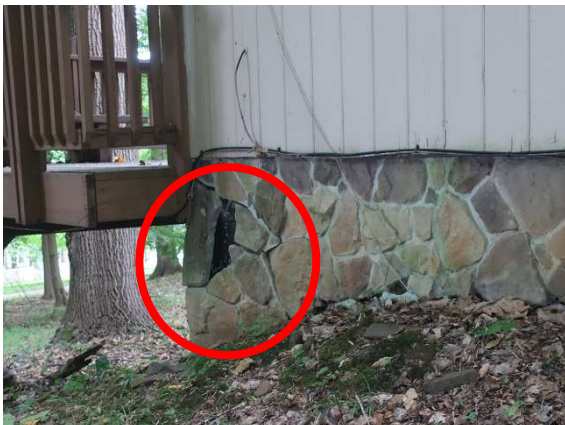
Observation #4.6: In multiple locations, the stone siding in front of the foundation wall cracked/loose/missing and exposing the waterproofing/insulation/foundation behind. Some of the insulation was also observed to be missing.

Implication: Possible water infiltration into interior space and damage to the structural wood members.

Comment: Recommends hiring a contractor to replace the damaged siding.

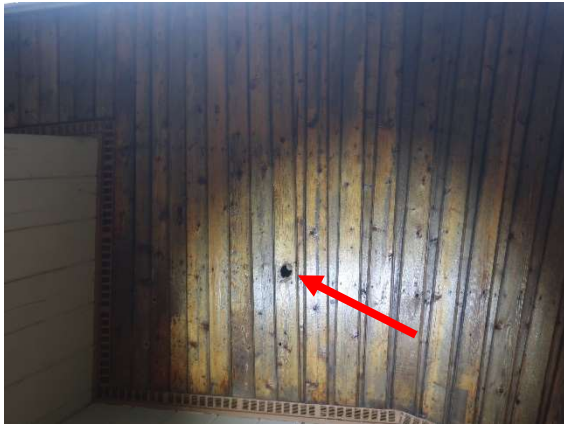
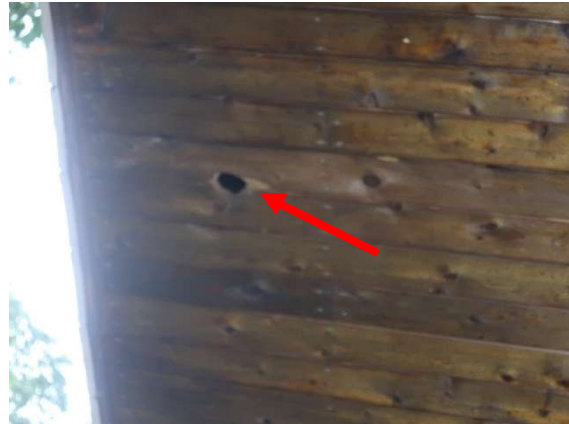
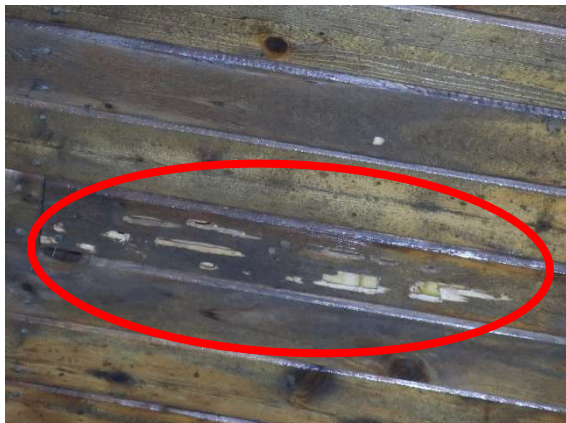
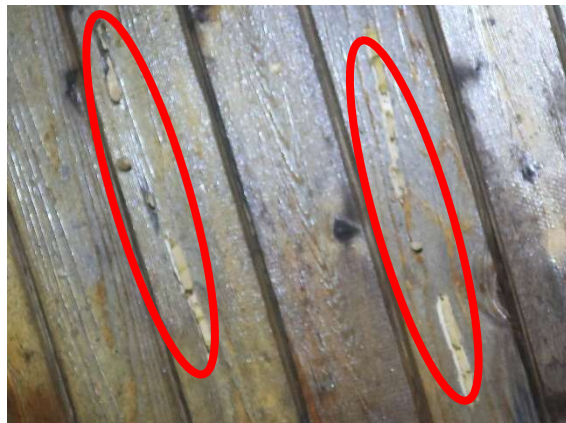
Observation #4.7: Localized holes were observed at the bottom of the awning at the roofing level. Some of the wood plank cover appeared to have damaged by wood destroying insects.

Implication: Possible access for unwanted insect/pests/animal.

Comment: Recommends hiring a contractor to seal the holes.

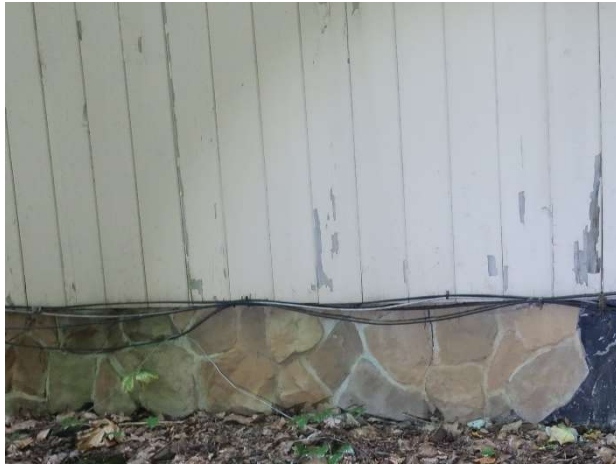
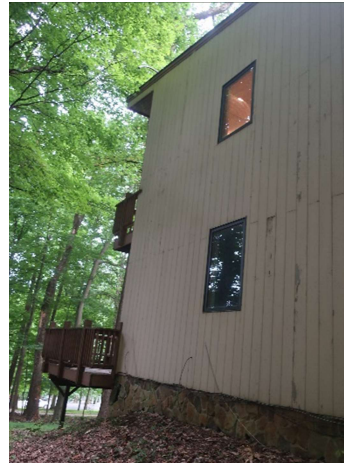
Observation #4.10: Paint peeling and green algae were observed on the wood sidings at multiple locations.

Implication: Excessive moisture.

Comment: Recommends hiring a contractor to clean the algae and repaint the wood sidings.

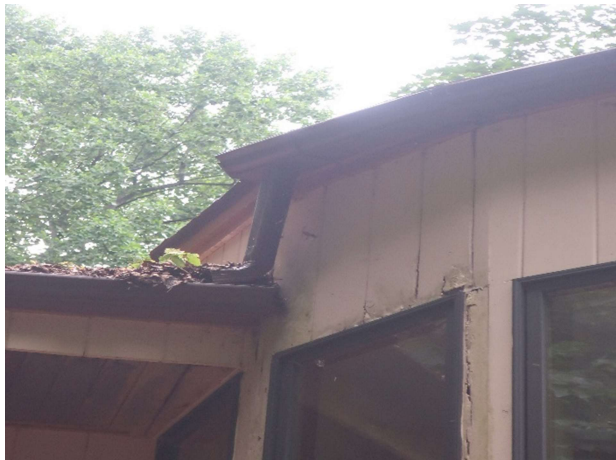
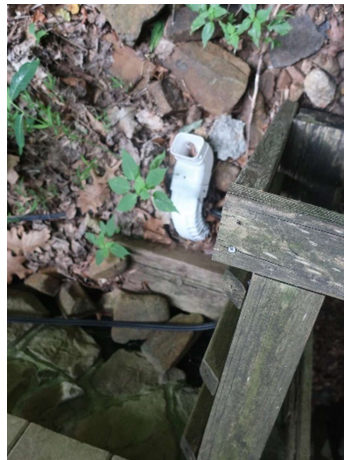
Observation #4.11: Some of the gutter downspouts were loose or too draining too close to the building.

Implication: Possible water damage to foundation and siding.

Comment: Recommends hiring a contractor to repair the loose downspouts and extend the downspouts away from the building

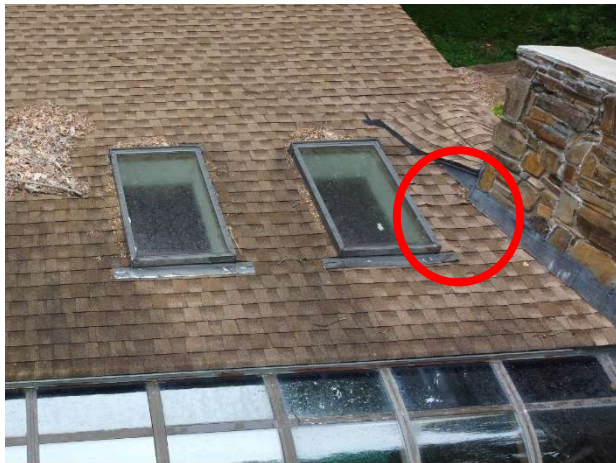
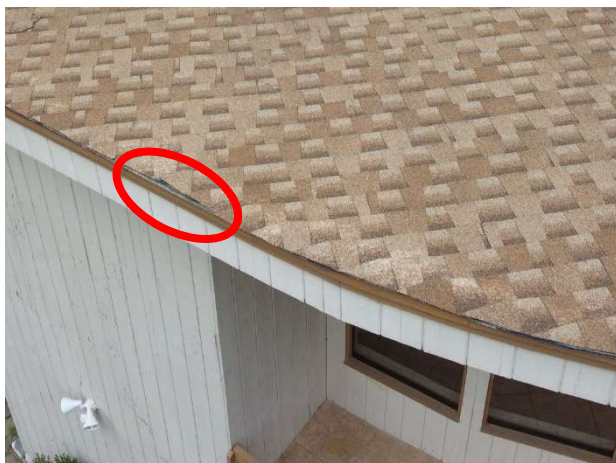
Observation #5.1: Portion of the existing roofing appears to be deteriorated. Fishmouthed shingles were observed around the skylight and at the edge of the roof.

Implication: Possible water infiltration below the shingles and into the house

Comments: Recommends hiring a licensed roofer to further evaluate and repair/replace the roofing as required.

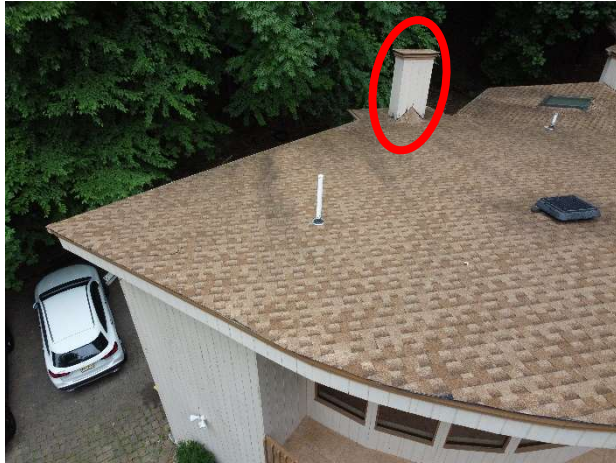
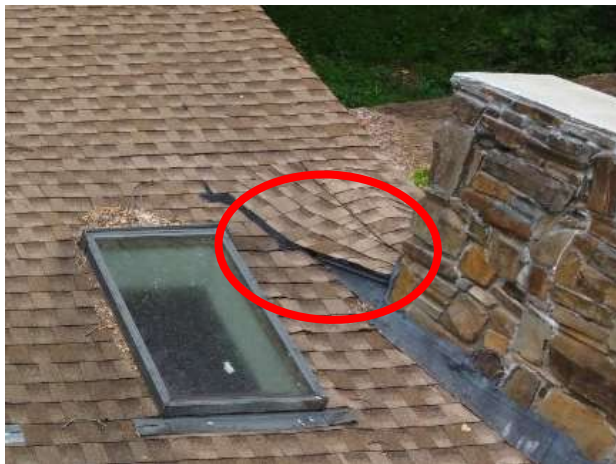
Observation #5.2: Flashing around one of the chimneys appears to be missing. The bottom of the wood shingle cover around this chimney was deteriorated. The flashing behind another chimney appeared to be not properly installed.

Implication: Possible water infiltration below the shingles and into the house

Comments: Recommends hiring a licensed roofer to further evaluate and repair/replace the chimney flashing as required.

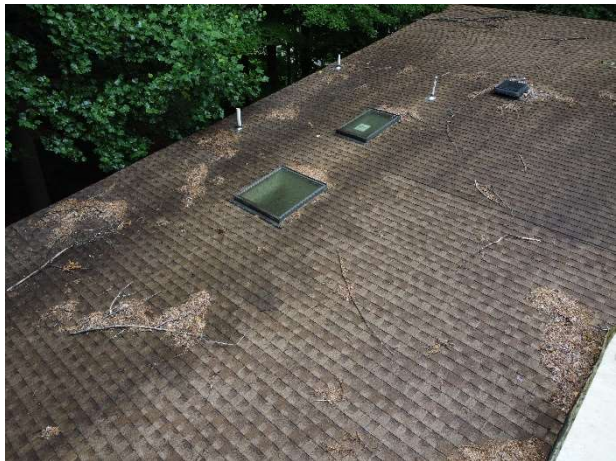
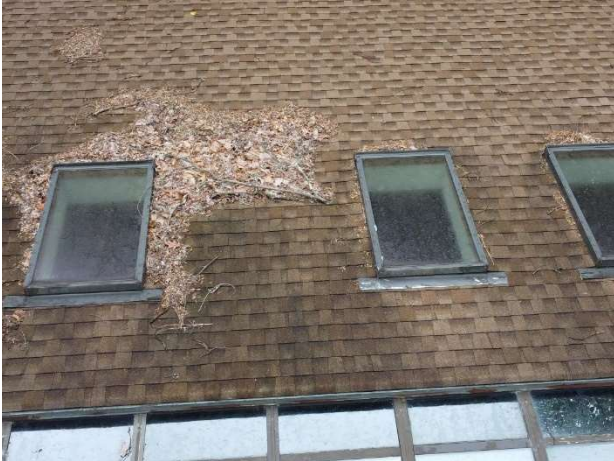
Observation #5.3: Excessive debris was observed on the roof. Vegetation was growing on top of some portion of the roof.

Implication: Possible roofing damage from falling of tree brunch. The saturated leaves on the roof would become compost. The compost from the leave in addition with the excessive moisture from the poor roof drainage would allow vegetation to grow.

Comments: Vegetation can damage the roofing and could cause water infiltration. Recommends cleaning the debris and remove the vegetation on top of the roof and hiring a licensed roofer to further evaluate the roof for required repair/replacement

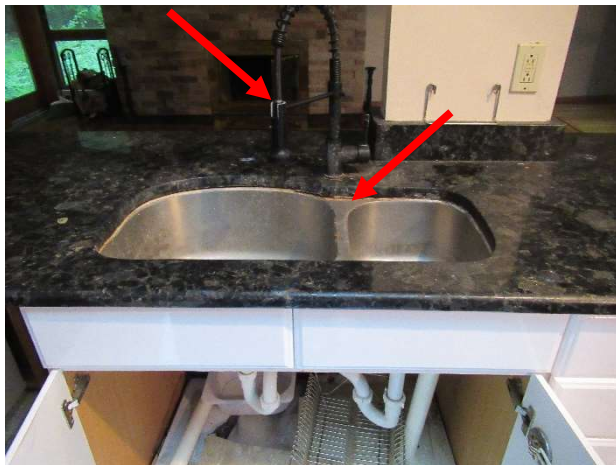
Observation #6.1: The kitchen sink faucet was broken and the seal around the sink was appeared to be severely deteriorated.

Implication: Possible water leakage into the sink

Comment: Recommends faucet replacement and replace/reseal the sink into place.

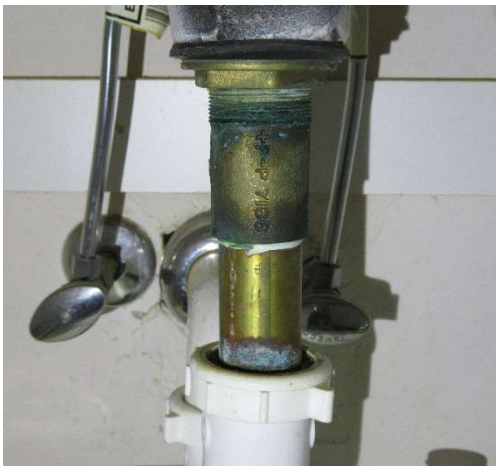
Observation #6.5: Visible patina stain along copper piping under bathroom sink

Implication: Indicate excessive moisture or water leakage

Comment: Recommends hiring a plumber for further evaluation and repair.

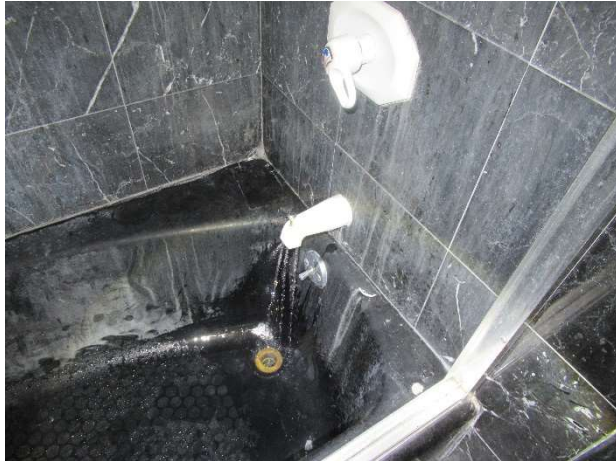
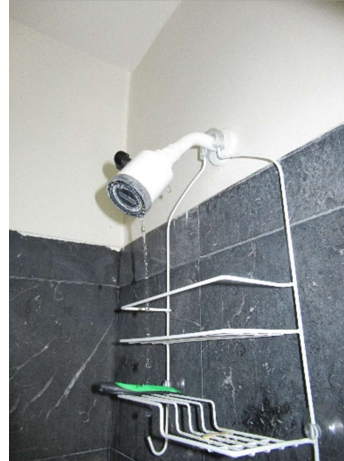
Implication: Possible clogged shower head and broken rubber stopper in the diverter

Comment: Recommends hiring a plumber for further evaluation and repair.

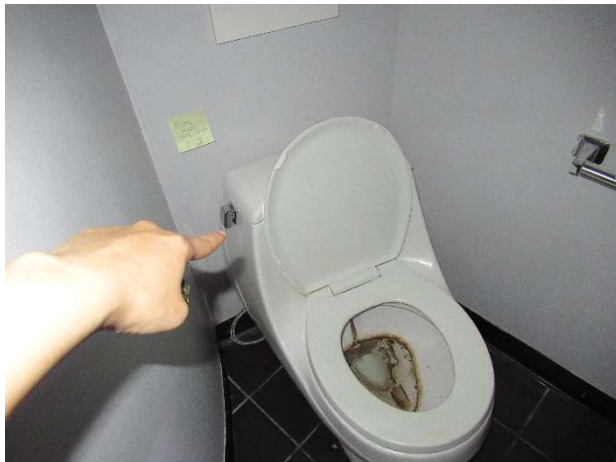
Observation #6.8: The handle for toilet was not properly working

Implication: Possible faulty flushing mechanism or flush link not properly connected

Comment: Recommends hiring a plumber for further evaluation and repair.

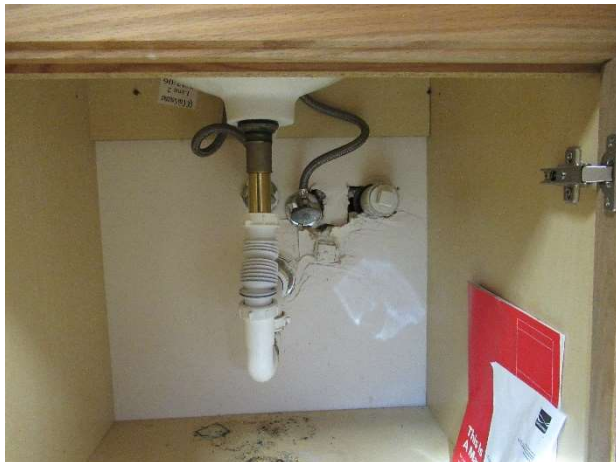
Observation #6.10: Flexible p-trap drainage piping was observed under the sink.

Implication: Possible pipe clog up in the flexible part of the pipe which may slow down the water flow through the flexible p-trap

Comment: Recommends hiring a plumber for further evaluation and repair as required.

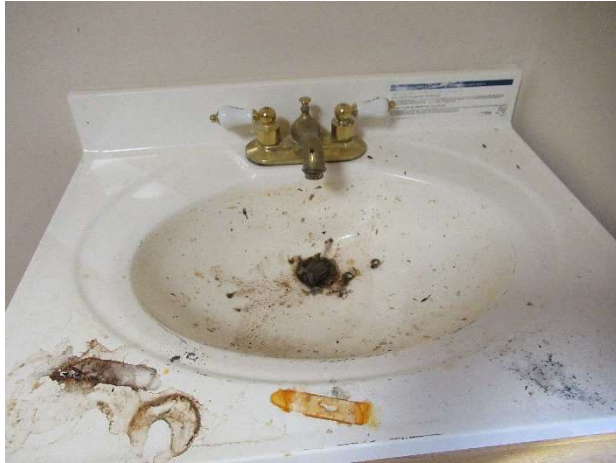
Observation #6.11: Most of the sinks appeared to be dirty and missing sink drain cover. Most of the toilets were observed to be dirty.

Comment: Recommends regular cleaning and maintenance.

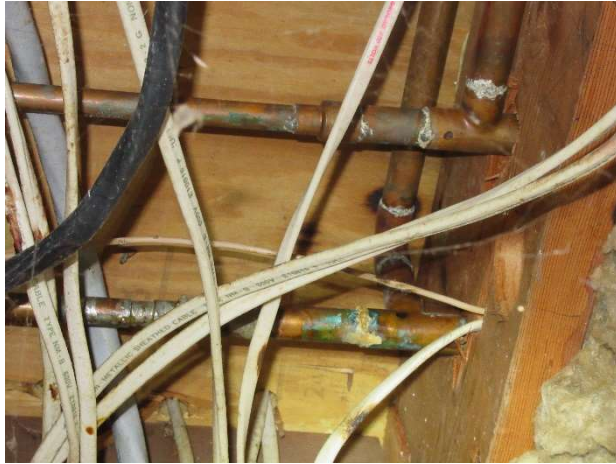
Observation #6.13: Visible patina stain along copper piping

Implication: Indicate excessive moisture or water leakage

Comment: Recommends hiring a plumber for further evaluation and repair.

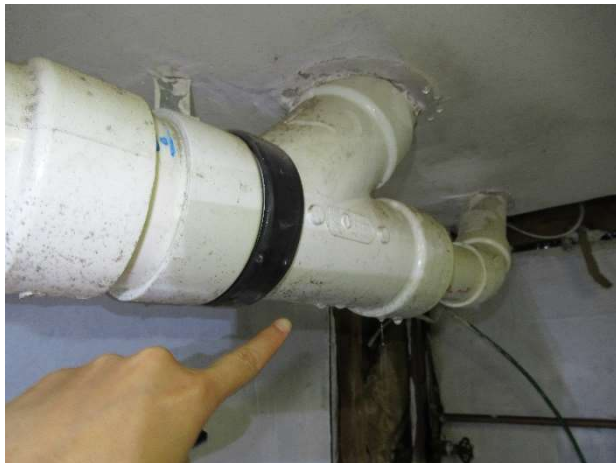
Observation #6.14: Visible water leaks in the drainage piping system in the basement

Implication: Possible water damage to interior home space

Comment: Recommends hiring a plumber for further evaluation and repair.

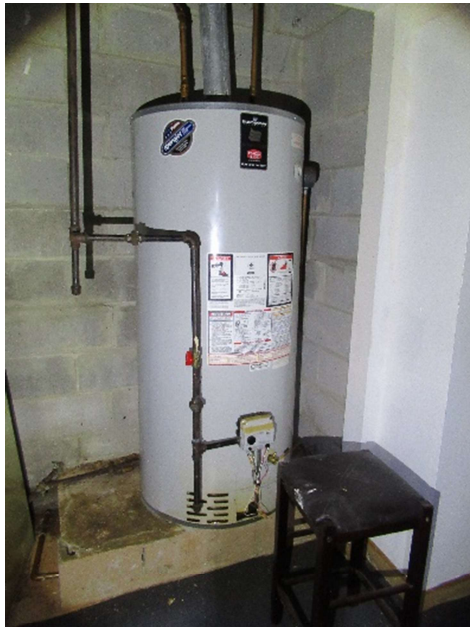
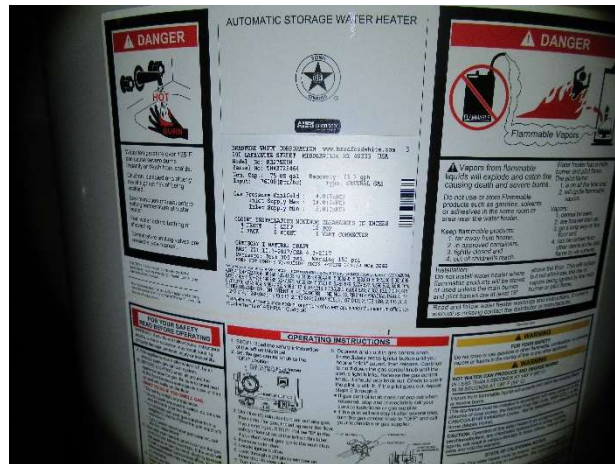
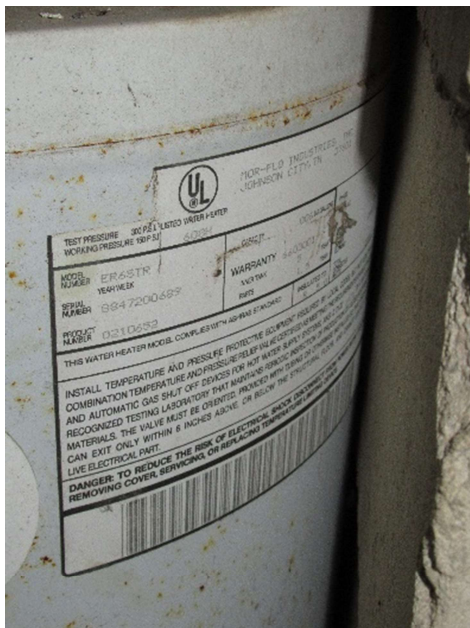
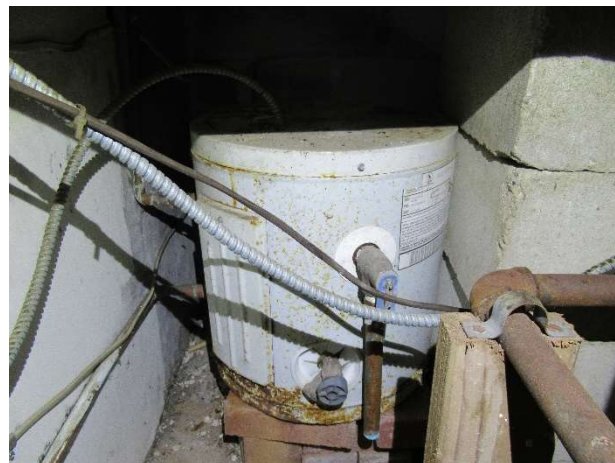
Observation #6.15: The Bradford White water heater and Mor-flo water heater were manufacturer in 1999 and 1988 respectively. They are near the end of their service lives and the hot water supply on all faucets were faulty.

Comment: Recommends installing new water heater and hiring a plumber for further evaluation and repair.

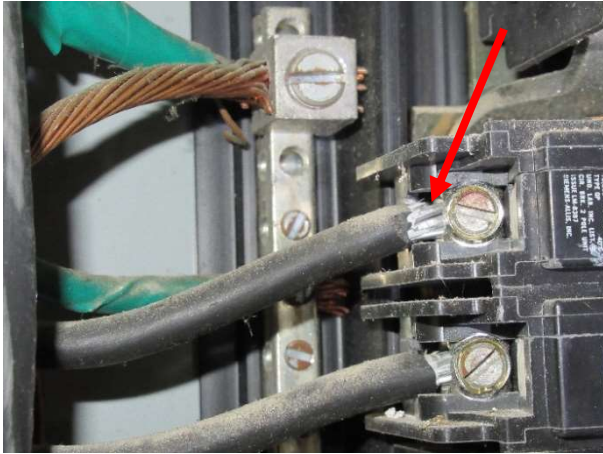
Observation #7.1: Aluminum wiring conductors at lug was observed without anti-oxidant paster

Implication: Possible aluminum conductors oxidization

Comment: Recommends hiring an electrician to apply anti-oxidant paste at terminals

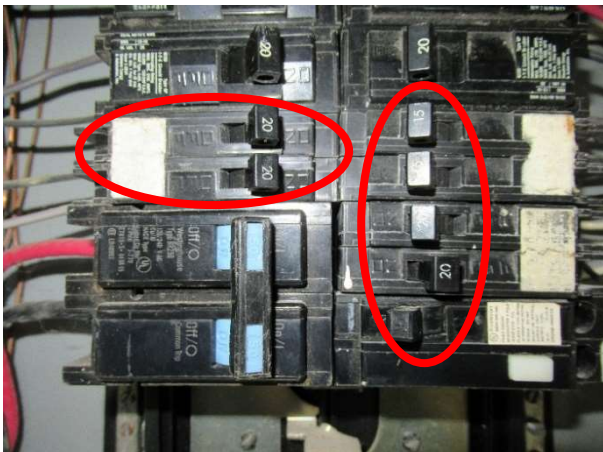
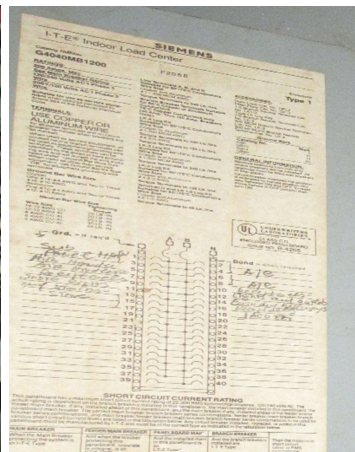
Observation #7.2: Tandem circuit breakers were installed in the electrical panel which was not allow per panelboard diagram.

Implication: Possible improper physical connection to the bus bar in the panelboard, the bus bars of the panelboard could have been damaged or altered to allow for the installation of tandem circuit breakers

Comment: Recommends hiring an electrician for further evaluation, repair and replacement

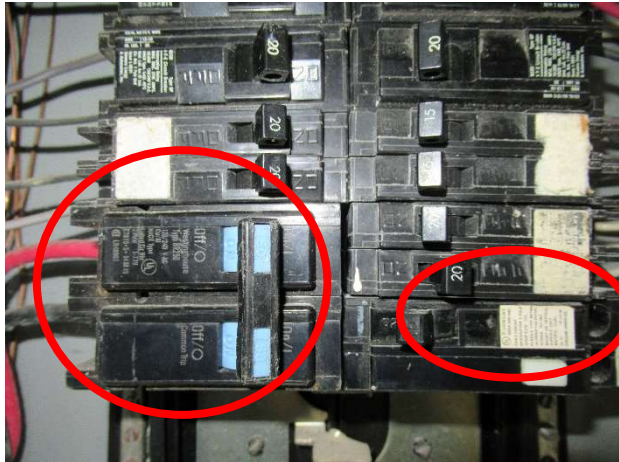
Observation #7.3: Some of the breakers installed do not match the electrical panel brand.

Implication: Possible safety hazard

Comment: A breaker from different manufacturer may not be used even if it seems to fit. Recommends hiring an electrician for further evaluation and replacement.

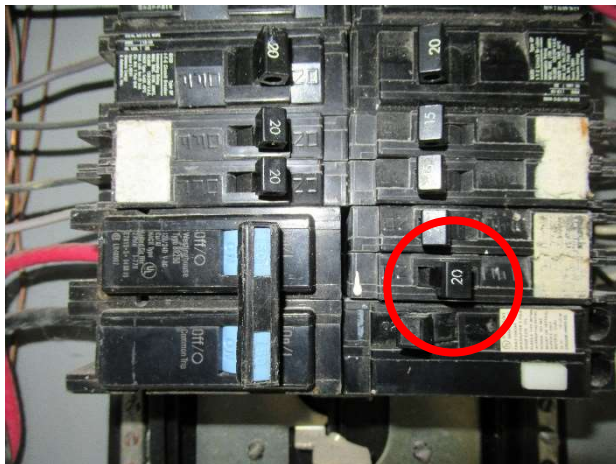
Observation #7.4: One of the breakers was tripped.

Comment: Recommends consulting seller about the tripper breaker.

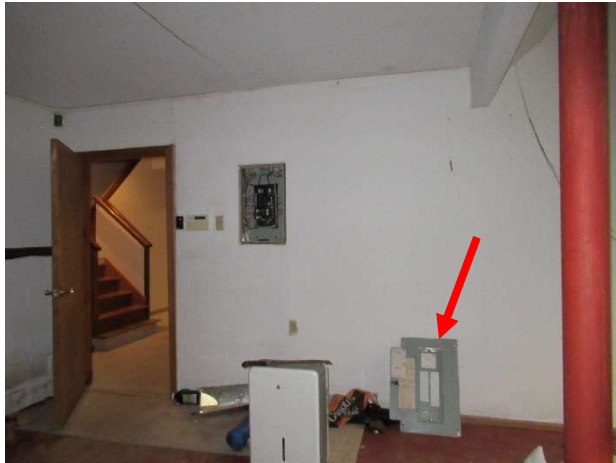
Observation #7.5: The cover for the subpanel was removed prior to home inspection. It was observed that the panel cover missing a breaker knockout.

Implication: Possible safety hazard

Comment: Recommends hiring electrician to seal these breaker blanks and securely screw up the electrical panel.

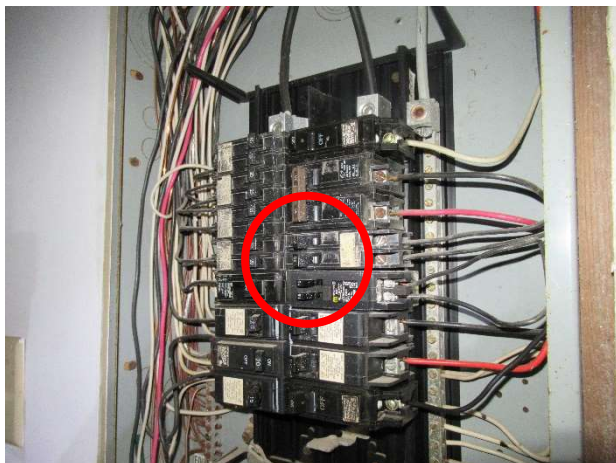
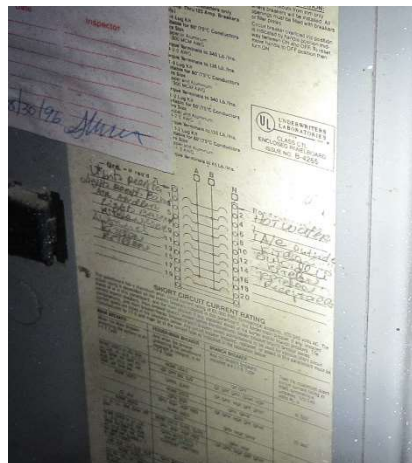
Observation #7.6: Tandem circuit breakers were installed in the electrical panel which was not allow per panelboard diagram.

Implication: Possible improper physical connection to the bus bar in the panelboard, the bus bars of the panelboard could have been damaged or altered to allow for the installation of tandem circuit breakers

Comment: Recommends hiring an electrician for further evaluation, repair and replacement

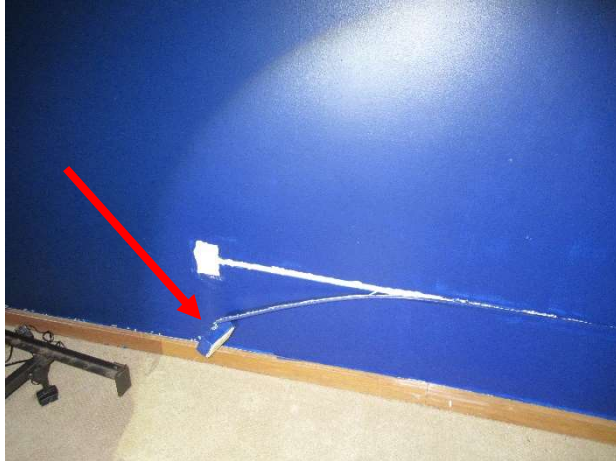
Observation #7.12: Multiple receptacle outlets were malfunction and missing cover plate

Implication: Possible safety hazard

Comment: Recommends hiring an electrician for further evaluation, repair and replacement.

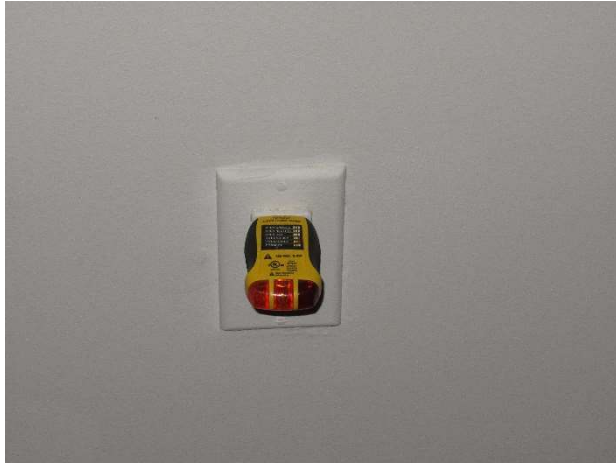
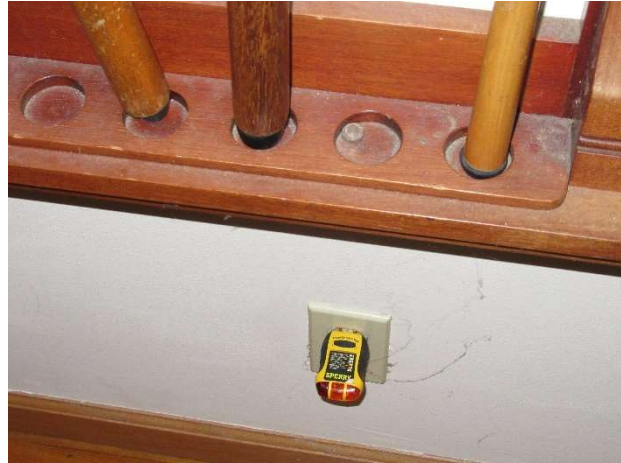
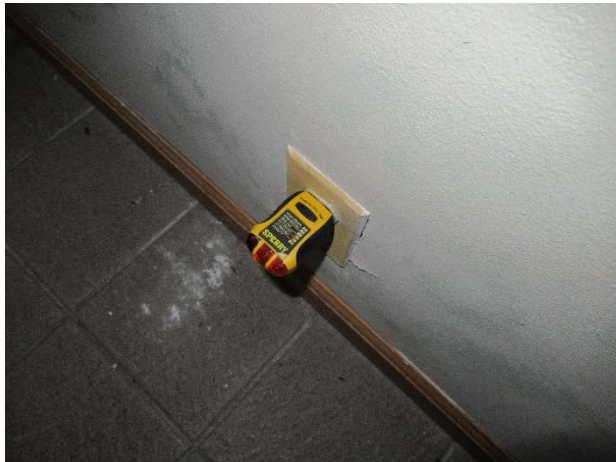
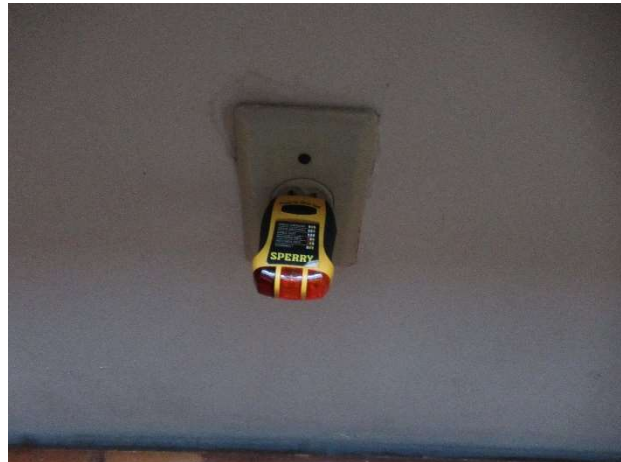
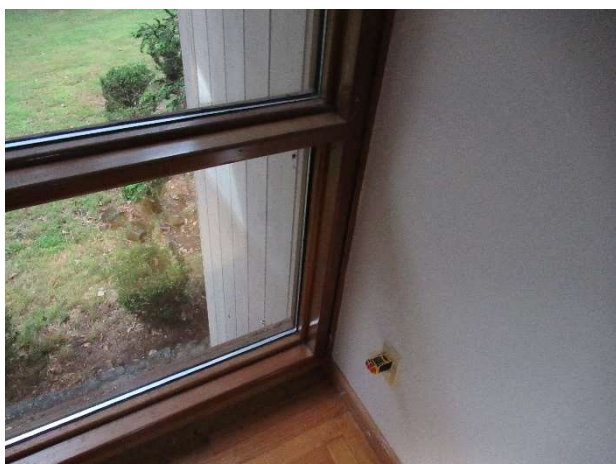
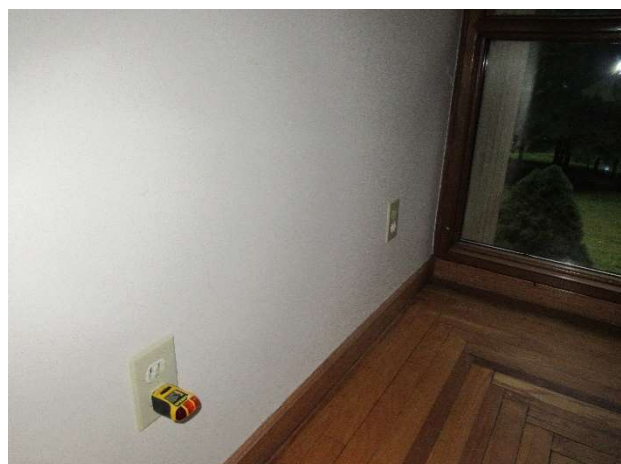
Observation #7.16: Most of the electrical outlets were malfunction

Comment: Recommends hiring an electrician for further evaluation, repair and replacement.

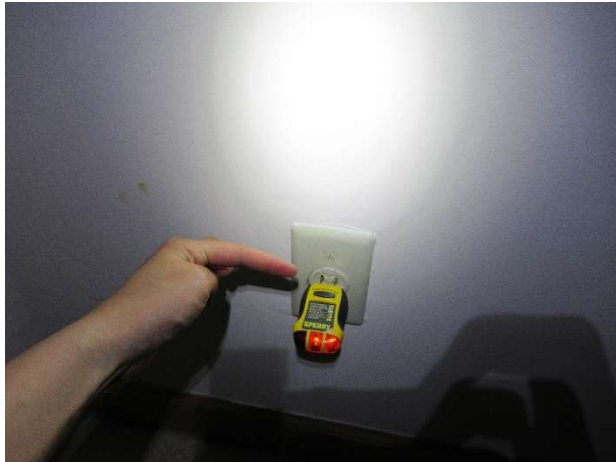
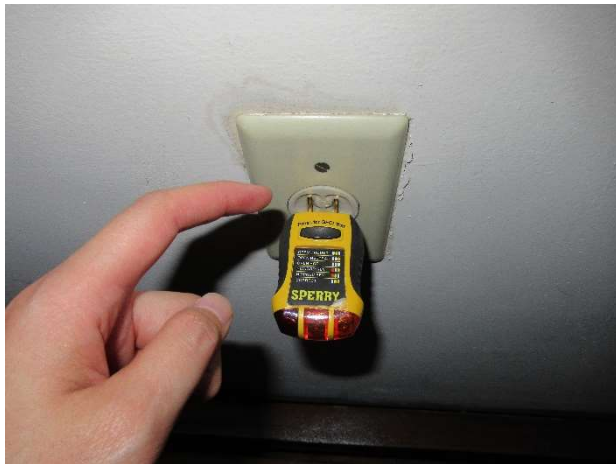
Observation #7.17: The electrical tester was not able to plug in all the way on some of the electrical outlets

Implication: Possible safety hazard

Comment: Recommends hiring an electrician for further evaluation, repair and replacement.

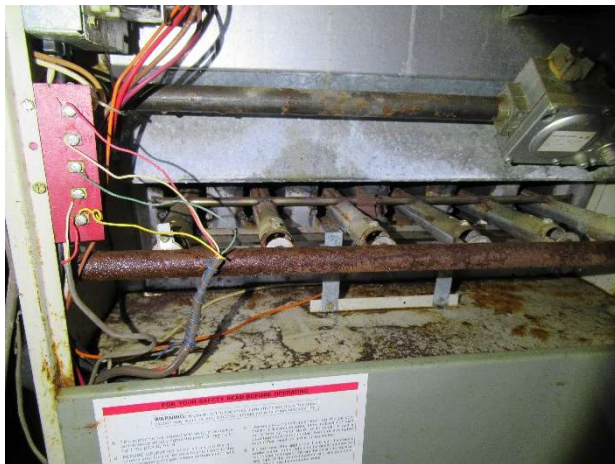
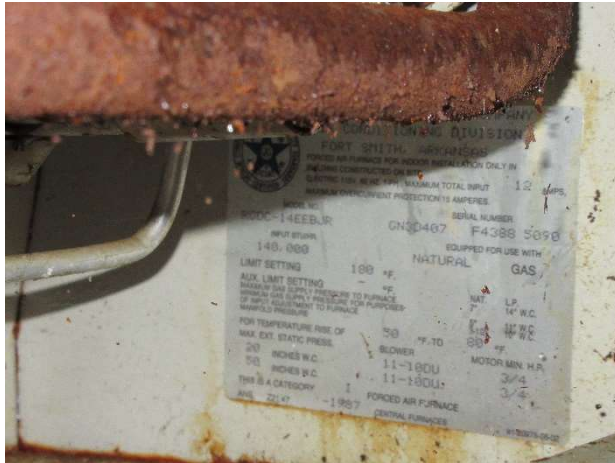
Observation #8.1: The furnace was malfunction and the ribbon burners appeared to be severely rusted. The furnace manufacture date is 1988 and it is near the end of the service life.

Comment: Recommends installing new furnace.

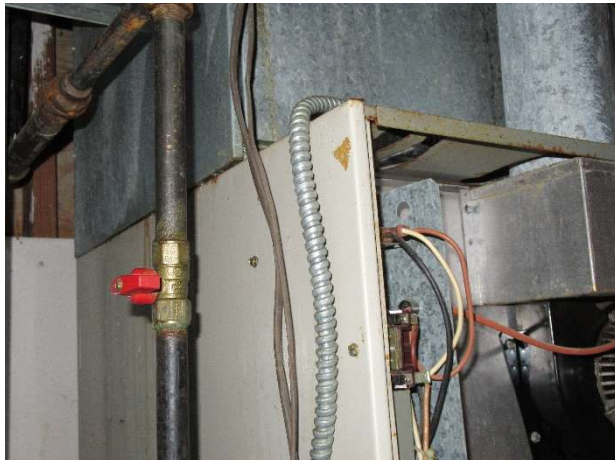
Observation #8.2: The gas valve was shut off prior to home inspection

Comment: Recommends consulting seller agent regarding gas valve shut off.

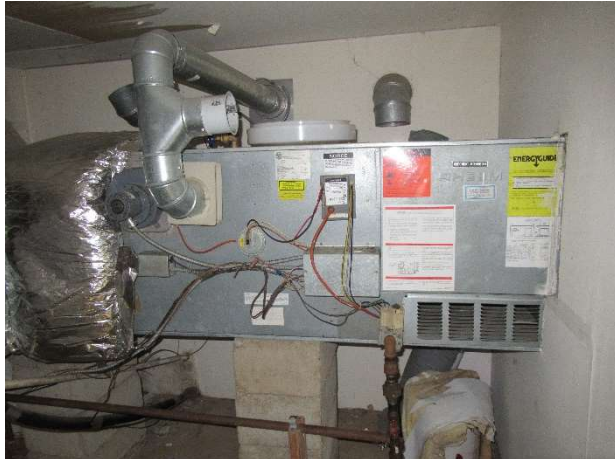
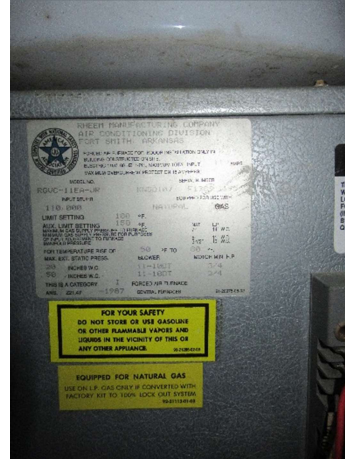
Observation #8.3: The furnace was malfunction during home inspection test run. The furnace manufacture date is 1989 and it is near the end of the service life.

Comment: Recommends installing new furnace.

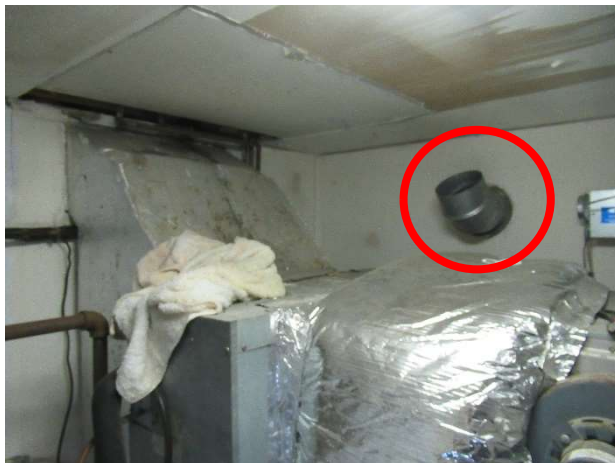
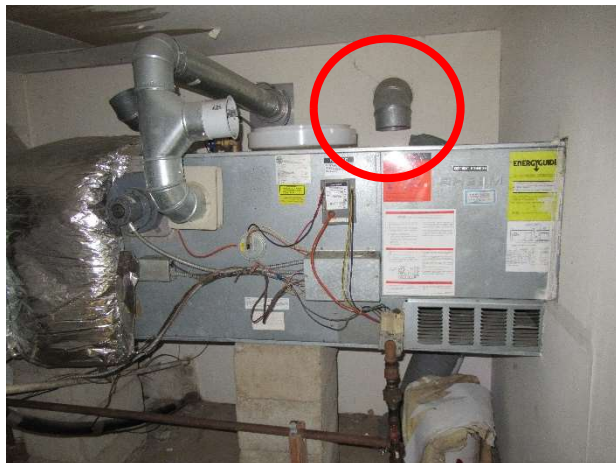
Observation #8.4: There was an open vent outlet in the basement room near the furnace.

Implication: Possible exhaust air entering the home space

Comment: Recommends hiring an HVAC technician to verify vent outlet and install proper enclosure.
