# Home Inspection Report

**Prepared By:** Zoey Tham, NJ #24GI00217600

PE Home Inspection, LLC • [www.pehomeinspection.com](http://www.pehomeinspection.com) • 609-203-0265 • pehomeinspection@gmail.com

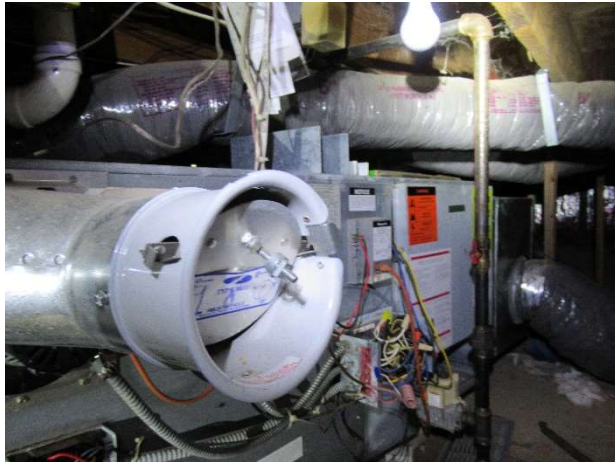
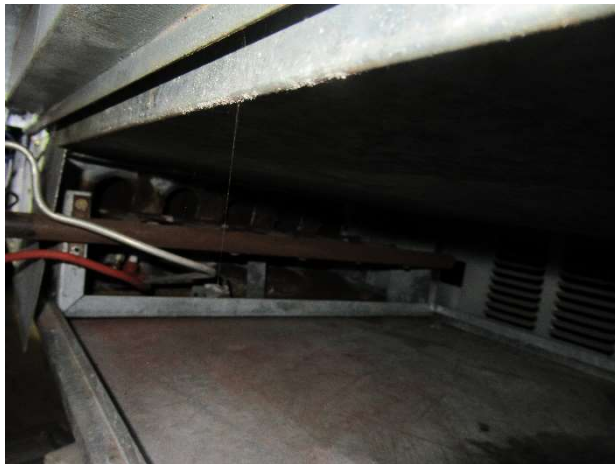
Observation #8.5: The furnace was malfunction and rusty. No flame was observed during test run. The furnace manufacture date is 1989 and it is near the end of the service life.

Comment: Recommends installing new furnace.

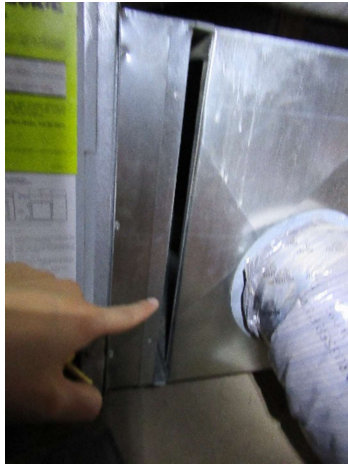
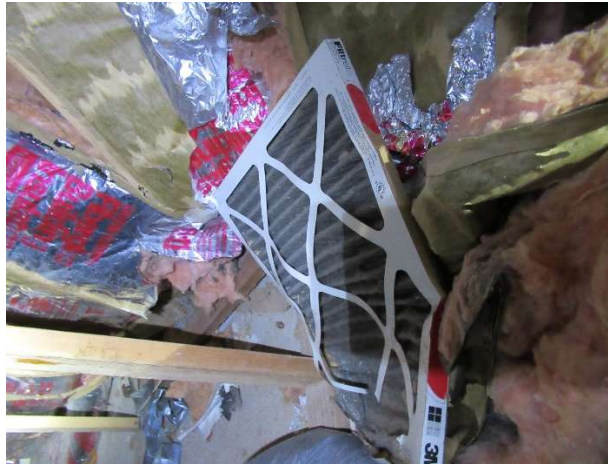
Observation #8.6: The furnace filter hole was missing an air filter.

Implication: The returned air was not filter properly and possible circulating unfiltered air in the house

Comment: Recommends installing air filters regularly. Recommends regular cleaning and maintenance for HVAC unit and duct work.

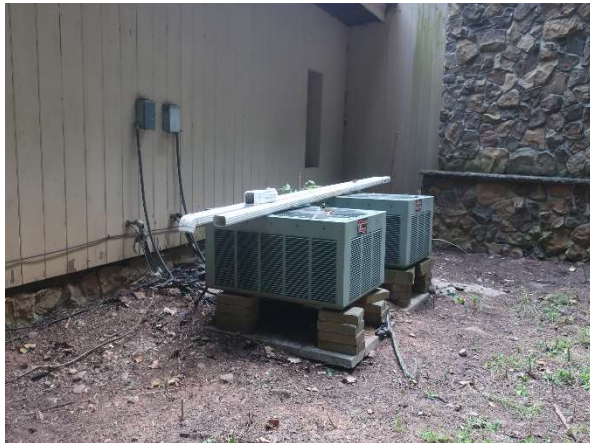
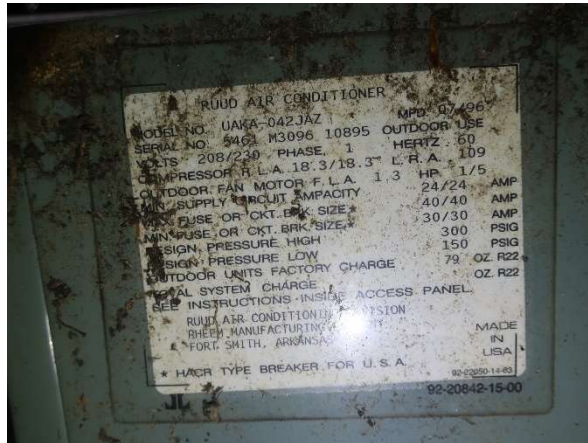
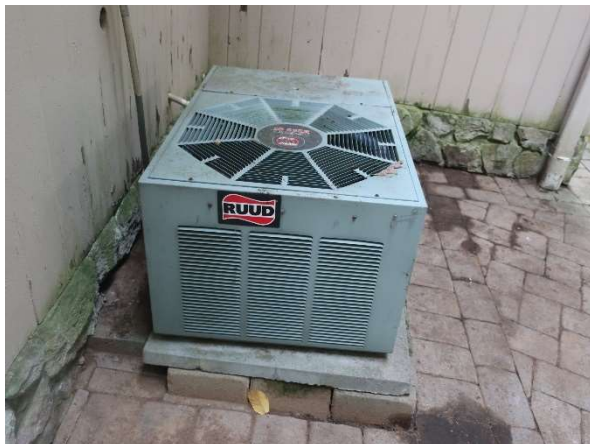
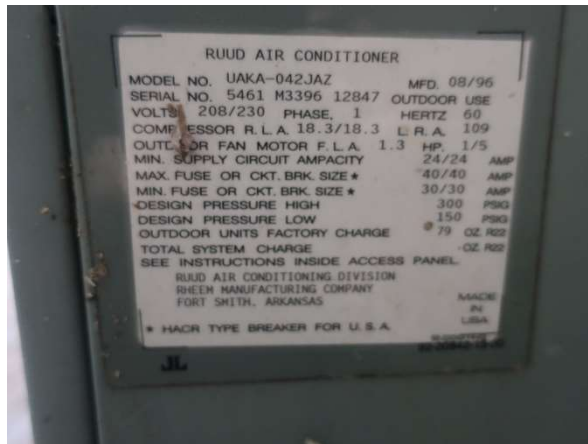
Observation #9.1: All three air conditioner units were manufacture in 1996 and it is near the end of their service lives.

Comment: Recommends installing new air conditioner.

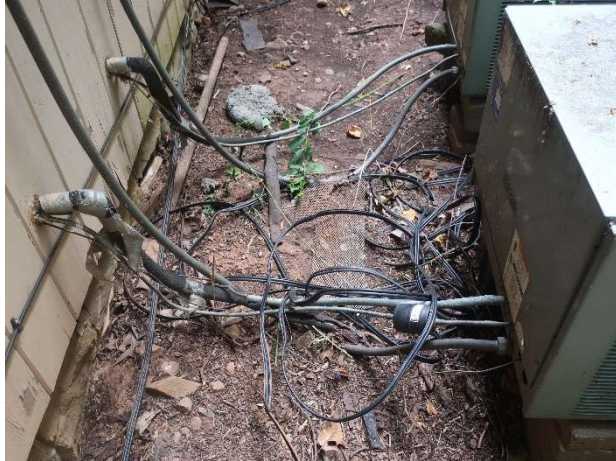
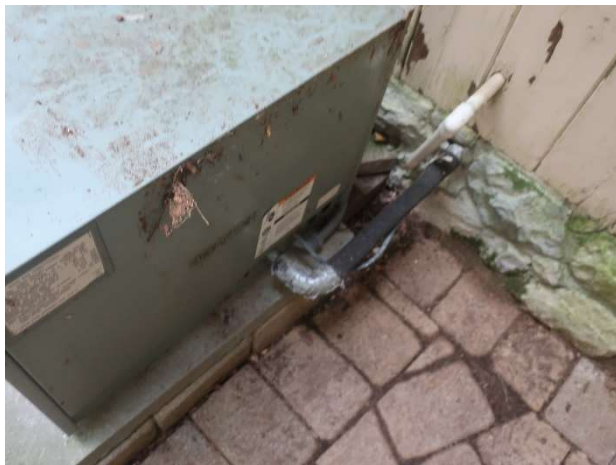
Observation #9.2: The insulation on outdoor air conditioner freon line was deteriorated with section loss.

Implication: Reduce efficiency of air conditioning system

Comment: Recommends repair or replacement of freon line insulation.

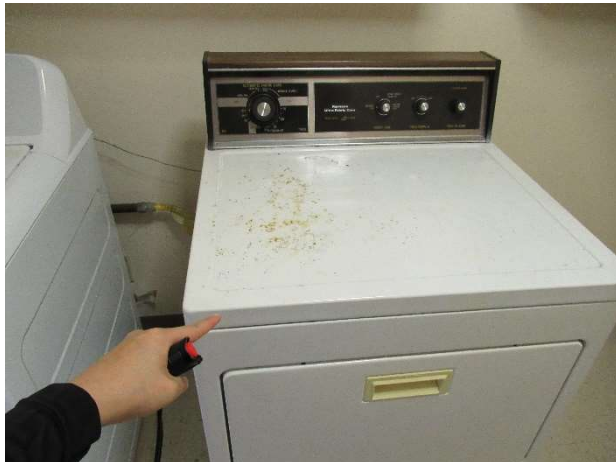
Observation #10.1: The dryer was inoperable

Comments: Recommends installing a new dryer.

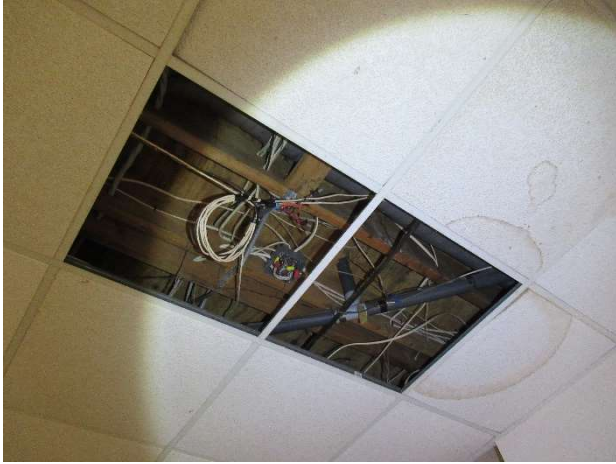
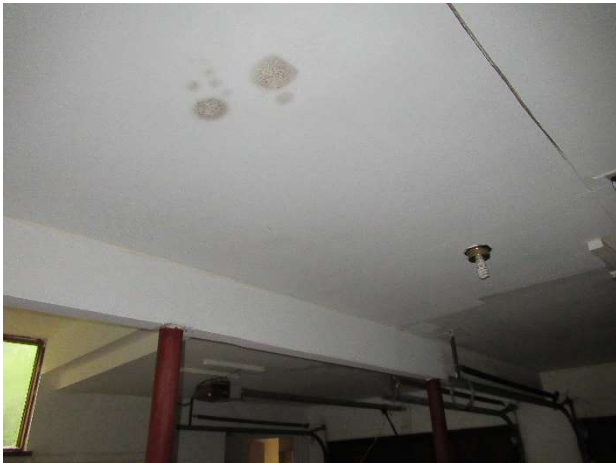
Observation #10.2: Water stains were observed in the basement drop ceiling and garage ceiling at many locations. Mold was observed on some of the floor planks above the drop ceiling.

Implication: Possible previous water leakage from piping or floor above.

Comments: Recommends hiring a contractor to replace the drop ceiling with water stains and hiring a plumber to evaluate the piping above the ceiling for possible source of water leakage and perform the required repair.

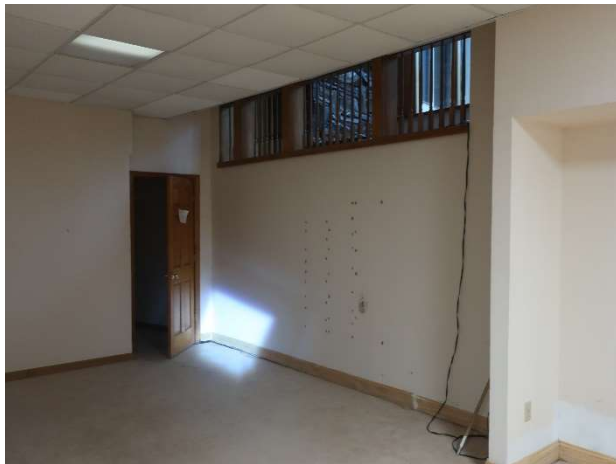
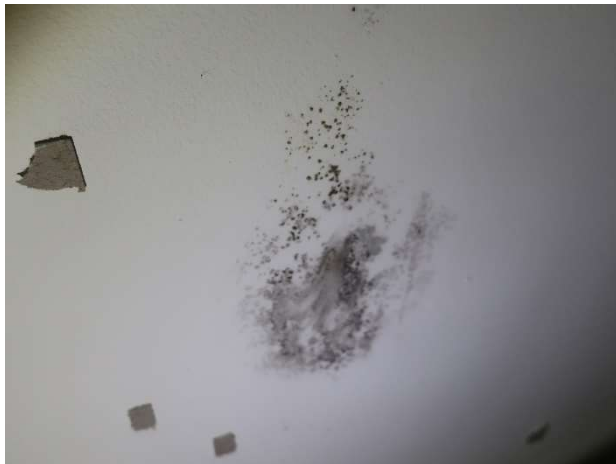
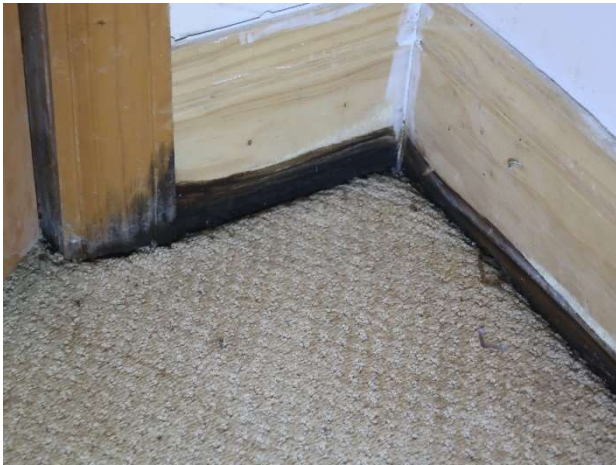
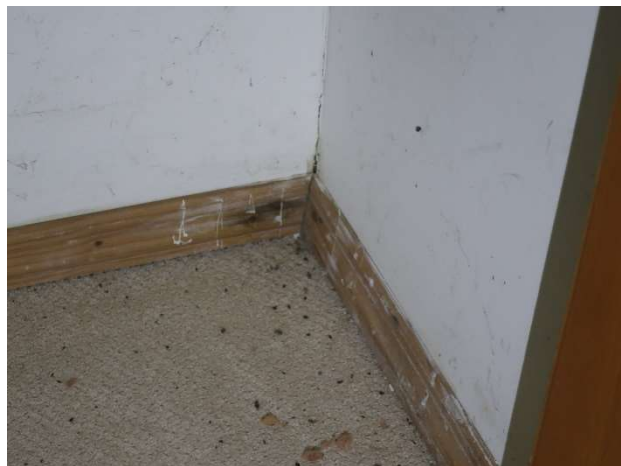
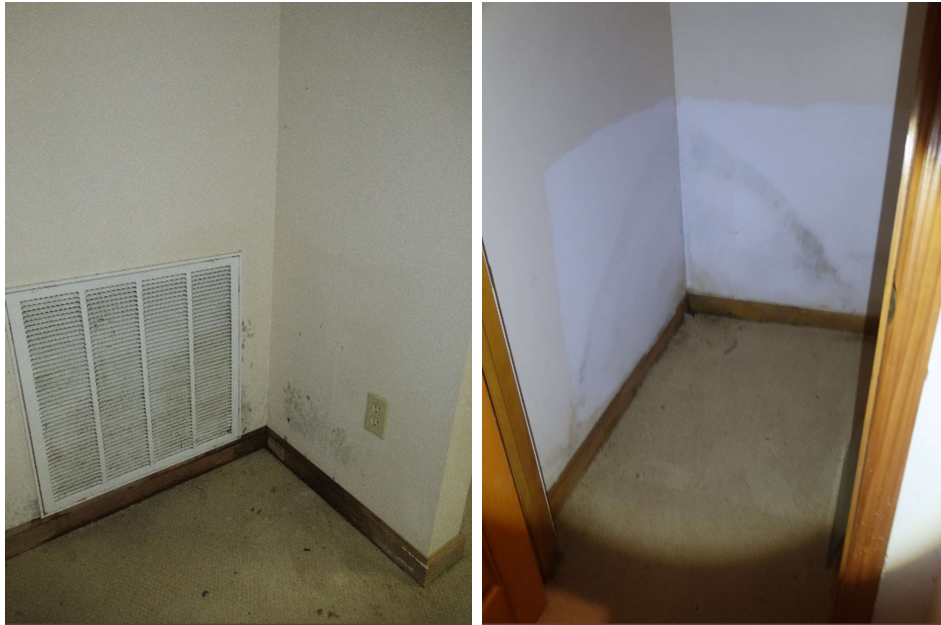
Observation #10.3: Water stain and mold were observed at multiple locations along the interior face of the basement wall.

Implication: Health Issue. Excessive moisture condition in along the basement wall. Possible water infiltration from the exterior side of the wall. This could imply possible damage of the waterproofing at the exterior side of the foundation wall or even damage in the foundation walls.

Comments: Recommends hiring a contractor and a structural engineer to further investigate the source of the water infiltration and the condition of the existing foundation wall. Repair the damaged waterproofing and foundation walls as required. Remove and replace the damaged interior wall finishes and floor moldings.

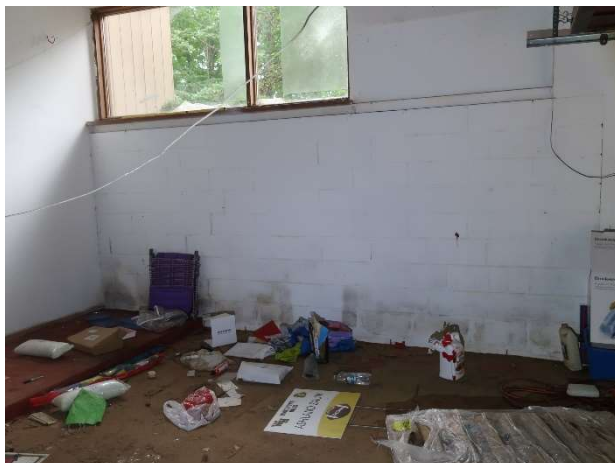
Observation #10.4: The bottom of the masonry wall in the garage space appeared to have black mold stains.

Implication: Health Issue. Excessive moisture condition in along the bottom of the masonry wall. Possible water infiltration from the exterior side of the wall.

Comments: Recommends hiring a contractor and a structural engineer to further investigate the source of the water infiltration and the condition of the existing masonry wall. Install waterproofing and repair masonry walls as required.

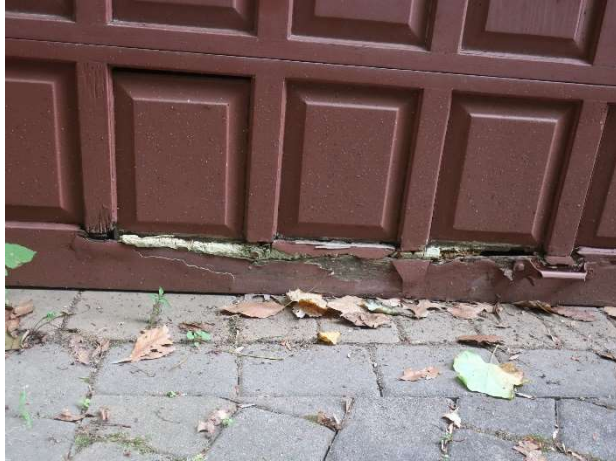
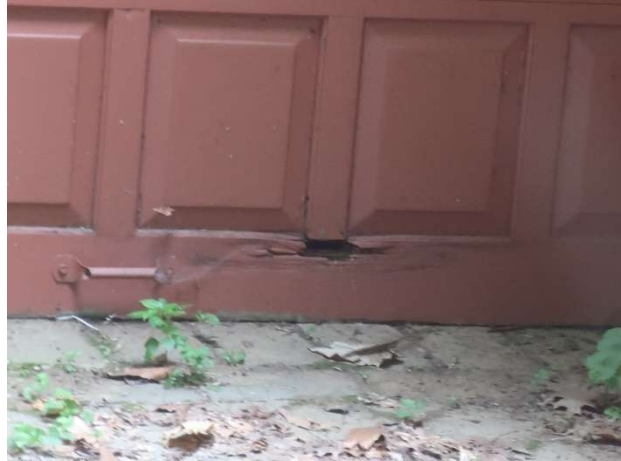
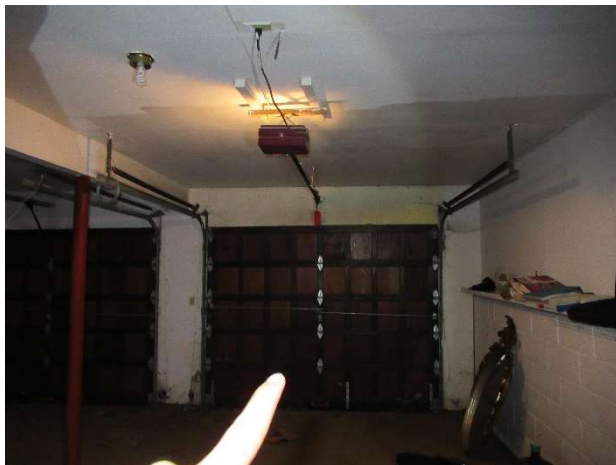
Observation #10.5: Two of the garage doors were observed to be damaged. One of garage door opening machine was inoperable.

Comments: Recommends hiring a garage door technician to repair/replace the damaged garage doors and the inoperable opening machine.

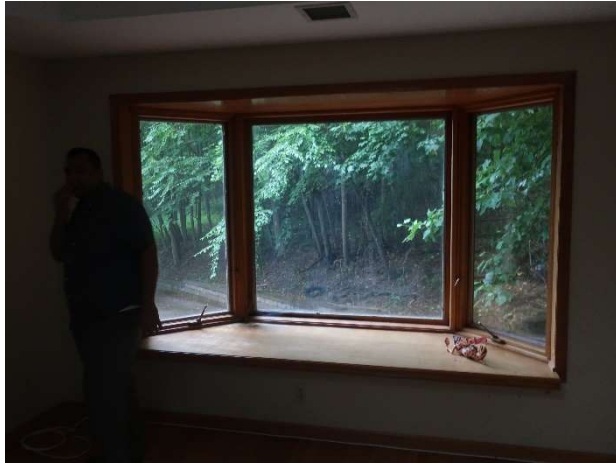
Observation #10.6: One of the bay window frames appeared to have significant water damage.

Implication: Water infiltration. Possible damage to window and adjacent structural components.

Comments: Recommends hiring a window profession to the replace the window frame and the window as required.

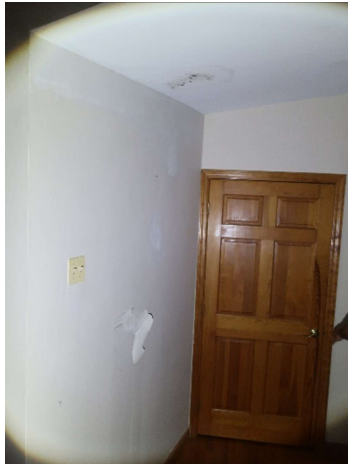
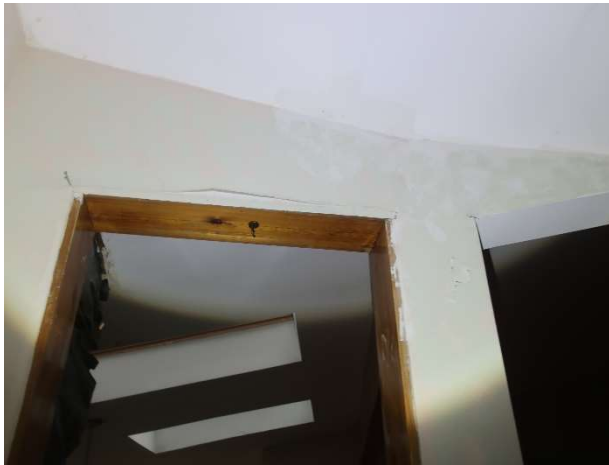
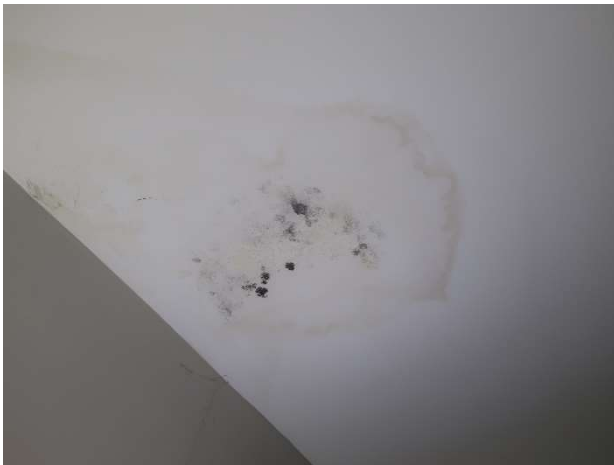
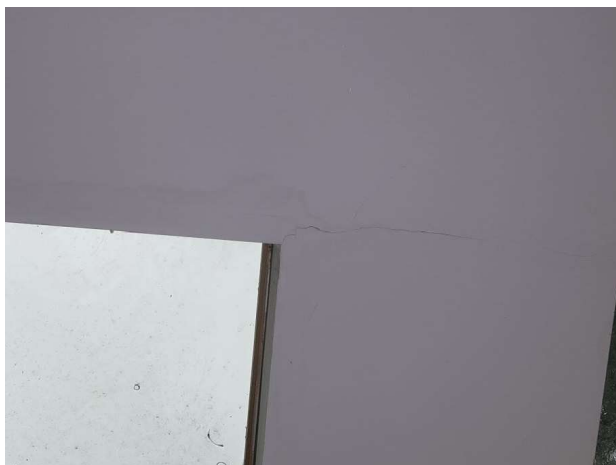
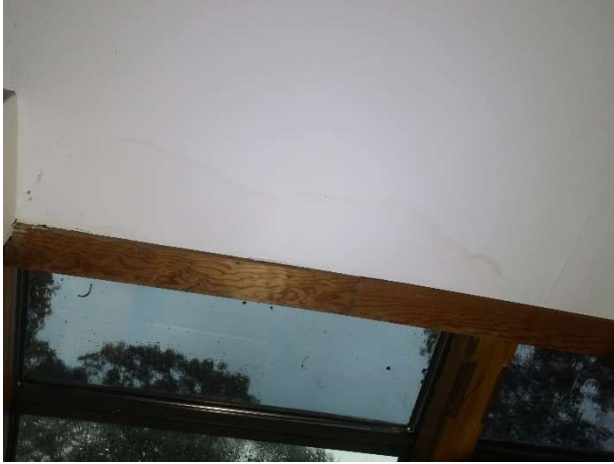
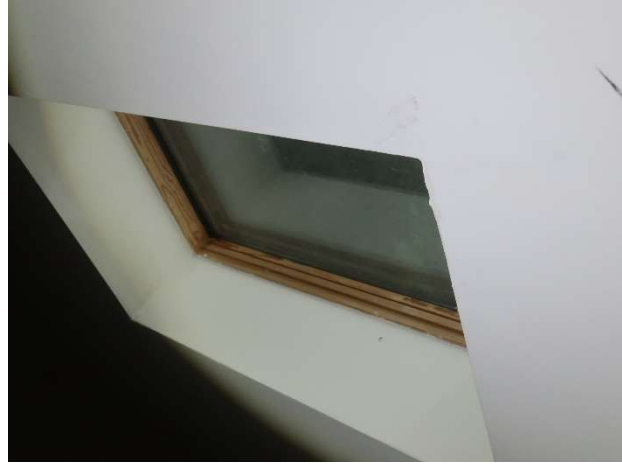
Observation #10.10: Water damage was observed on the 1<sup>st</sup> and 2<sup>nd</sup> floor ceiling finishes in many locations.

Implication: Water infiltration. Possible deteriorated/damaged roofing or damage roof structural elements.

Comments: Recommends hiring a contractor to localize remove the damage ceiling finish to expose the roof structural element behind for further investigation. See roofing section for roofing related observations.

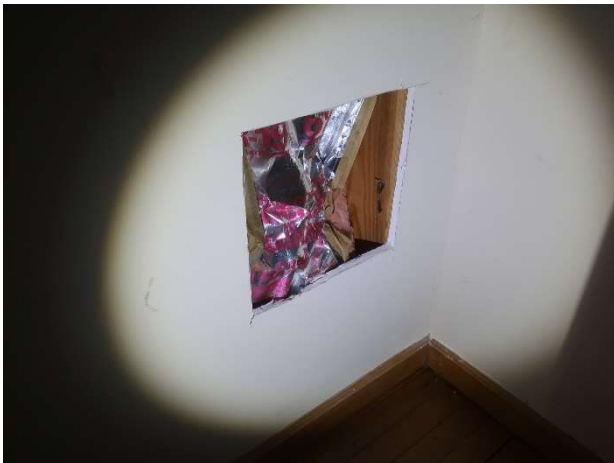
Observation #10.11: An opening was observed in the wall finish.

Comments: Recommends hiring a contractor to repair the opening.

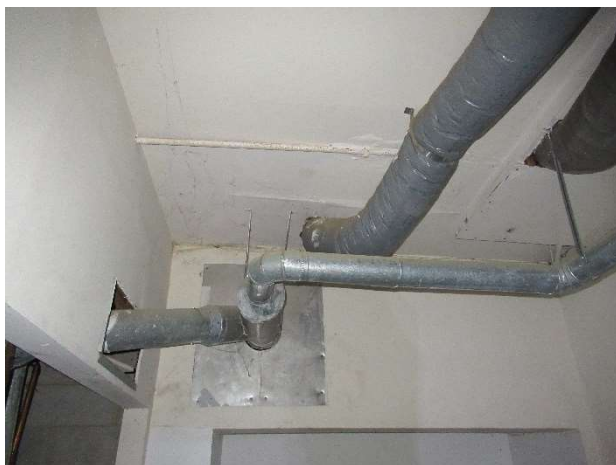
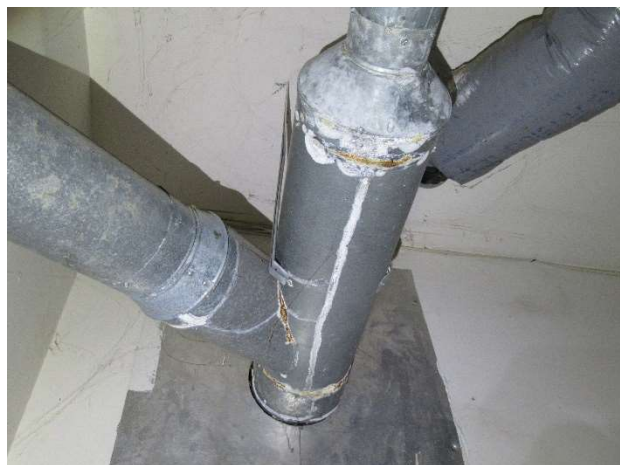
Observation #11.1: The water heating vent pipe and furnace flues appeared to have corroded and deterioration.

Implications: Possible vent/draft problem

Comments: Recommends hiring a contractor to repair and replace the affected vent system. The gas water heater vent connector should vent above the gas furnace vent connector.

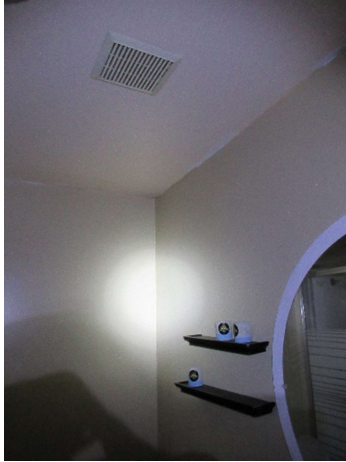
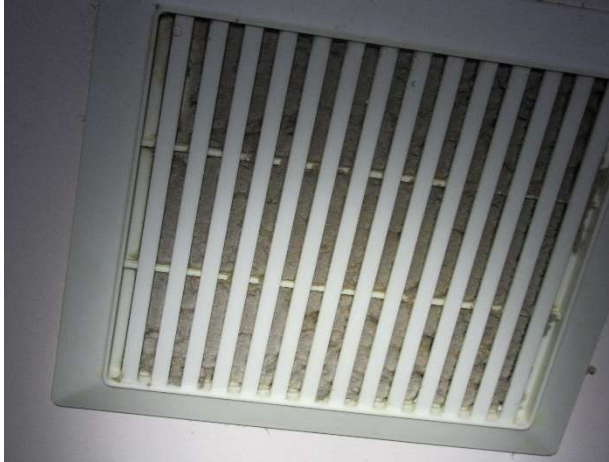
Observation #11.2: The bathroom exhaust vent

Implication: Possible poor air flow and improper air ventilation in the bathroom

Comments: Recommends cleaning bathroom vent regularly.

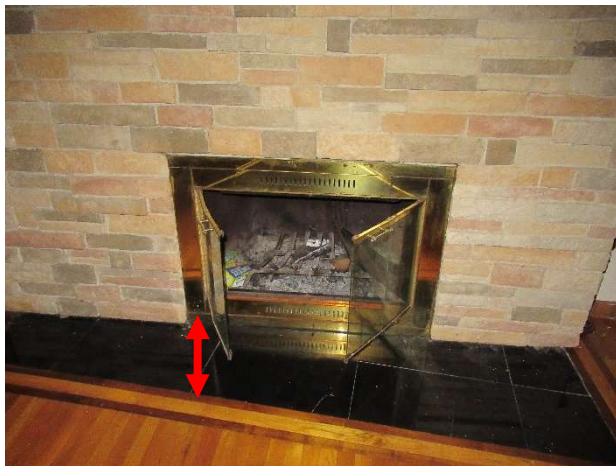
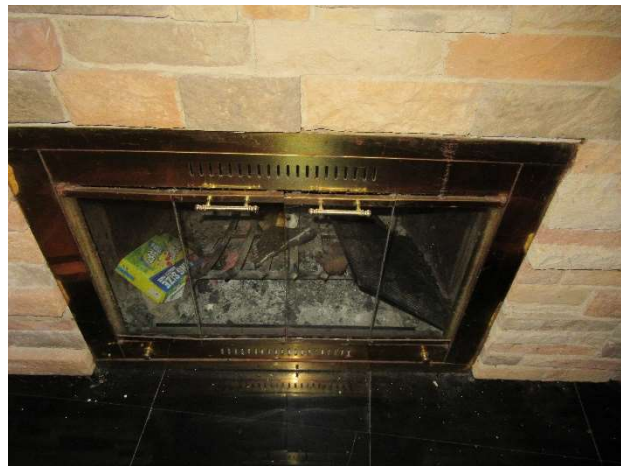
Observation #12.1: The fireplace hearth extension appeared to be inadequate. The hearth extension should extend at least 20 inches in front of the firebox opening that has an area of 6 or more square feet. The hearth extension for masonry fireplace should be made from concrete or solid masonry that is at least 2 inches thick.

Comments: Recommends hiring a qualified specialist for further evaluation and general contractor for repair work.

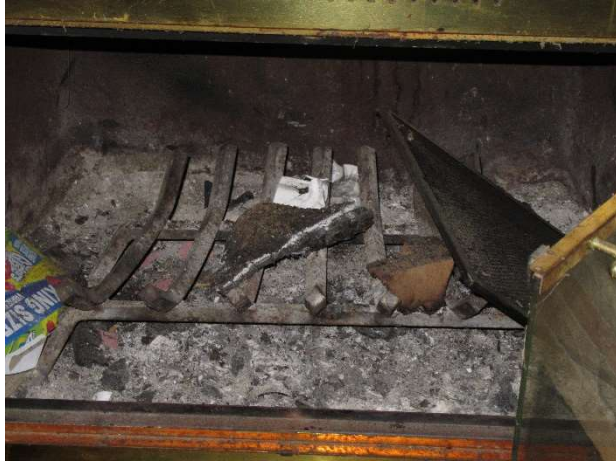
Observation #12.2: The interior of firebox was full of debris and ashes. The interior elements were appeared to be deteriorated.

Comments: Recommends hiring a qualified specialist for further evaluation and general contractor for repair work. Recommends regular cleaning of the firebox interior.

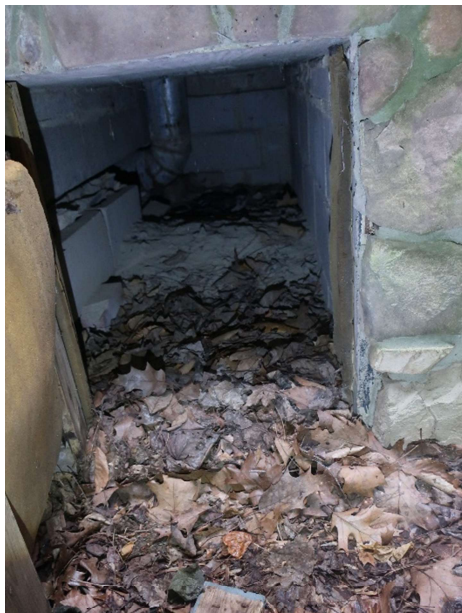
Observation #12.3: The cleanout located in rear yard appeared to be full of debris, leaves and ashes.

Comments: Recommends regular cleaning of the clean out.
