Home Inspection Report

Prepared By: Zoey Tham, #16000141960

PE Home Inspection, LLC • www.pehomeinspection.com • 609-203-0265 • pehomeinspection@gmail.com

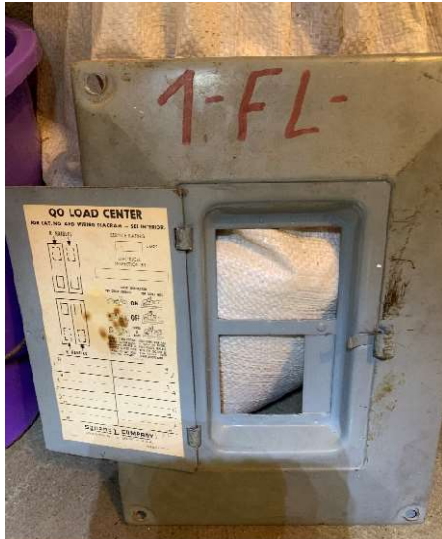
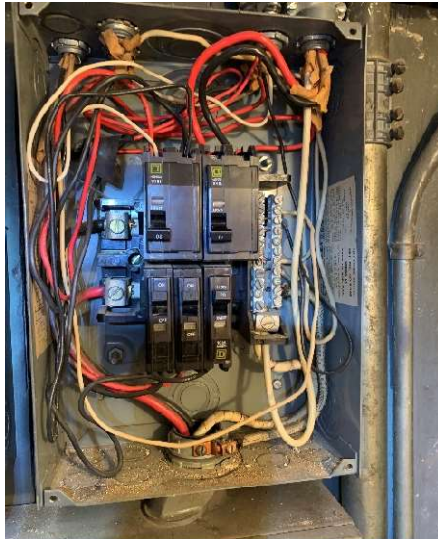
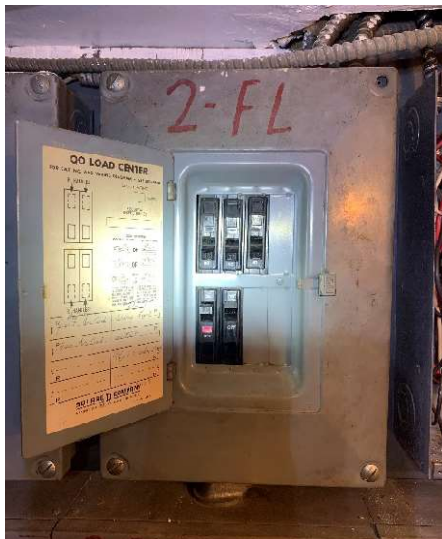
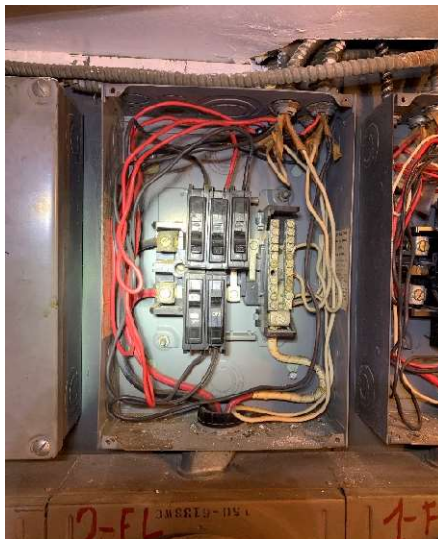
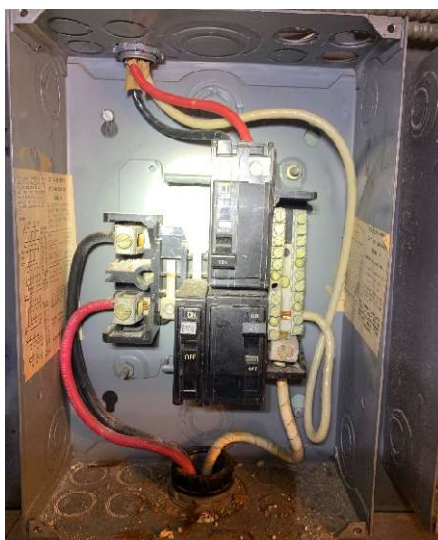
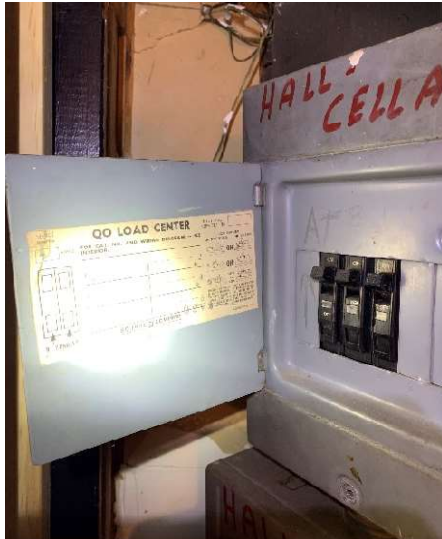
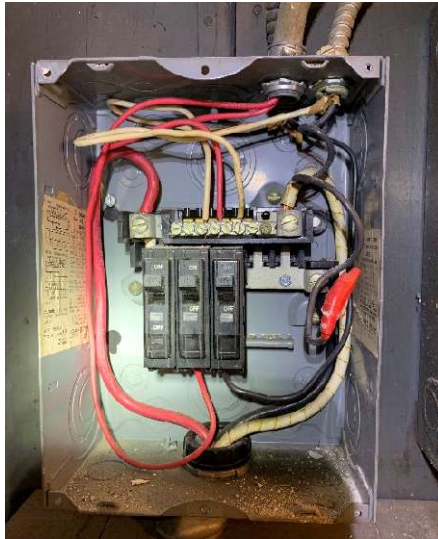
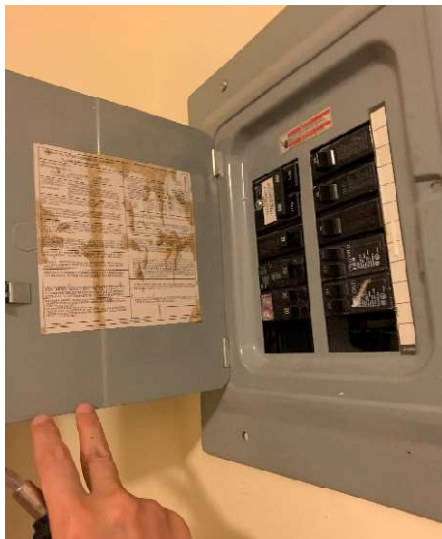
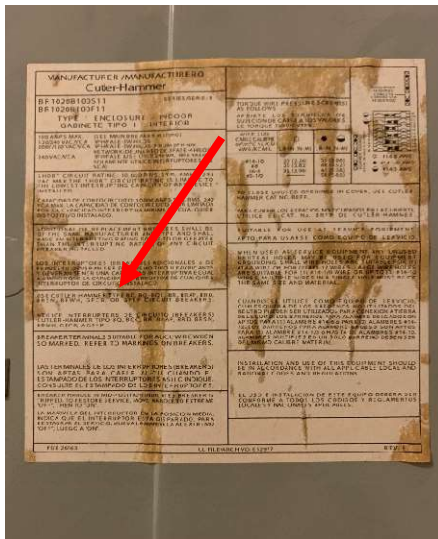
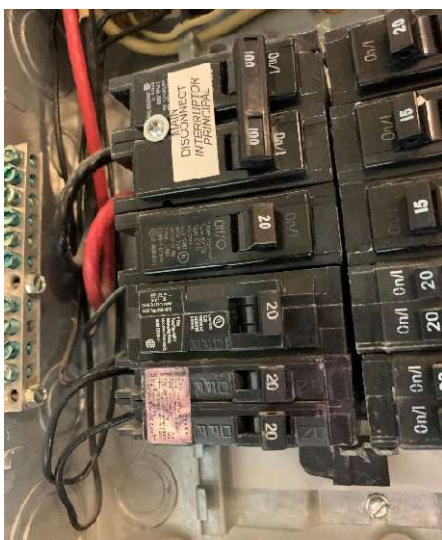
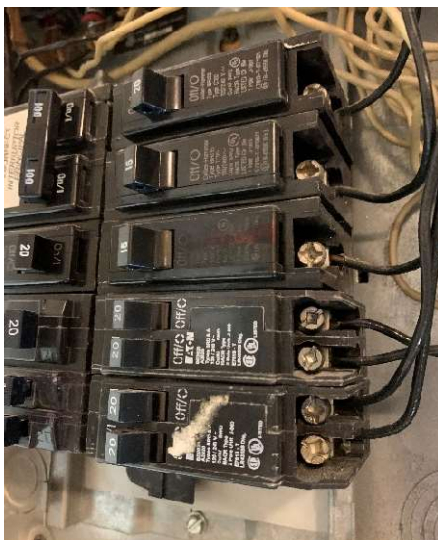
Condition 5: Most of the breakers installed do not match the electrical panel brand.

Comment: A breaker from different manufacturer may not be used even if it seems to fit. Recommends hiring an electrician for further evaluation and replacement.

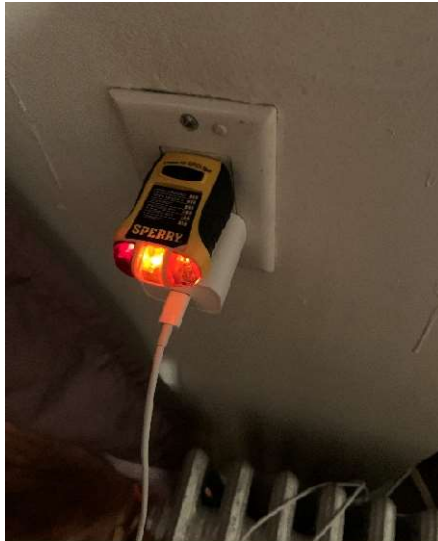
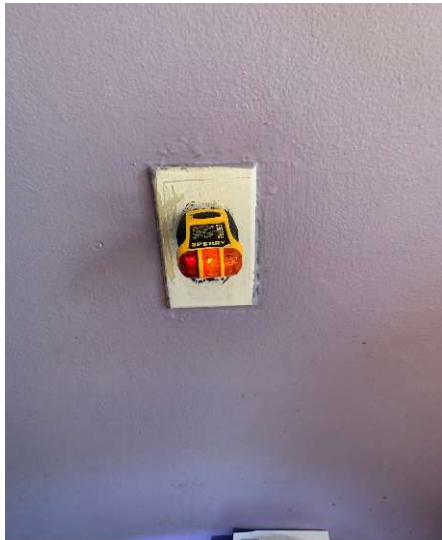
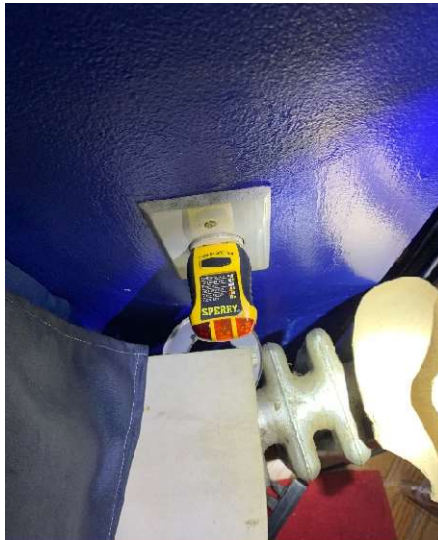
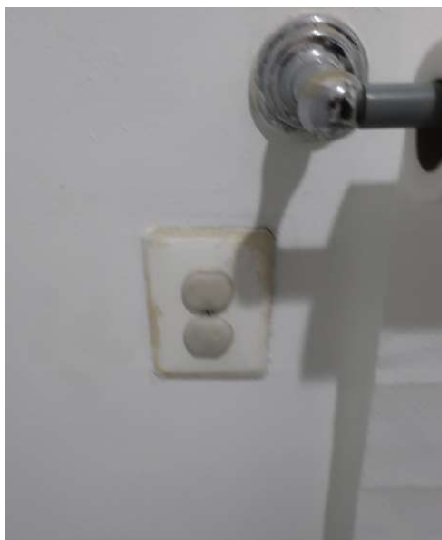
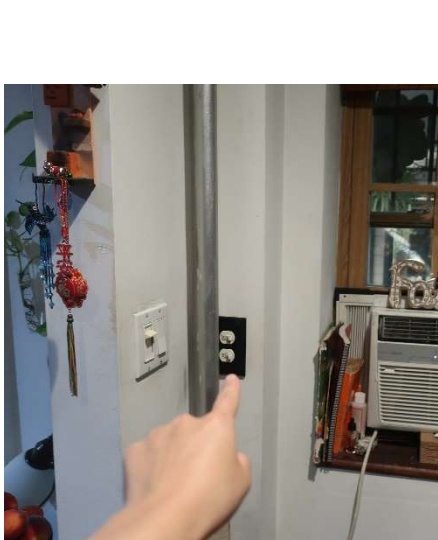
Condition 2: Various electrical outlets and switches were malfunction when tested.

Comment: Recommends hiring an electrician for further evaluation, repair, and replacement.
